Geotechnical Assessment

Project: Alterations & Additions
5A Wabash Avenue, Cromer NSW

REF: AG 19184
9th October, 2019

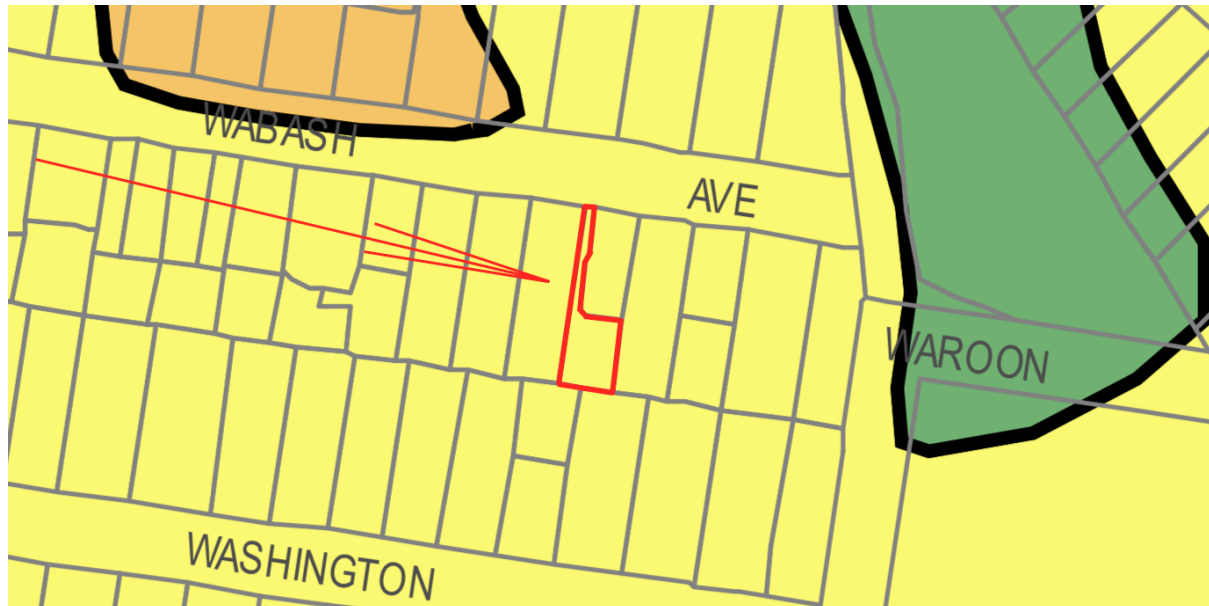
WARRINGAH LANDSLIP RISK MAP

- Area A - Slope less than 5 degrees
- Area B - Flanking Slopes from 5 to 25 degrees
- Area C - Slopes more than 25 degrees
- Area D - Collaroy Plateau Area Flanking Slopes 5 to 15 degrees
- Area E - Collaroy Plateau Area Slopes more than 15 degrees

- No evidence of significant soil creep, tension cracks or other indicators of slope instability were identified at the time of our inspection.
- The existing structures including retaining walls displayed no evidence of significant cracking or settlement that could be attributed to slope instability.
- The property is classified as **Area A** with reference to Northern Beaches Council WLEP Landslip Risk Map Sheet LSR_009 (WLEP Landslip Risk Map **Image 2** below).

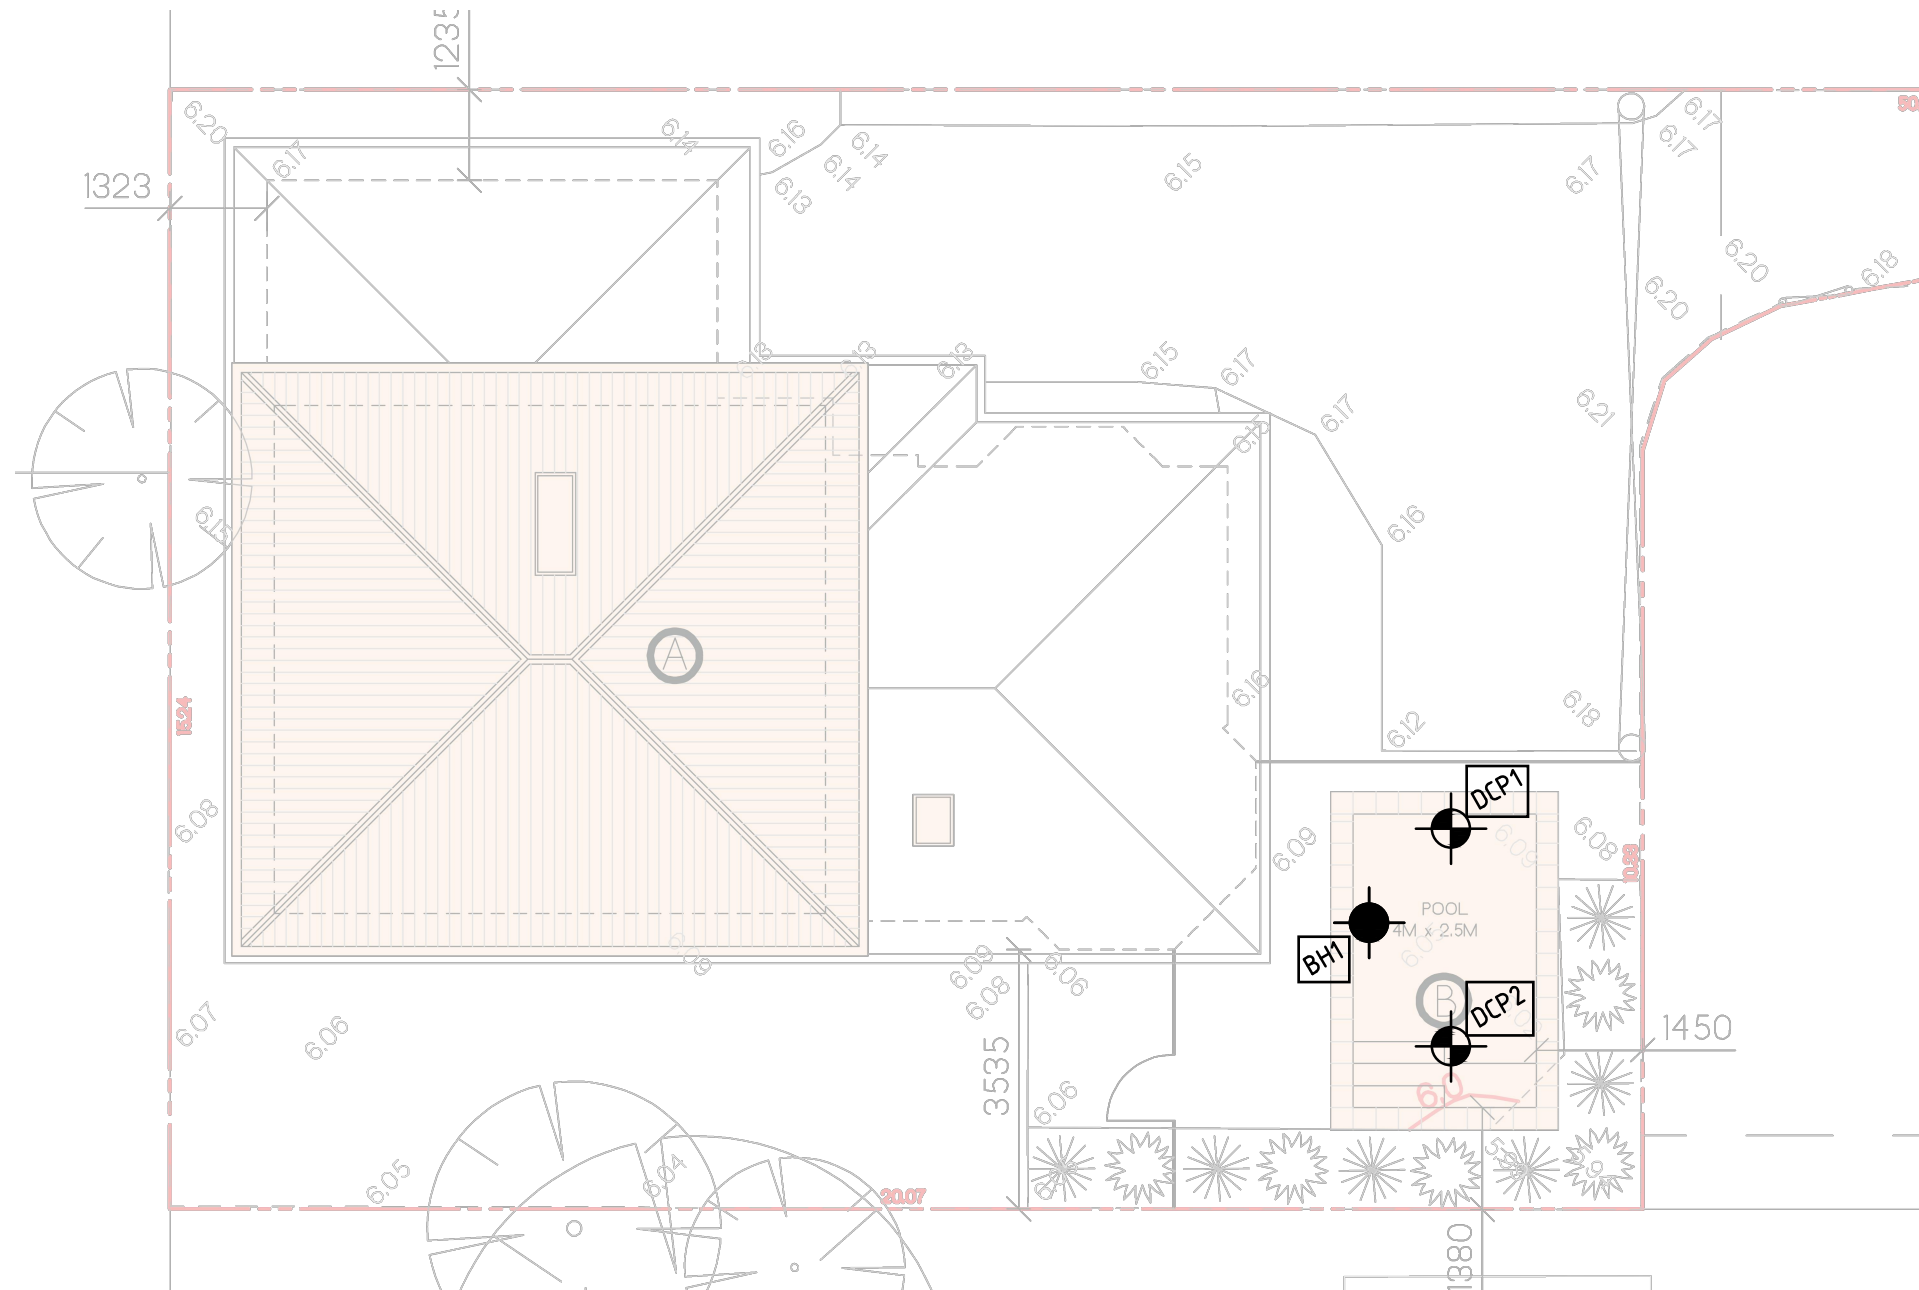
SITE PLAN/GROUND TEST LOCATIONS

DCP LOCATIONS

BOREHOLE LOCATION

Appendix A:	Site Plan/Ground Test Locations & Geological Cross Section
Appendix B:	Engineering logs
Appendix C:	General Notes
	CSIRO Sheet BTF-18 “Foundation Maintenance and Footing Performance: A Homeowners Guide”
	Australian Geoguide LR8 – Examples of Good/Bad Hillside Construction Practice
	Australian Geomechanics Guidelines 2007 Appendix C

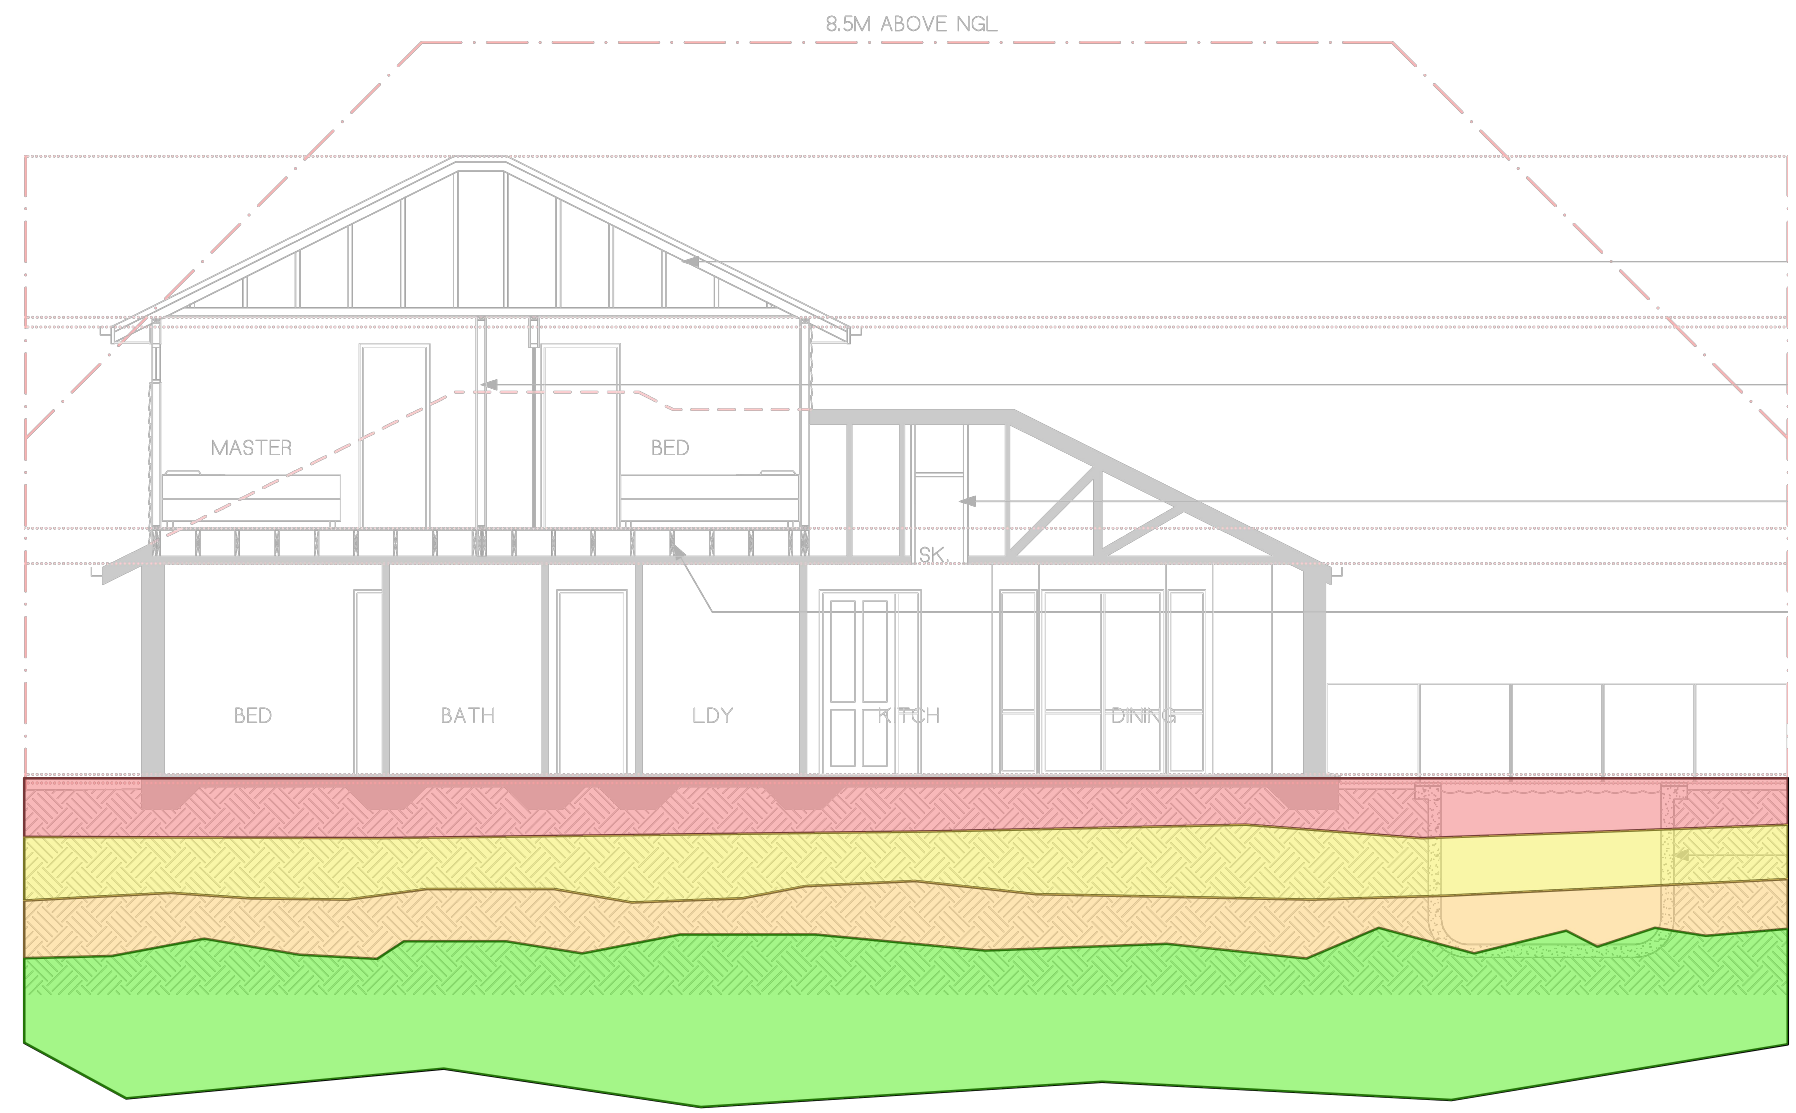
INFERRED GEOLOGICAL SECTION
SCALE NTS

INTERPRETED SUBSURFACE SECTION ONLY.
ACTUAL GROUND CONDITIONS MAY VARY.

- LEGEND**
- FILL
 - CLAYEY SANDS
 - SANDY CLAYS
 - HAWKESBURY SANDSTONE BEDROCK

The soil profile consists of fill (O & A Horizons) and sandy clays and clayey sands (B Horizon) overlying weathered sandstone bedrock (C Horizon). Based on our observations and the results of testing onsite, we would expect competent weathered bedrock to be found within 2100mm from current surface levels across the site of the proposed works.
