## **PRELIMINARY GEOTECHNICAL ASSESSMENT:**

### **26 Carnarvon Drive, Frenchs Forest**

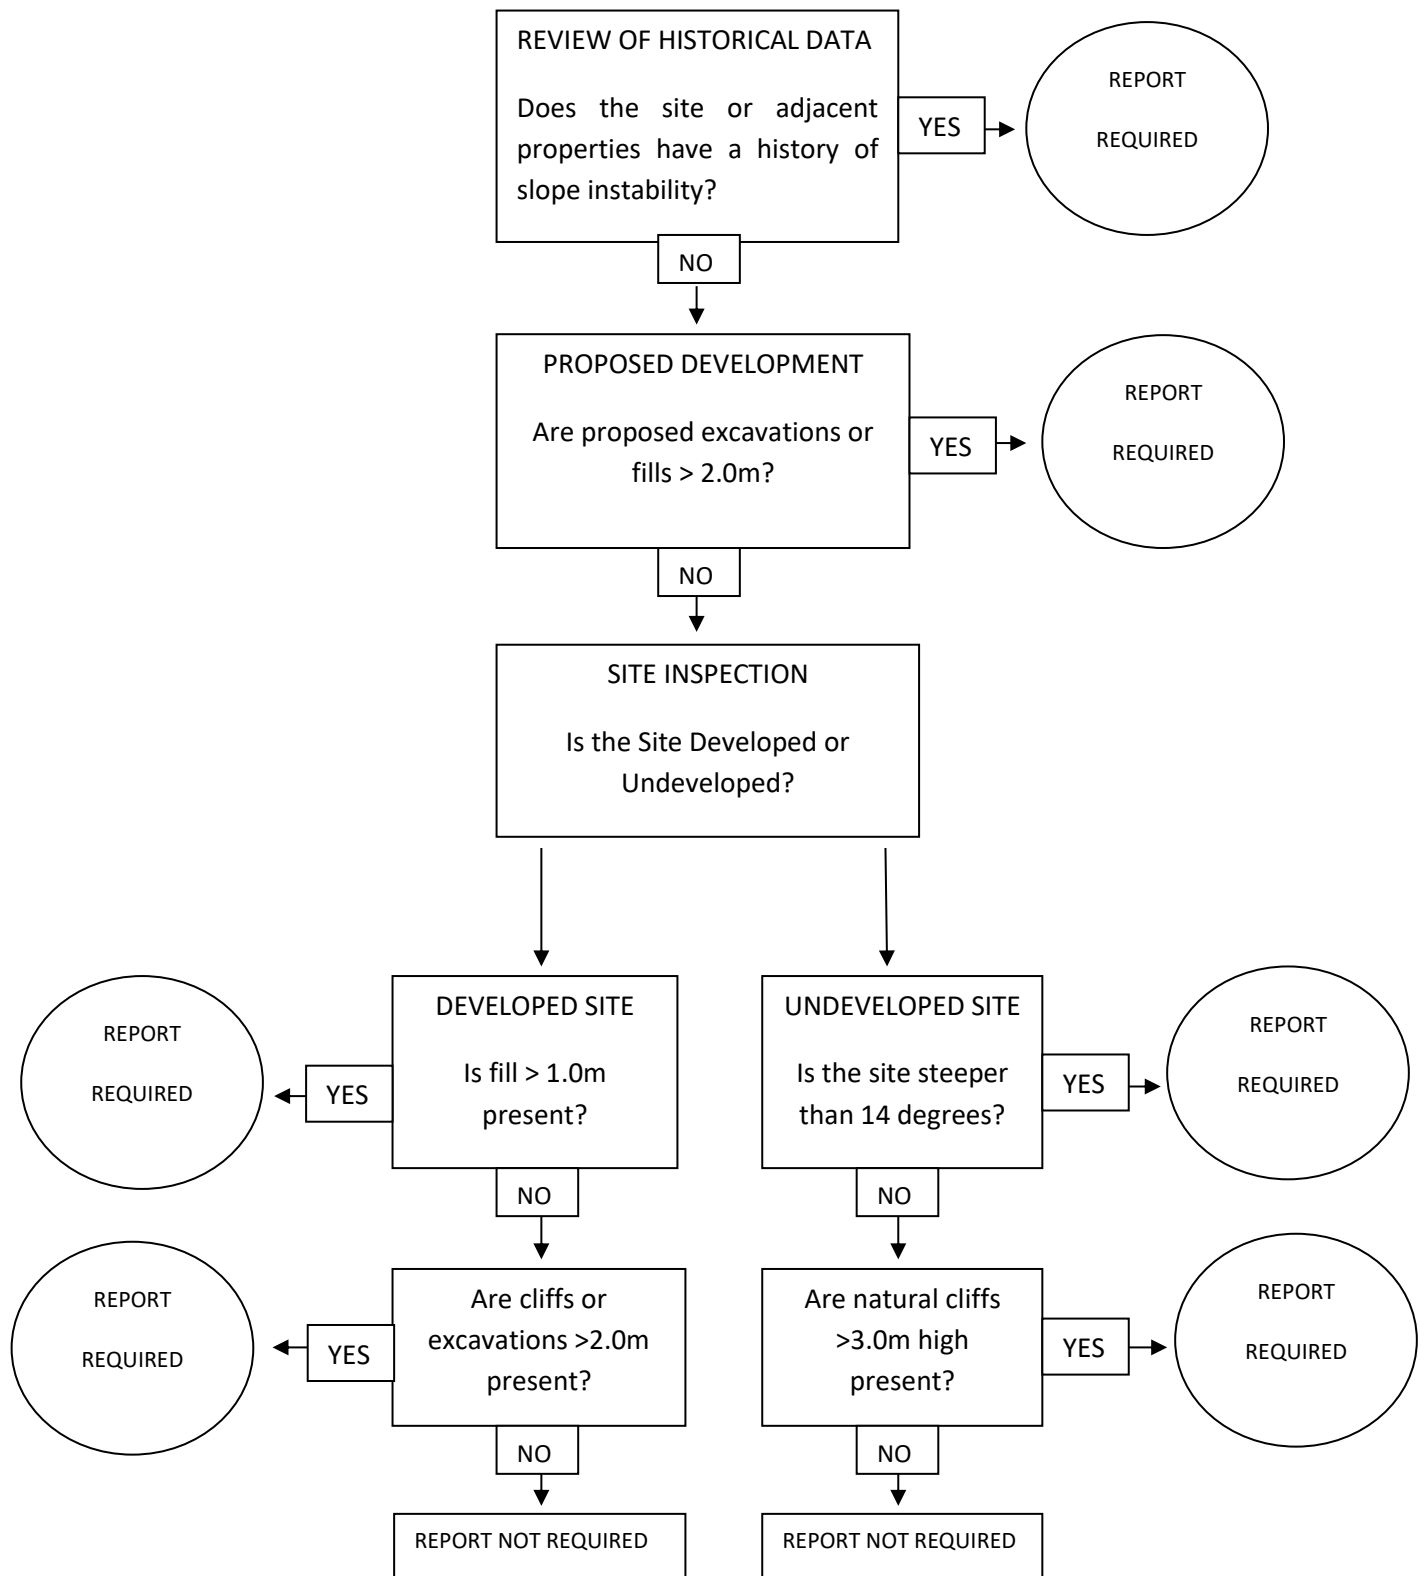
## Preliminary Assessment Flow Chart – Northern Beaches Council (Warringah)

The proposed development and site conditions were considered and applied to the Council Flow Chart.

Provided good engineering and building practice are followed, no further Geotechnical assessment is recommended for the proposed development.
