**GEOTECHNICAL RISK MANAGEMENT POLICY FOR PITTWATER  
FORM NO. 1 – To be submitted with Development Application**

Development Application for Roger & Helen Matthews  
Name of Applicant

Address of site 51 Park Avenue, Avalon

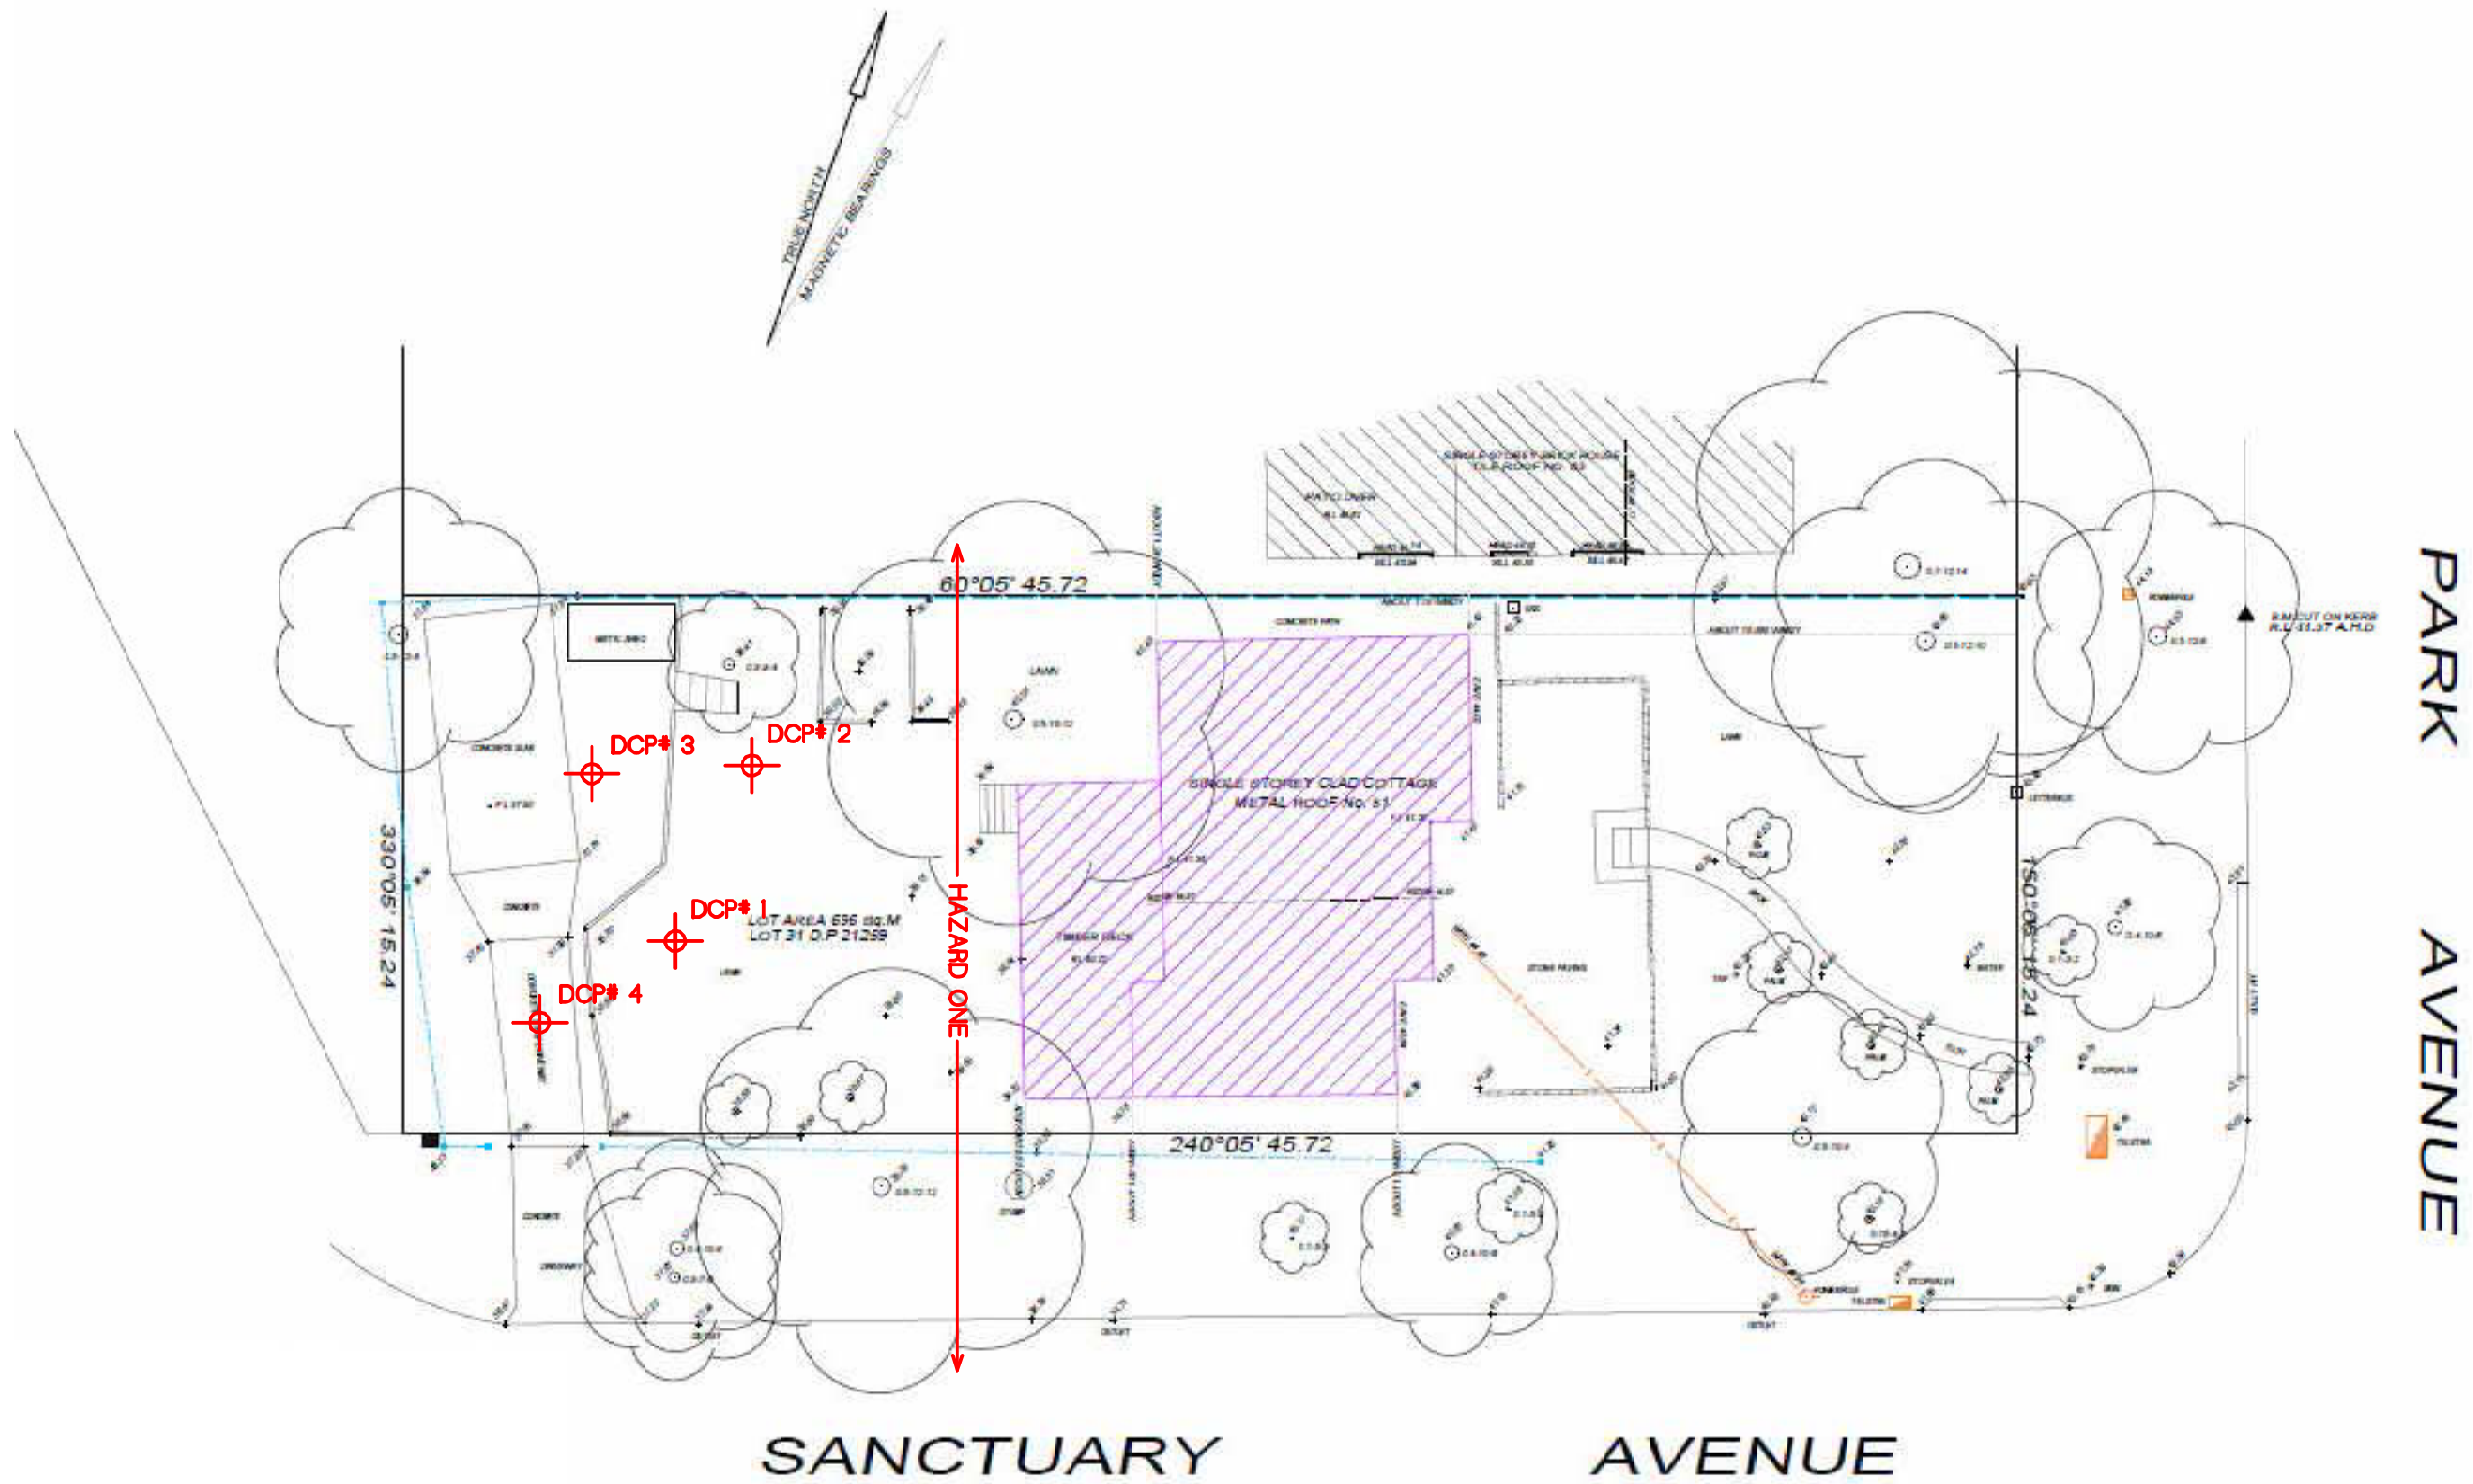
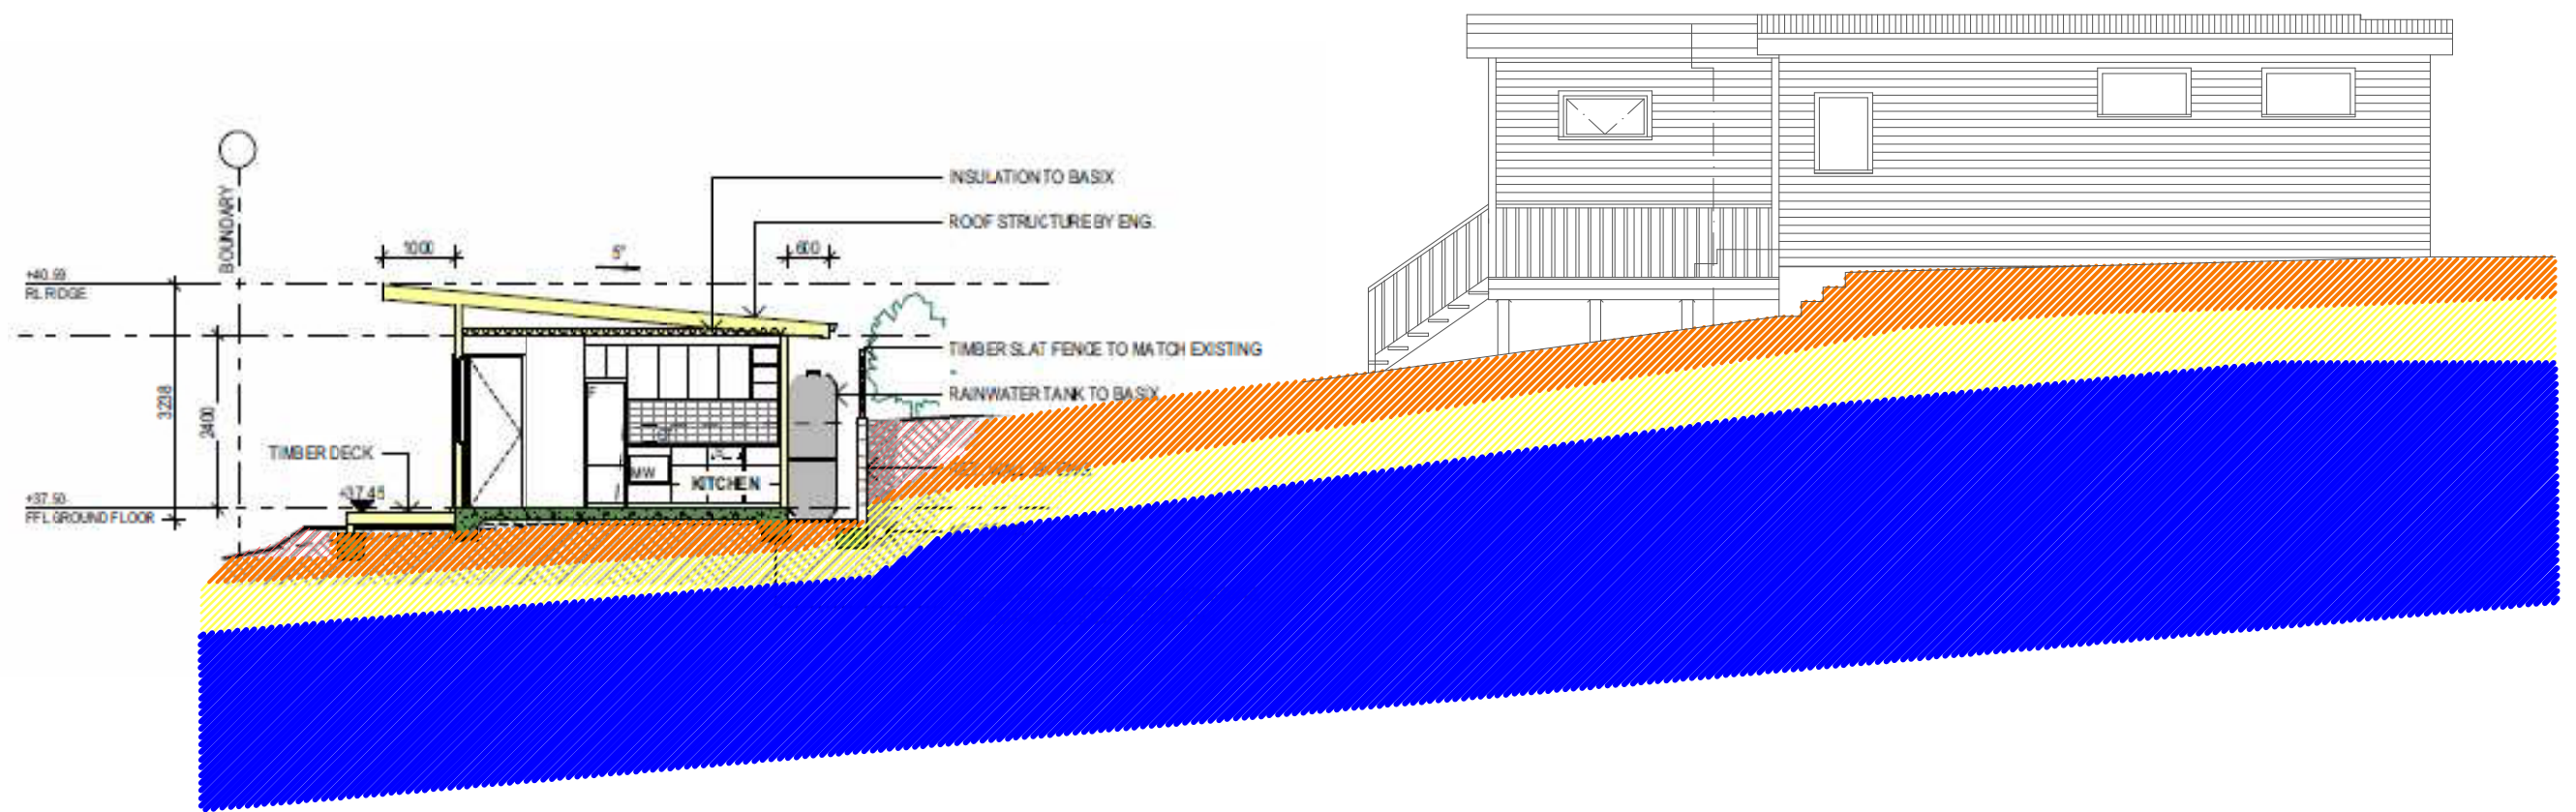
**NOTE**  
INTERPRETED SUB SURFACE SECTION ONLY.  
ACTUAL GROUND CONDITIONS MAY VARY.
