PRELIMINARY GEOTECHNICAL ASSESSMENT:

39 Pittwater Road, Manly

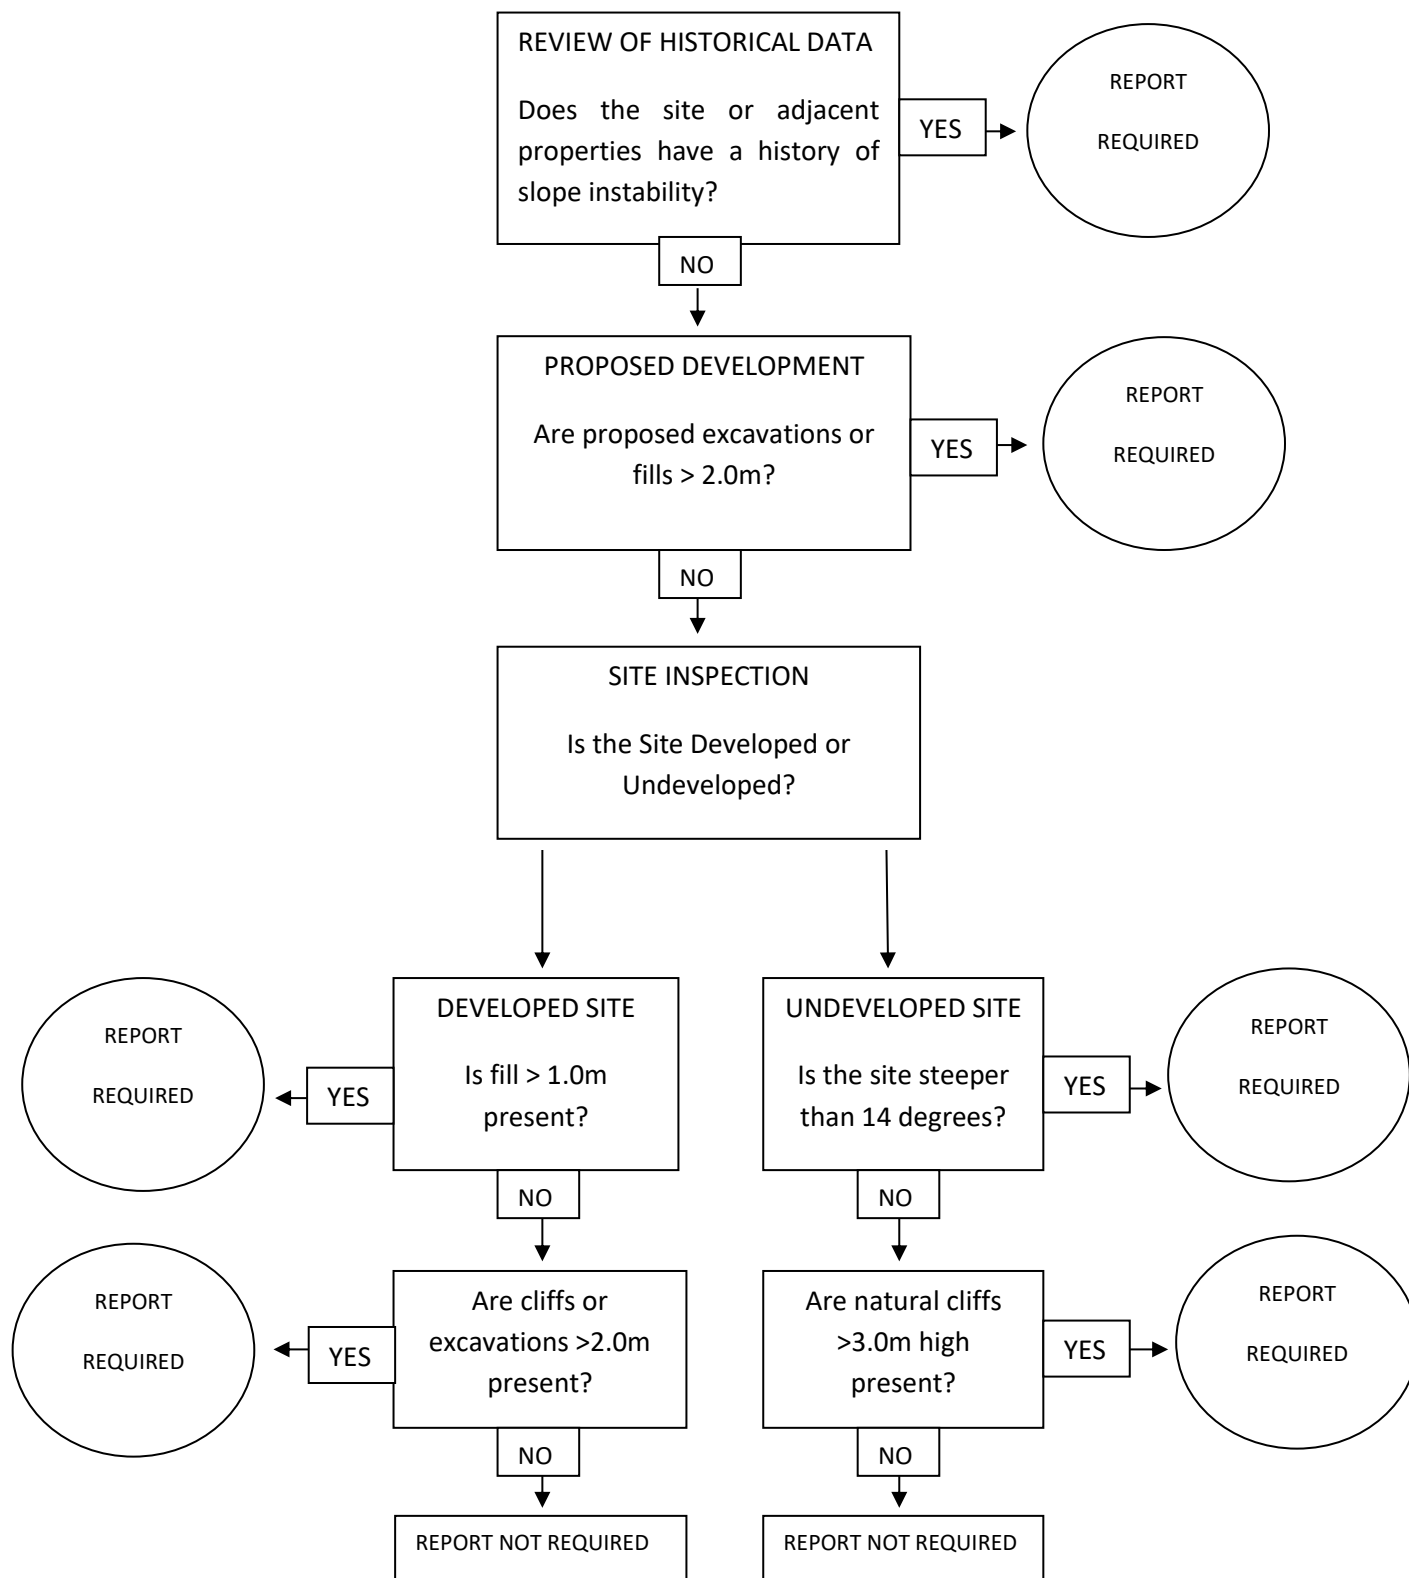
Preliminary Assessment Flow Chart – Northern Beaches Council (Manly)

The proposed development and site conditions were considered and applied to the Council Flow Chart.
