## **Geotechnical Assessment**

**Project:** Seniors Living Development  
85-87 Blackbutts Road, Frenchs Forest NSW

**REF: AG 19224**  
4<sup>th</sup> December, 2019

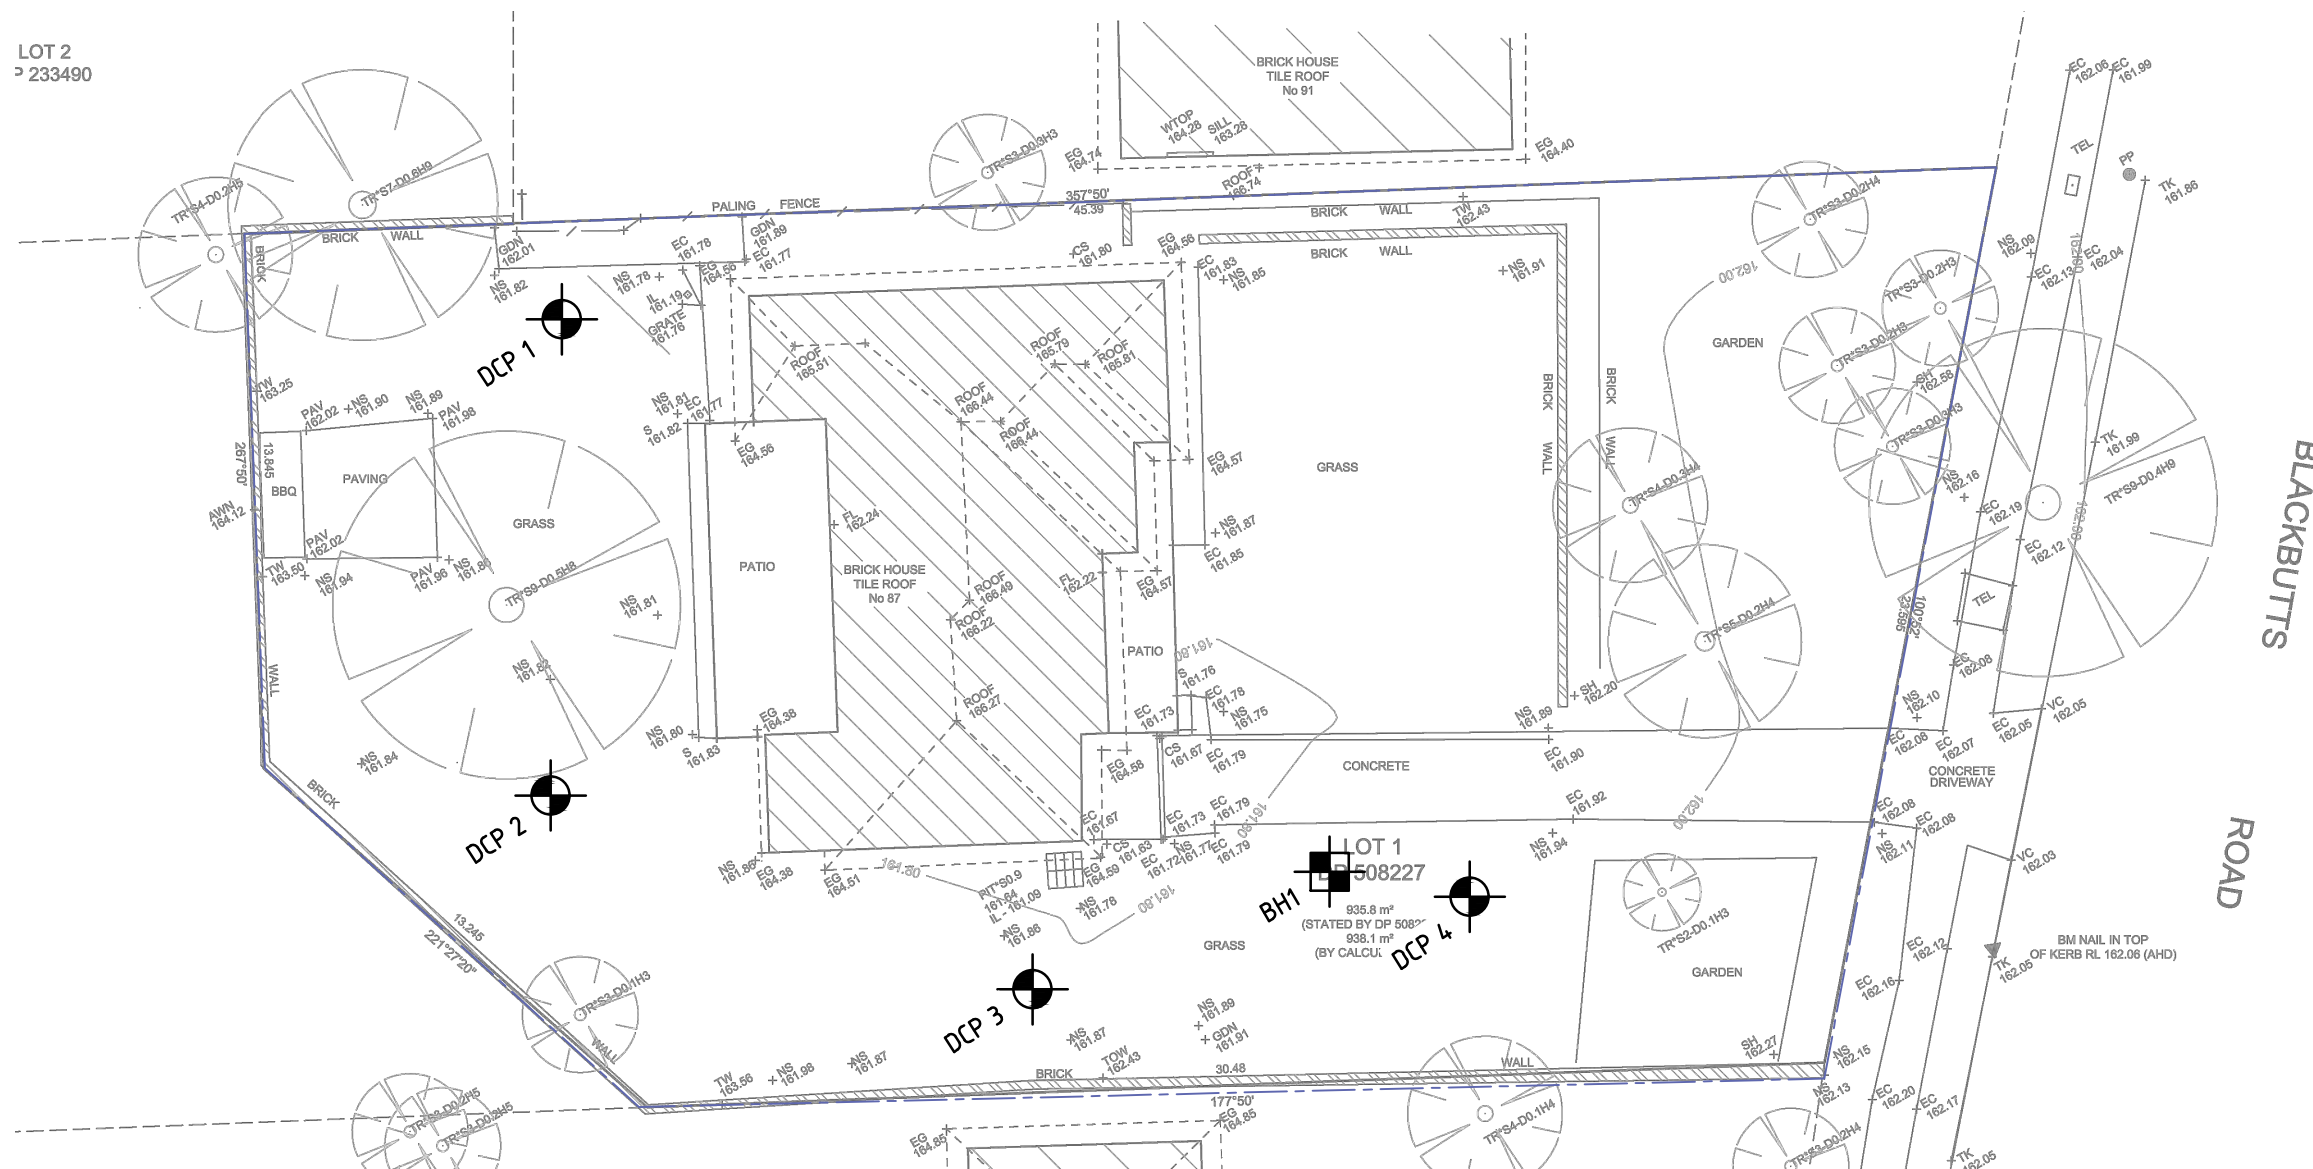
**SITE PLAN/GROUND TEST LOCATIONS**

BORE HOLE LOCATIONS

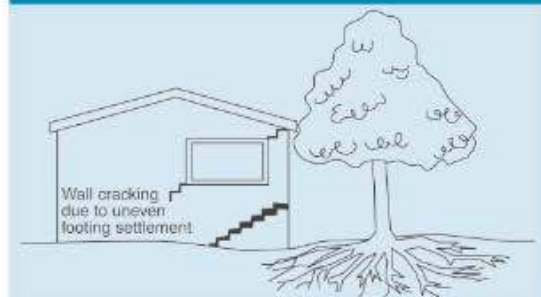
#### Trees can cause shrinkage and damage

As the weather pattern changes and the soil begins to dry out, the external footings will be first affected, beginning with the locations where the sun's effect is strongest. This has the effect of lowering the external footings. The doming is accentuated and cracking reduces or disappears where it occurred because of dishing, but other cracks open up. The roof lines may become convex.
