## **Geotechnical Assessment**

**Project:** New Inclined Lift  
15 Brindisi Place, Avalon Beach NSW.

**REF: AG 21385**  
22 November 2021

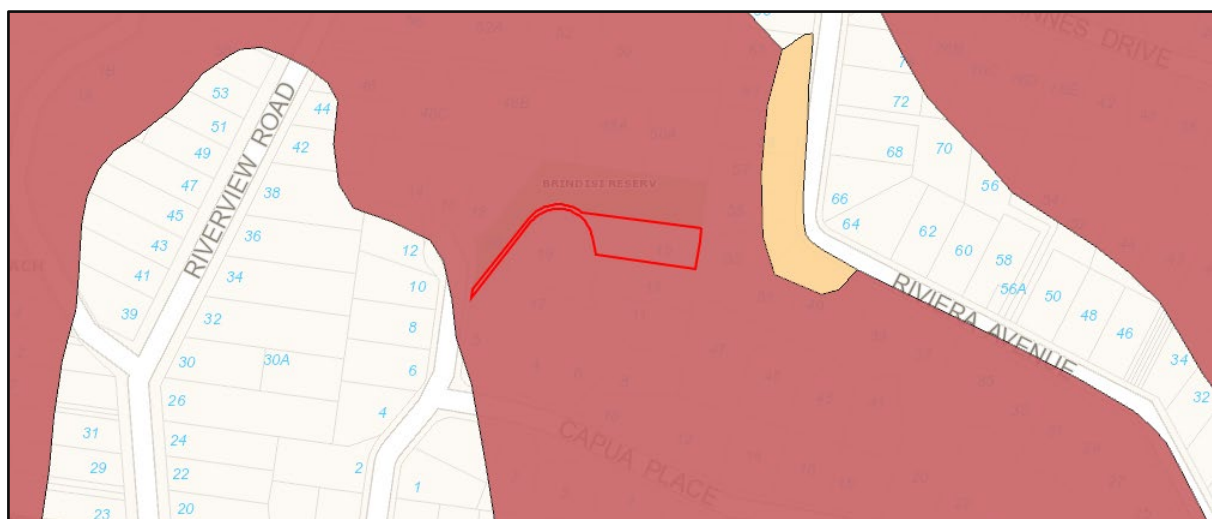
**Image 2.** PLEP Geotechnical Hazard Map  
– 15 Brindisi Place, Avalon Beach NSW (NBC Maps)

- No evidence of significant soil creep, tension cracks or landslip instability were identified across the site or on adjacent properties as viewed from the subject site at the time of our inspection.
- Based on reference to the plan entitled "Geotechnical Hazard Mapping" (Ref. P21DCP-BC-MDCP2002, dated 2007) prepared by GHD LONGMAC on behalf of Pittwater Council, the site is mapped as a **Geotechnical Hazard H1** area.

**LEGEND**  
**Pittwater Geotechnical Hazard Map**  
■ Geotechnical Hazard H1  
■ Geotechnical Hazard H2

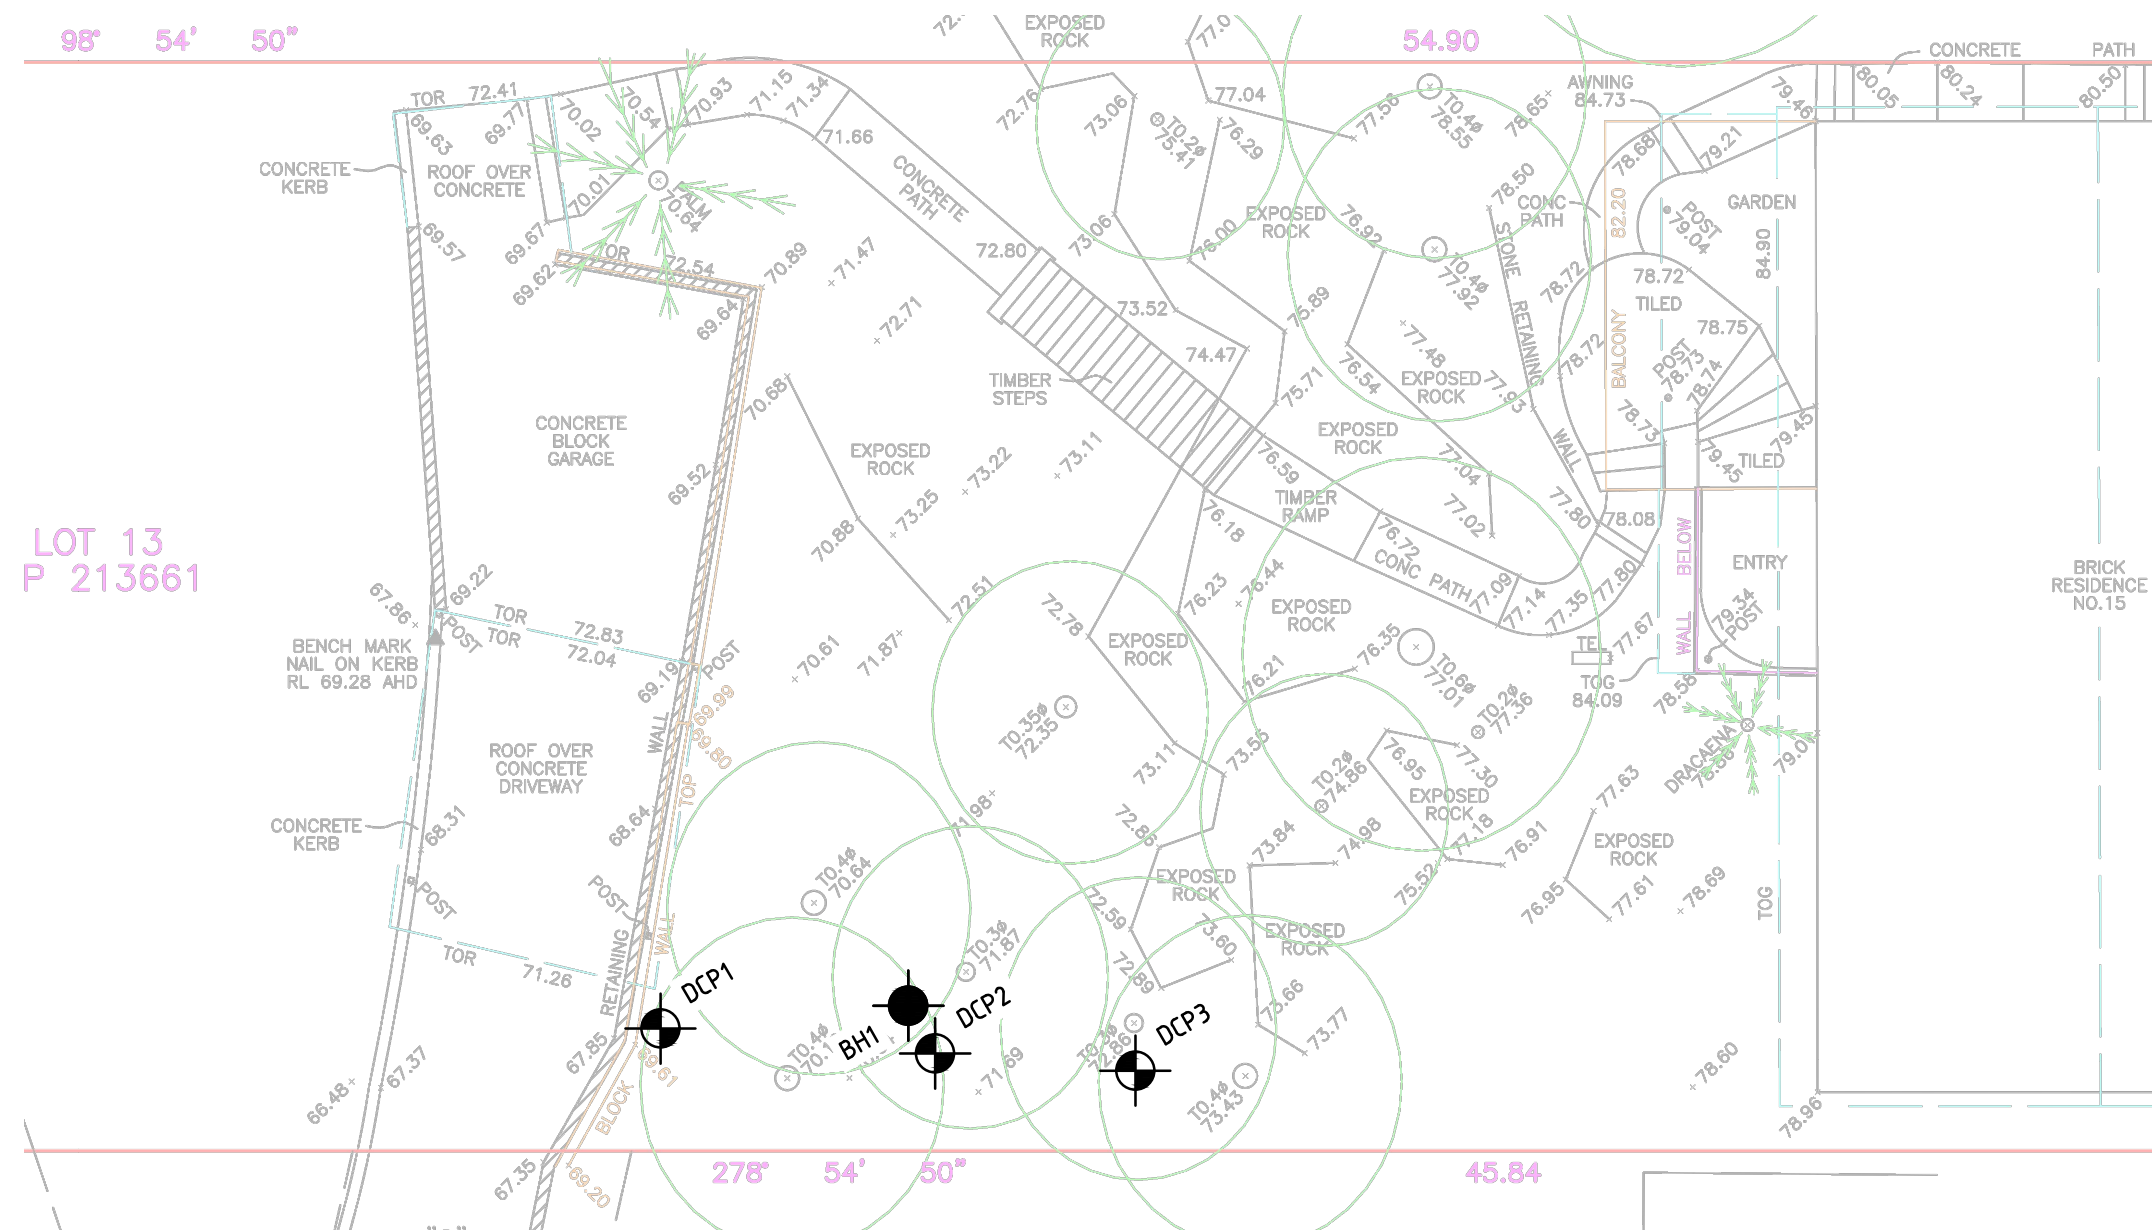
**SITE PLAN/GROUND TEST LOCATIONS**  
SCALE NTS

DCP LOCATIONS

BOREHOLE LOCATION

**SITE PLAN/GROUND TEST LOCATIONS  
AT 15 BRINDISI PLACE  
AVALON BEACH NSW**
