STATE TRANSIT AUTHORITY

JUNE 2020

# ENVIRONMENTAL MANAGEMENT PLAN

MONA VALE BUS  
DEPOT - 58 DARLEY  
ST, MONA VALE  
NSW

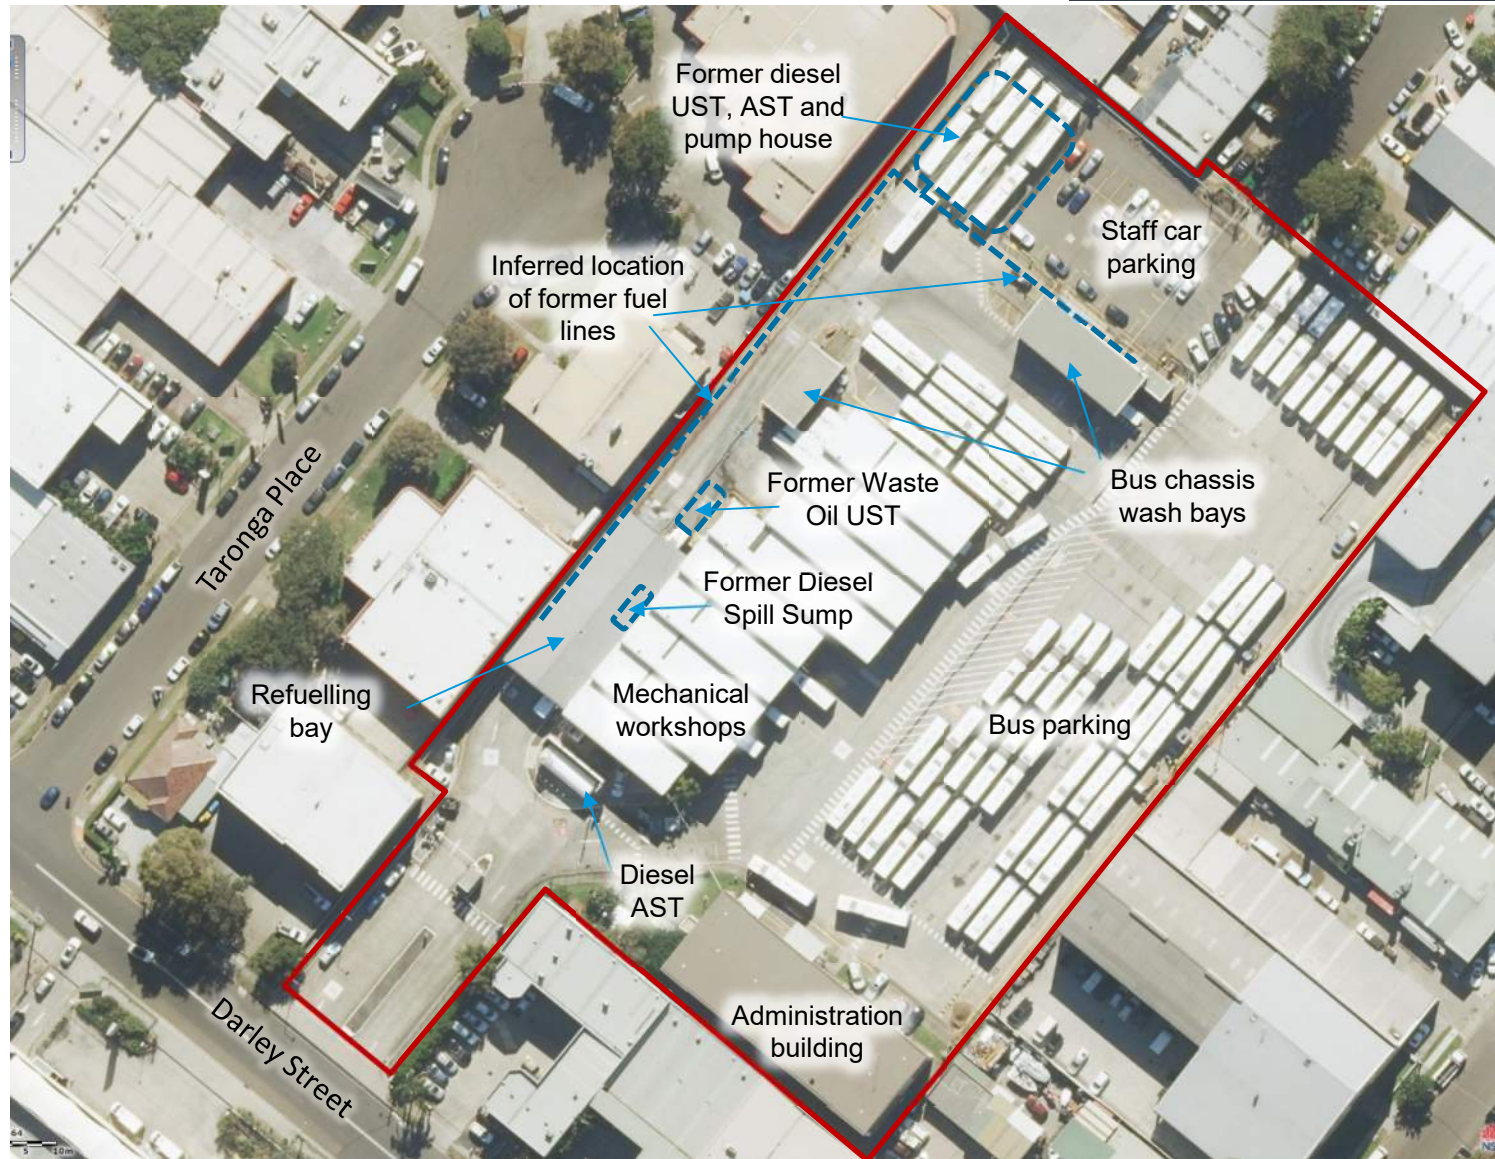
**Figure 3 Site Current and Historical Features**

Site Boundary
