## **Site Classification:**

New House at **Lot 3, 6-6A Orchard Street, Warriewood**

The aim of this assessment is to classify the site in accordance with AS2870-2011 and to provide footing recommendations.

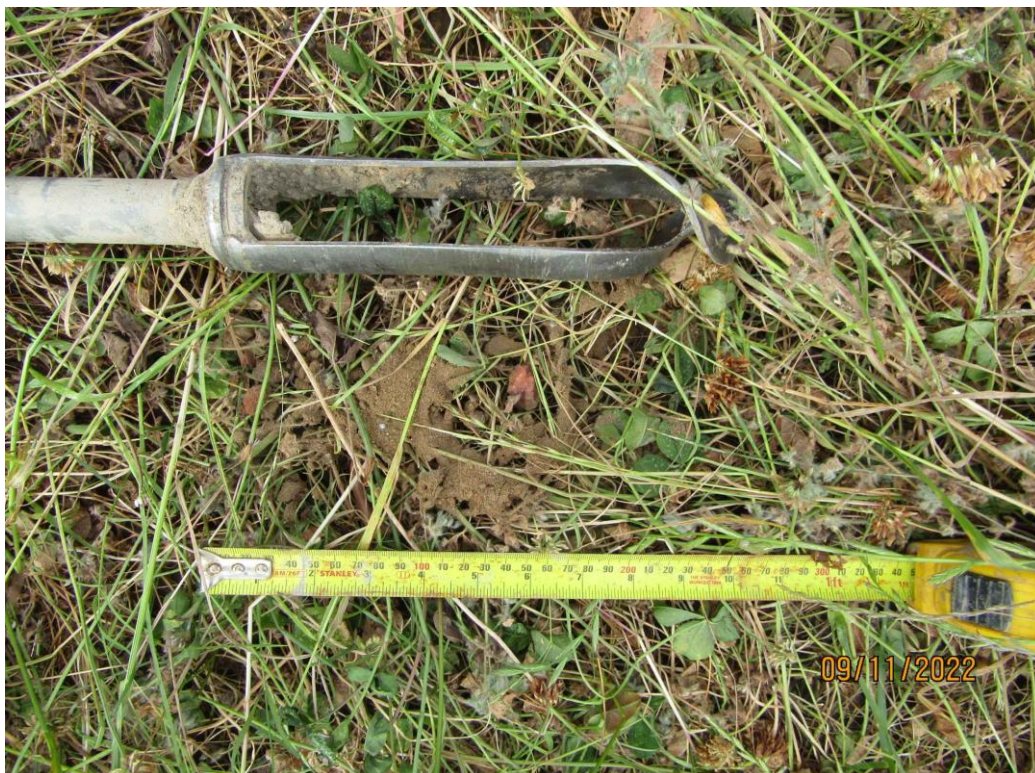
Photo 1: AH1 – Downhole is from left to right.

## AUGER HOLE 1 (~RL19.9) – AH1 (Photo 1)
