Geotechnical Checklist

51 Quinton Road, MANLY.

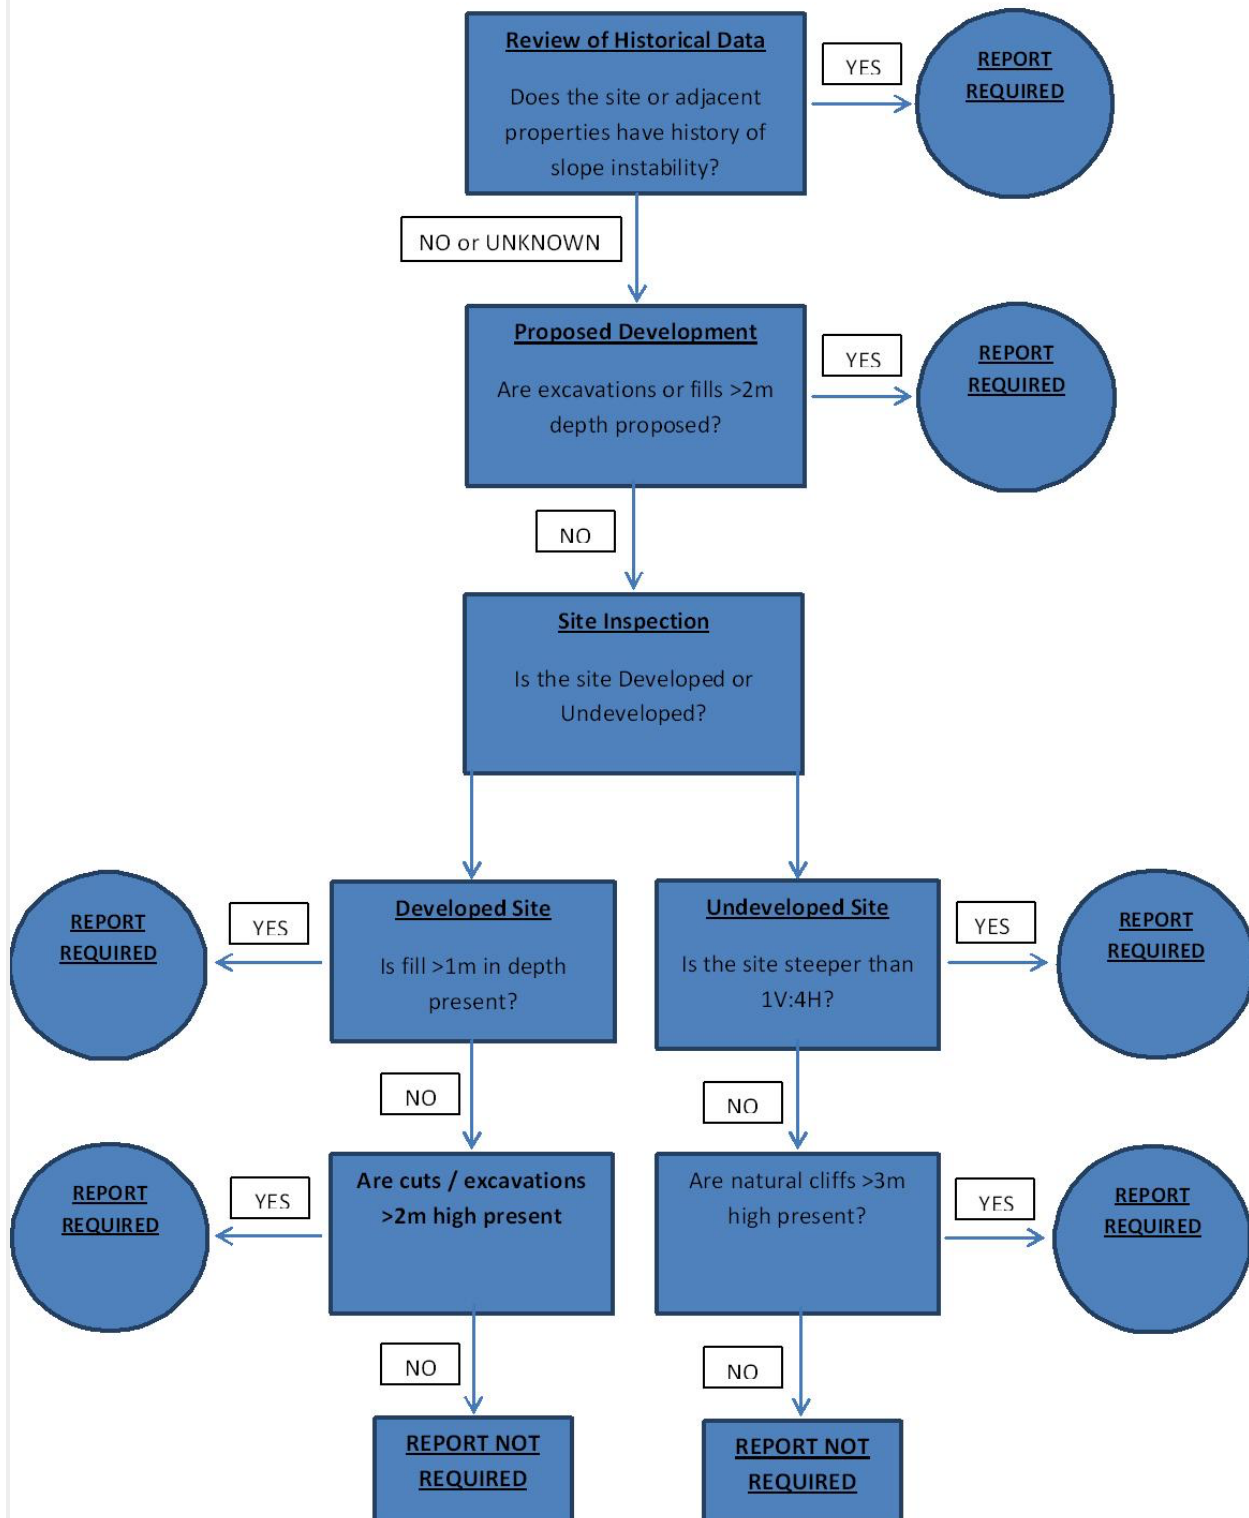
CHECKLIST FOR COUNCIL'S ASSESSMENT OF SITE CONDITIONS AND NEED FOR GEOTECHNICAL REPORT IN GEOTECHNICAL CLASS B AND D

Based on the above items, and the attached flowchart that indicates the principal factor(s) considered in the assessment, it is recommended that:
