## AS2870-2011 SITE CLASSIFICATION

Lot 24 No 1 Painters Parade Dee Why NSW

AS2870 Site Classification

**Class P**

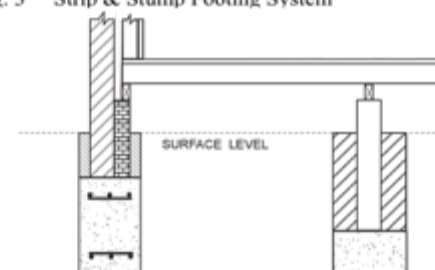
Fig. 3 Strip & Stump Footing System

**Footings** (often incorrectly called foundations) are the "members" that support the building. They are commonly concrete slabs or timber floors supported by strips and stumps. (Fig 1, 2 & 3).

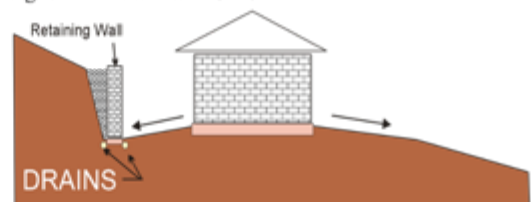
Fig. 5 Well Drained Sites

- Constructing sheds or outdoor roofed areas without connecting the roof drainage to storm water lines.
- Constructing paving around the building without sufficient slope away from the building. (In sandy soils and low and moderate "reactivity" clays, a slope of 1:40 up to 1 metre away from the building is adequate. In highly reactive clays a slope of 1:20 works better. In large paved areas a drain and collection pit may be necessary). (Fig. 5 & 18)

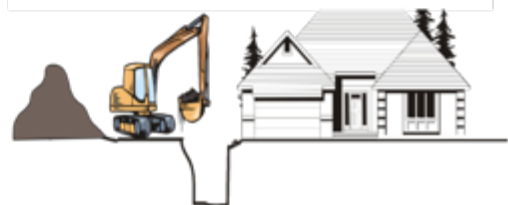
Fig. 11 De-stabilizing house foundations

- Ensuring that excavations are well supported or are dug to avoid collapses. (Fig. 11)
- Constructing well-compacted and retained 'soil aprons' around the building to stop erosion.

- Special considerations if any excavations are to be dug near adjoining structures. (Fig. 11)
- Sloping the soil and paths away from the building by the minimum amount required by the building regulations to prevent water flowing towards the building foundations. (Fig. 10 & 18)

- Running machinery over shallow drain pipes may break them causing leaks and subsequent foundation movements.
- Any excavations close to building footings can cause them to sink by disturbing the foundation material or by drying the foundation clay. (Fig 11)
