GEOTECHNICAL INVESTIGATION REPORT

Project Title – 1-3 CAREEL HEAD RD, AVALON BEACH

Project Type – Proposed Mixed Use Development

Project No. – GR24118

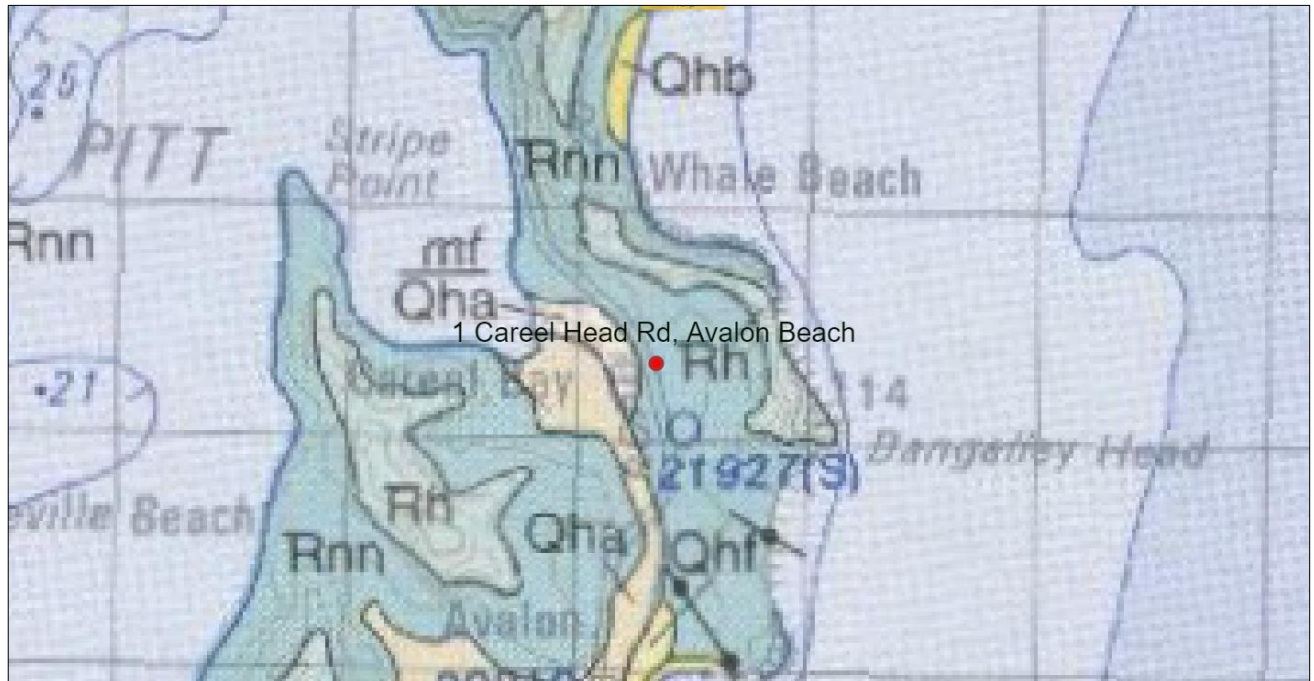
Figure 2: 1:100,000 scale Geological Series Map of the Sydney Region

The 1:100,000 scale Geological Series Sheet 9030 (Edition 1) 1991 of the Penrith region (Figure 2) indicates that the subject site is underlain by Narrabeen group Terrigal Formation (Rnn) consists of interbedded laminite, shale, and quartz, to lithic-quartz sandstone. Minor red claystone north of Hawkesbury River. Clay pellet sandstone (Garnie Fm) south of Hawkesbury River.

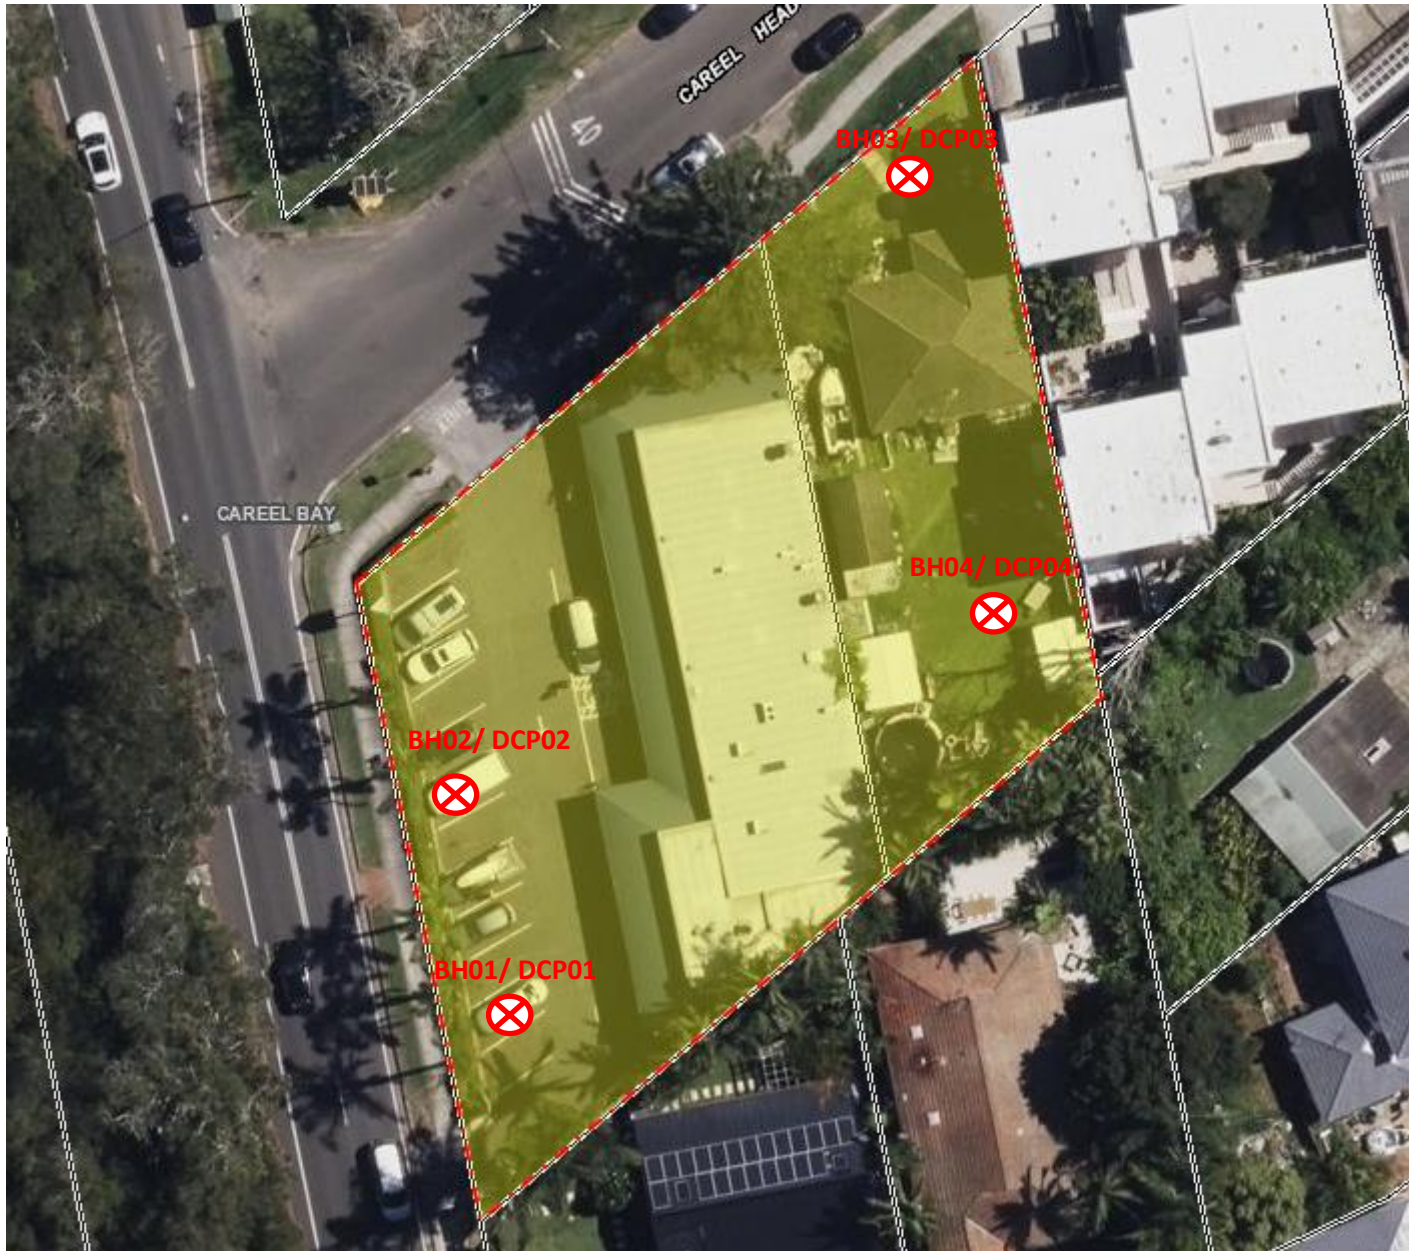
APPENDIX A – Site Plan

Drawn	DE	CLIENT: JONATHAN ODISHO SITE ADDRESS: 1-3 CAREEL HEAD RD, AVALON BEACH	Figure	1
Checked	SG		Title	Site Plan
Date	19/06/2024		Job No	GR24118
Scale @ A3	NTS

The results of the investigation indicate that the subsurface profile comprises of Sandy CLAY and SAND underlain by SANDSTONE bedrock. Based on the borehole information, a summary of subsurface conditions is presented below. The location of each borehole can be found in Appendix A and more detailed logs can be found in Appendix B.
