Geotechnical Assessment

Project: Alterations & Additions
46 Pine Street, Manly NSW

Prepared for:
Anthony Simkins

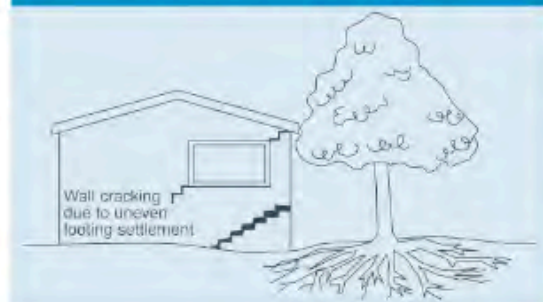
Trees can cause shrinkage and damage

As the weather pattern changes and the soil begins to dry out, the external footings will be first affected, beginning with the locations where the sun's effect is strongest. This has the effect of lowering the external footings. The doming is accentuated and cracking reduces or disappears where it occurred because of dishing, but other cracks open up. The roof lines may become convex.

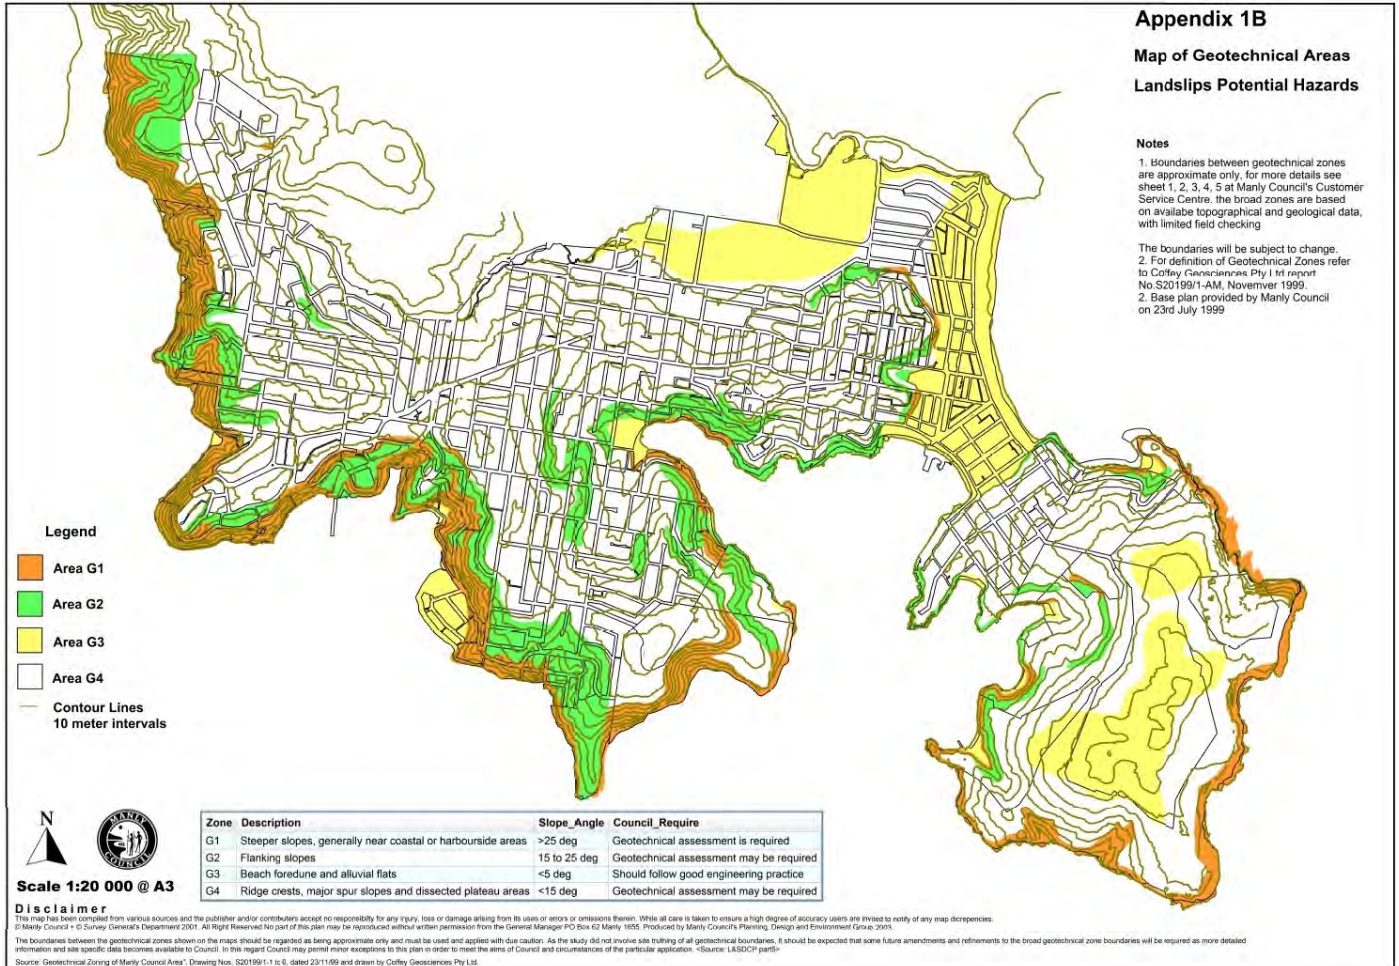
Schedule 1 – Map C – Potential Geotechnical Landslip Hazard Areas

Map of Geotechnical Areas - Manly

The site is mapped as **G2** landslide risk/geotechnical hazard with reference to Schedule 1 – Map C – Potential Geotechnical Landslip Hazard Areas, Manly DCP, Northern Beaches Council (**Appendix B**).
