Proposed Additions and Alterations 32 Reddall Street, Manly NSW

Preliminary Geotechnical Assessment

Our ref: 6416-G1
15 April 2021

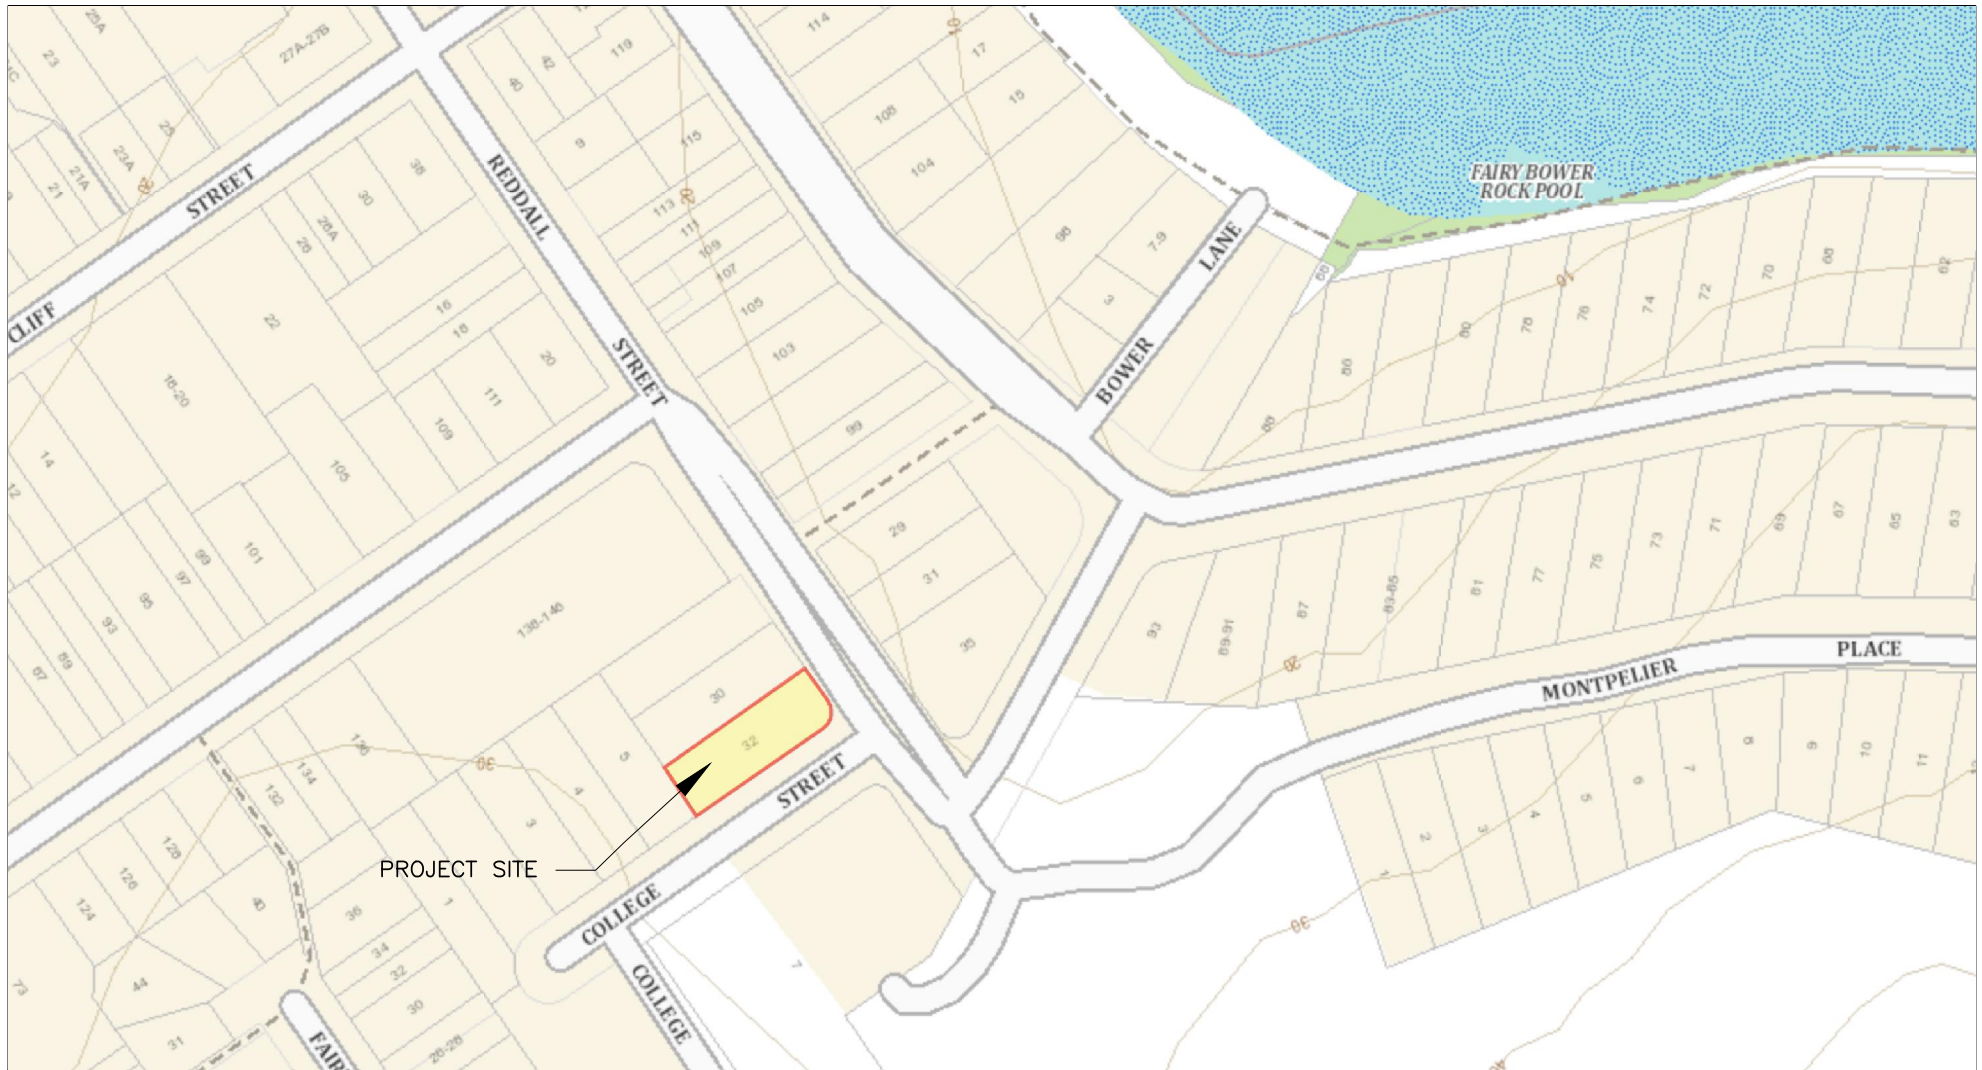
Figure 1 – Site Locality
Figure 2 – Aerial Photo – History 1943

APPROXIMATE ONLY – SUBJECT TO DETAIL SURVEY.

The Site is located at the corner of intersection of Reddall Street and College Street, as shown in Figure 1. It is roughly rectangular in shape with a street frontage of about 10.4m along Reddall Street, increasing to about 15.2 towards the rear lawn area, and is about 45.7m front to back. The Site is bounded to the south east by College Street, to the north east by Reddall Street and to the south west and north west by existing residence and beyond. 12 Fairy Bower Road is approx. 173m to the south.

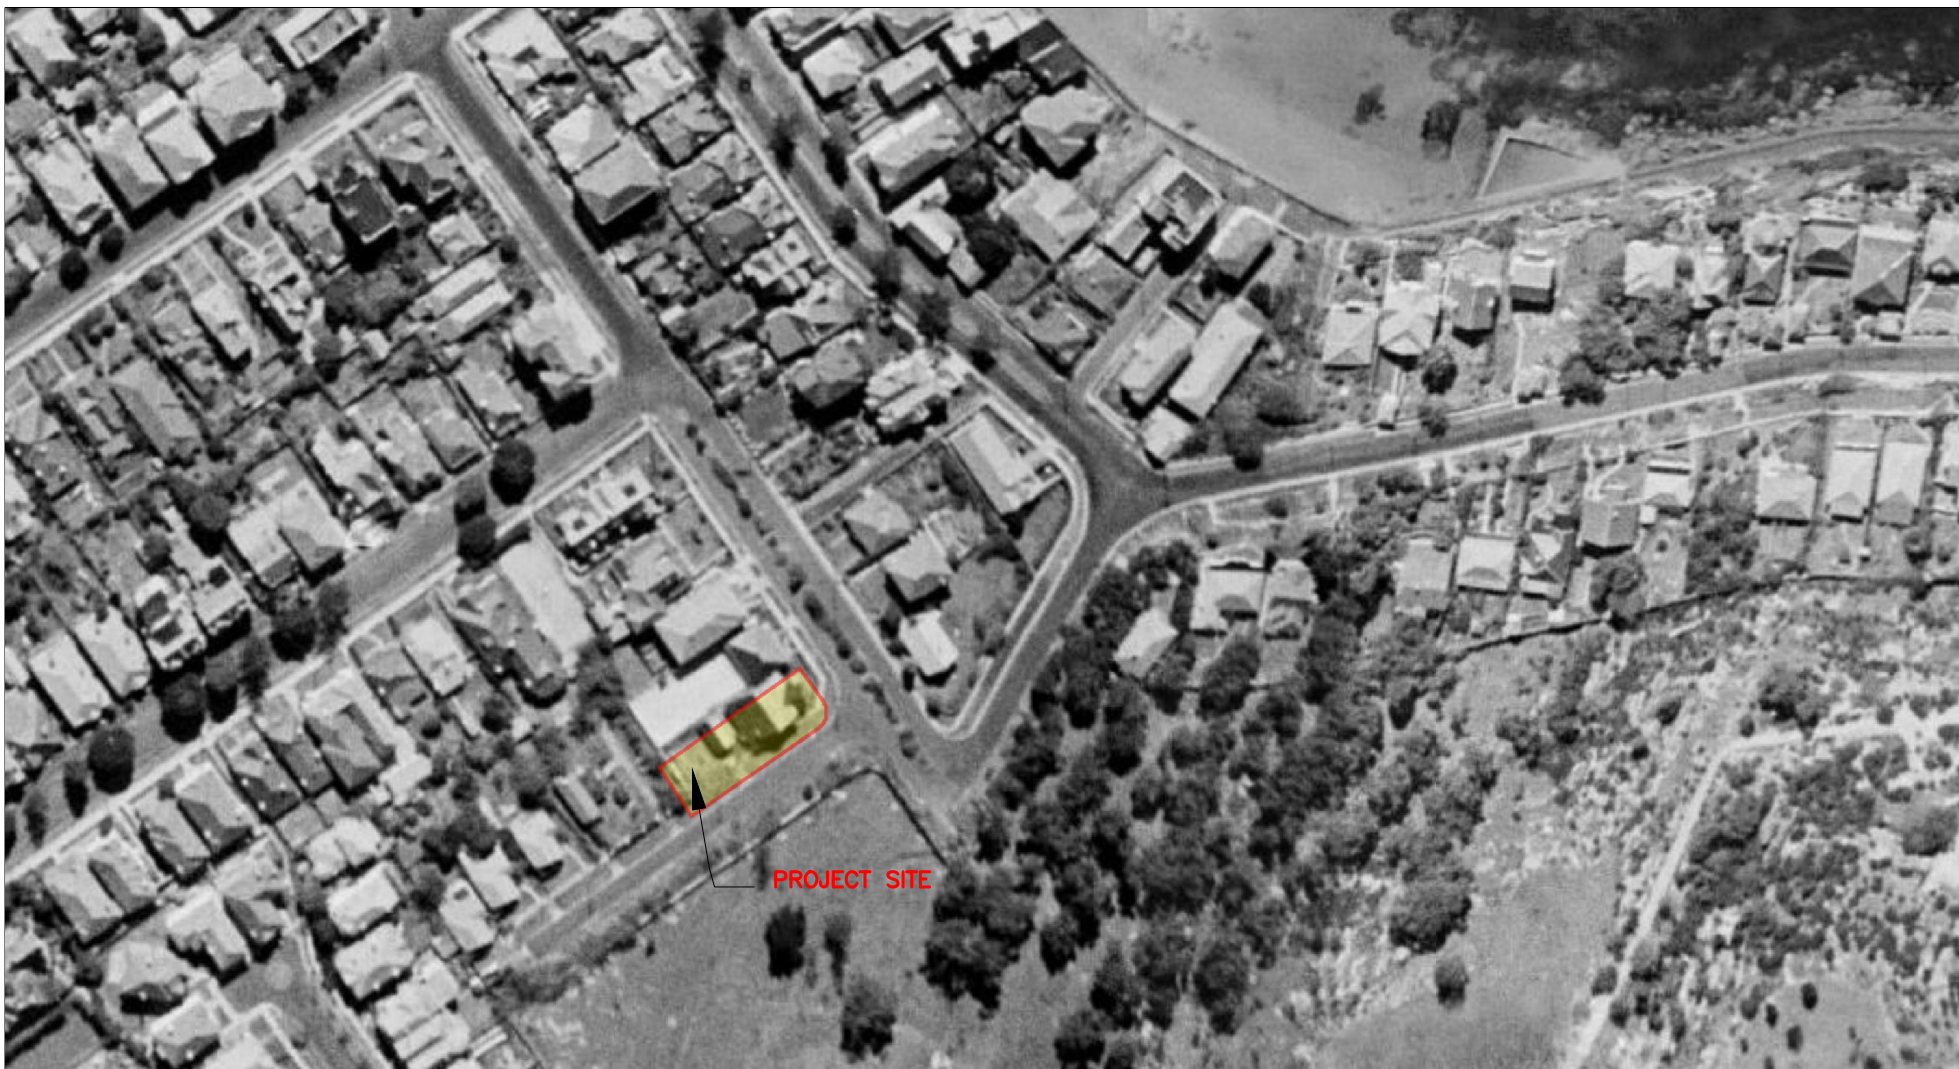
fig: 2
issue: A

APPROXIMATE ONLY – SUBJECT TO DETAIL SURVEY.

Based on the 1943 aerial photo (see Figure 2), the Site area appears to be used for residential purposes prior to that date. There has been little change to the environs since then. More residential dwellings had been built along College Green.

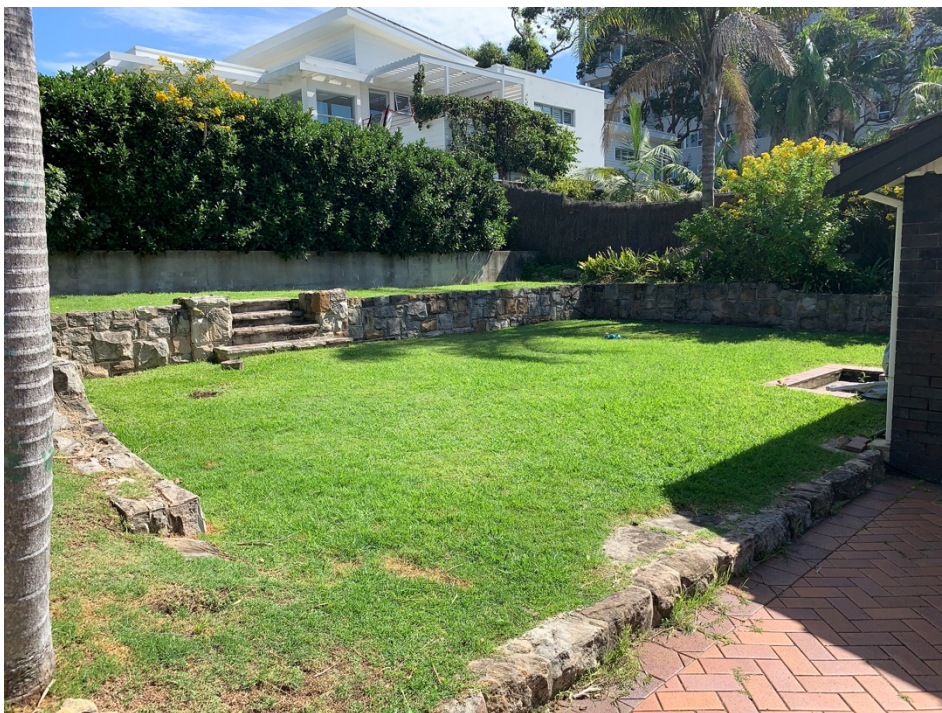
Photo 2
Overview of existing
rear lawn and
proposed basement
and garage location.
