Geotechnical Assessment

Project: Alterations & Additions
62A Iris Street, Beacon Hill NSW

Ref: AG 22115
31 March 2022

Preliminary Geotechnical Assessment

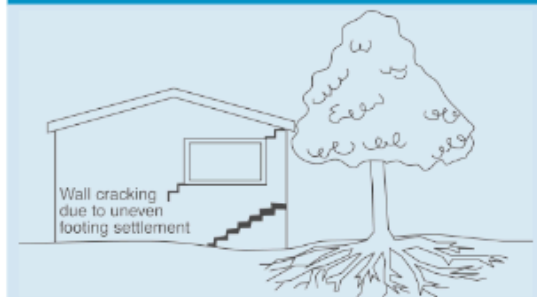
Trees can cause shrinkage and damage

As the weather pattern changes and the soil begins to dry out, the external footings will be first affected, beginning with the locations where the sun's effect is strongest. This has the effect of lowering the external footings. The doming is accentuated and cracking reduces or disappears where it occurred because of dishing, but other cracks open up. The roof lines may become convex.
