## Preliminary Geotechnical Assessment

For Alterations and Additions at  
9 Poate Place, Davidson, NSW

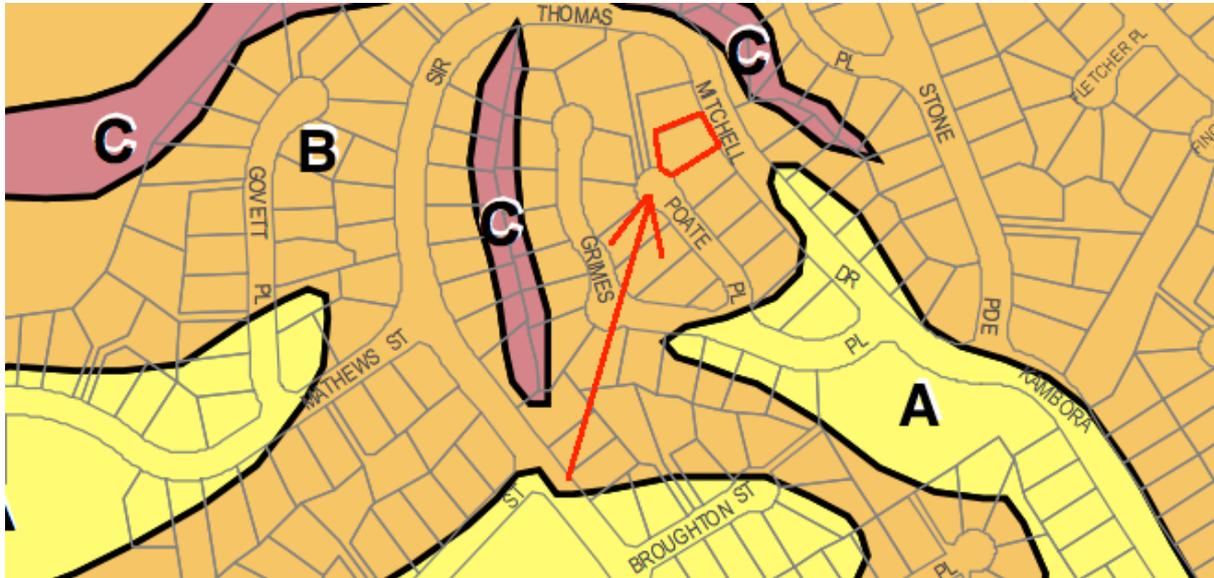
The site is mapped as **Area B** on the Landslip Risk Map LSR\_003 (Image 1, below).

**WARRINGAH LANDSLIP RISK MAP**

- Area A - Slope less than 5 degrees
- Area B - Flanking Slopes from 5 to 25 degrees
- Area C - Slopes more than 25 degrees
- Area D - Collaroy Plateau Area Flanking Slopes 5 to 15 degrees
- Area E - Collaroy Plateau Area Slopes more than 15 degrees
