Geotechnical Assessment

Project: Alterations and Additions
18 Norma Road, Palm Beach NSW

REF: AG 20049

10th March, 2020

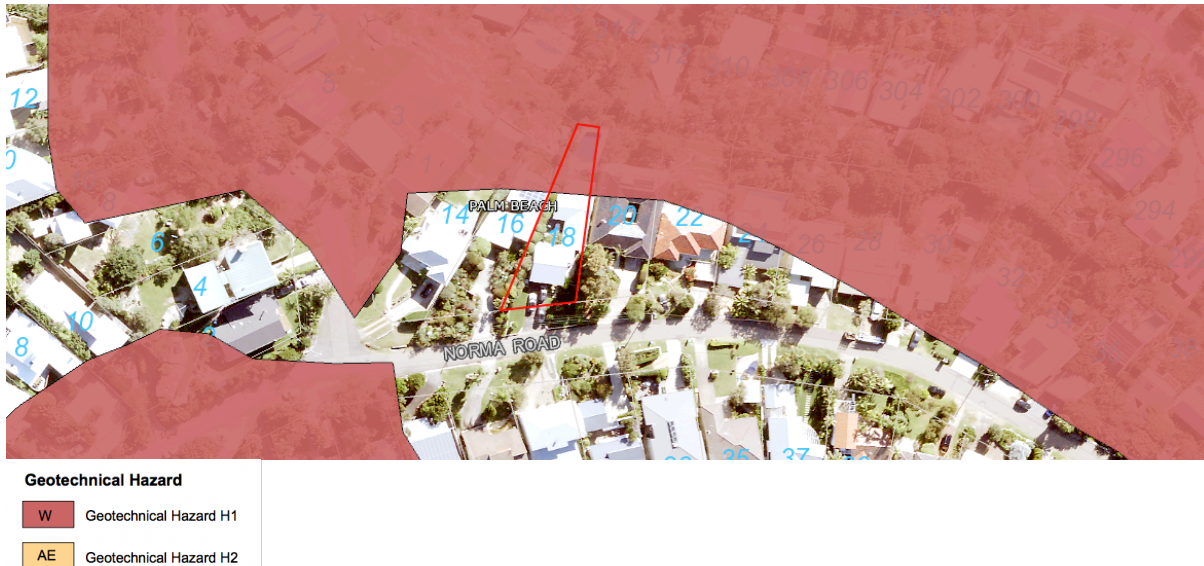
Image 2: 18 Norma Road, Palm Beach NSW – **Geotechnical Hazard Map**– Red polygon (PLEP 2014)

- No evidence of significant soil creep, tension cracks, unstable outcrops, or other indicators of slope instability were identified at the time of our inspection.
- The existing structure displayed no evidence of significant cracking or settlement that could be attributed to slope instability.
- The property is classified ‘**Geotechnical Hazard H1**’ in Northern Beaches Council PLEP Geotechnical Hazard Map (PLEP Geotechnical Hazard Map **Image 2** below).

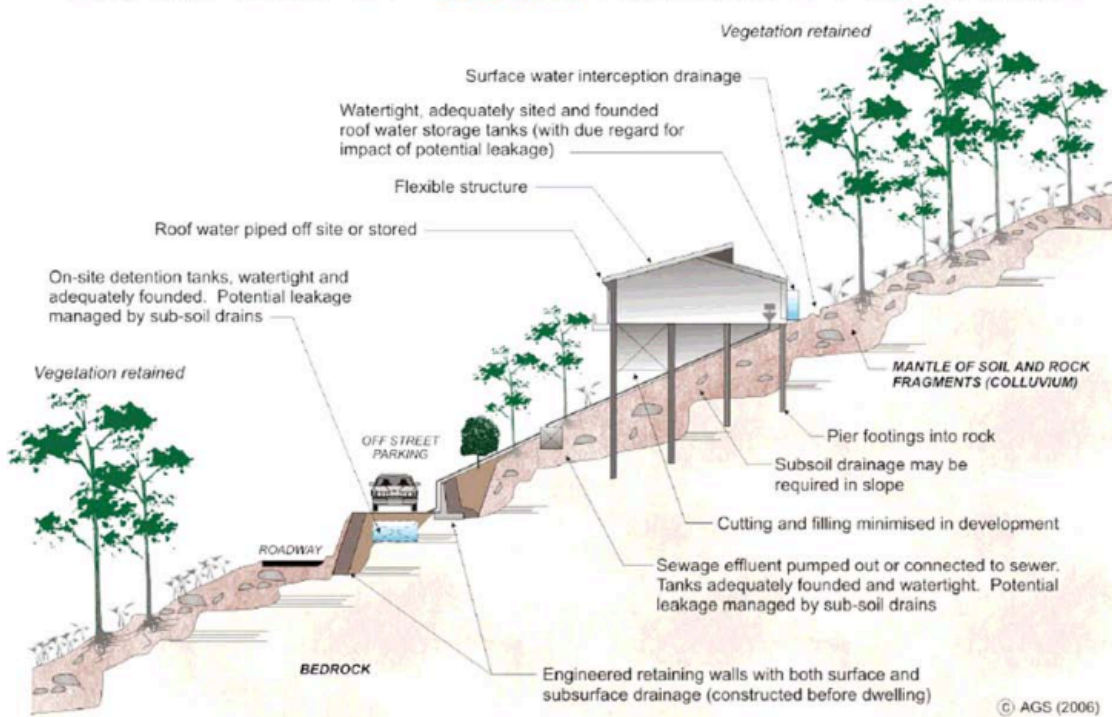
EXAMPLES OF **GOOD** HILLSIDE PRACTICE

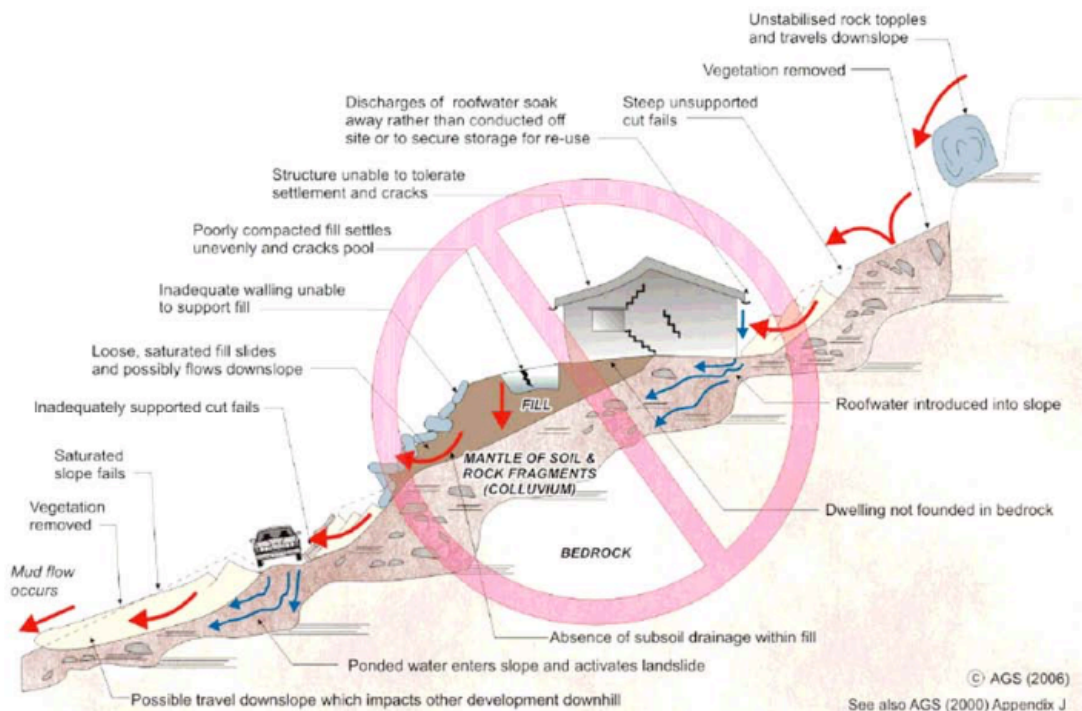
EXAMPLES OF **POOR** HILLSIDE PRACTICE

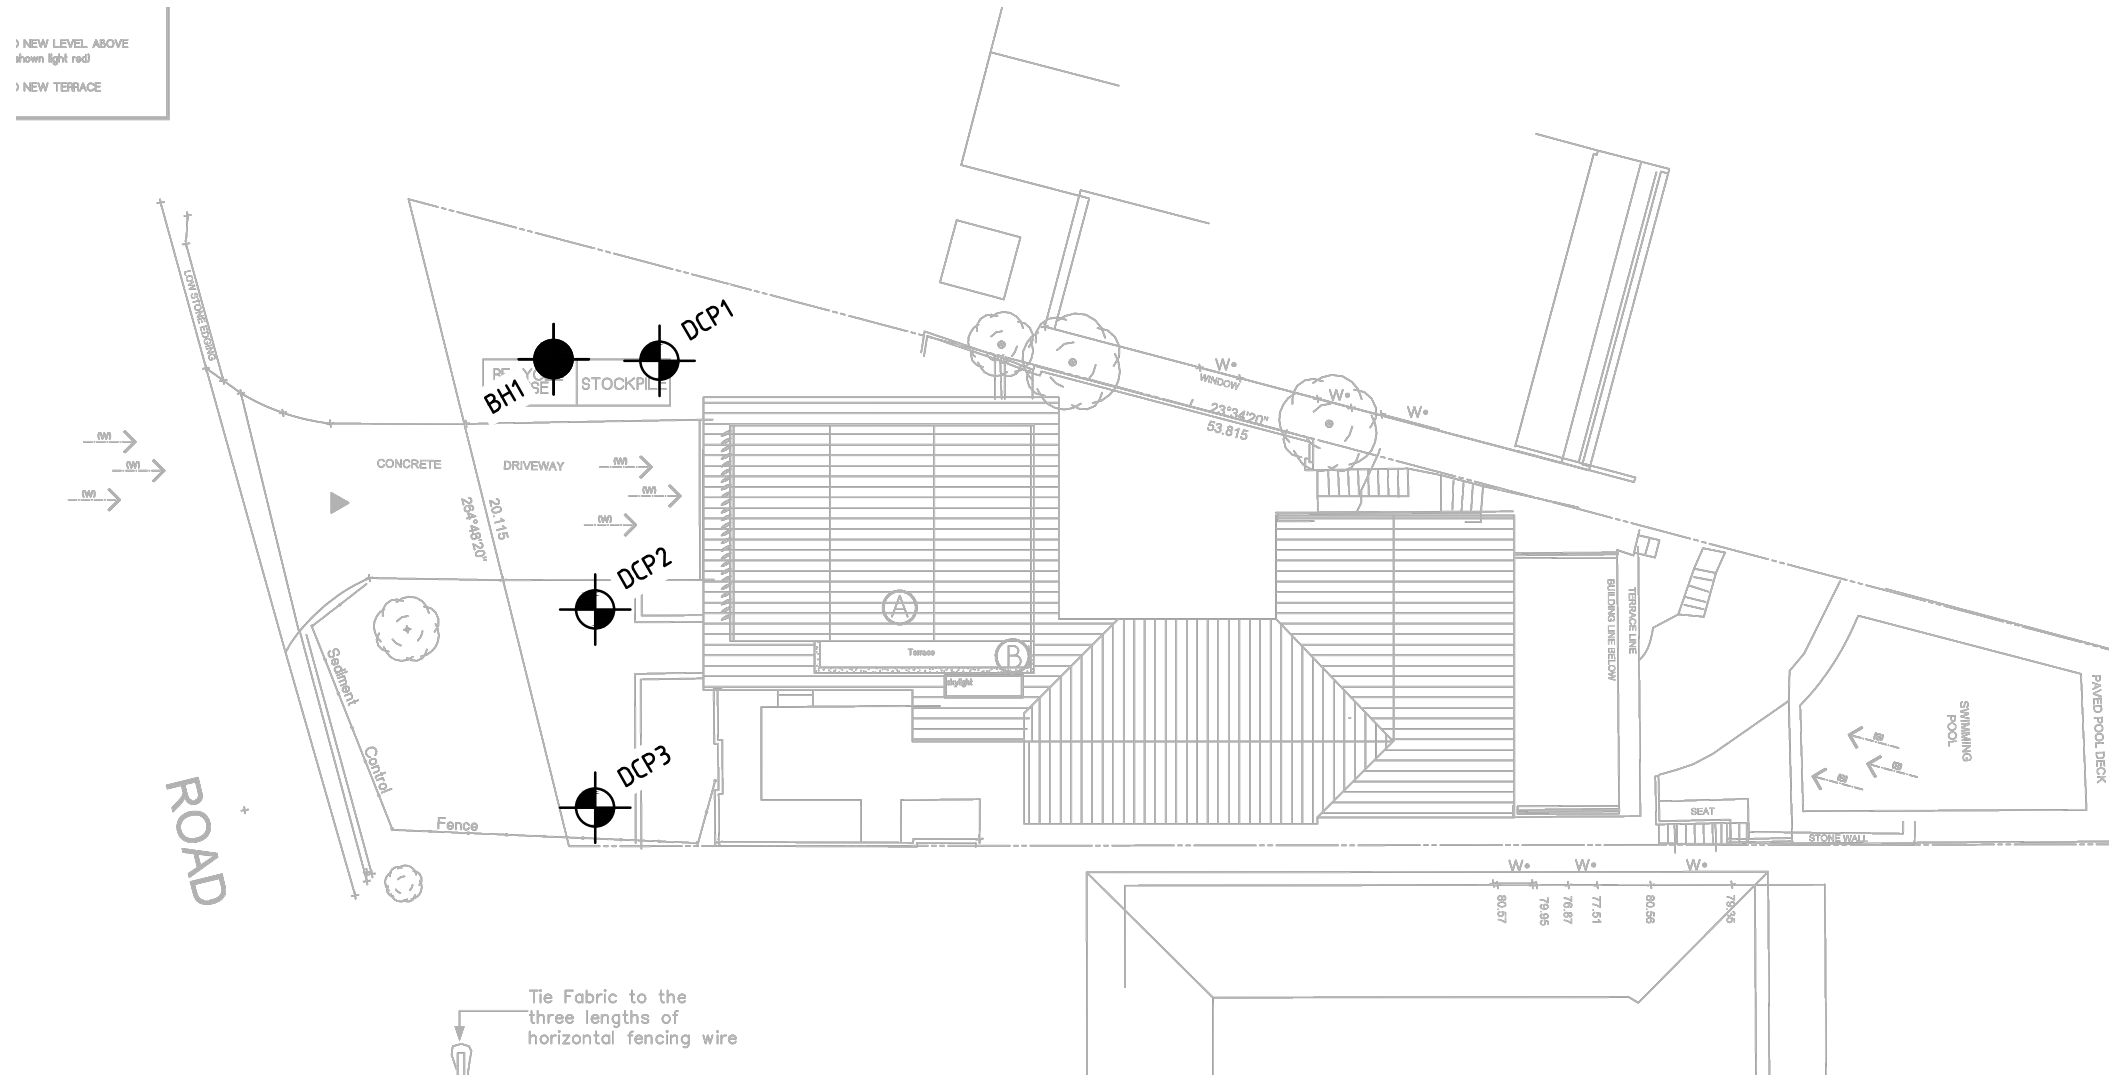
SITE PLAN/GROUND TEST LOCATIONS
SCALE NTS

- DCP LOCATIONS
- BOREHOLE LOCATION

DATE:	08/03/2020
SCALE:	AS SHOWN @ A3
DRAWING TITLE:	SITE PLAN
DRAWING NO:	AG20049- S1

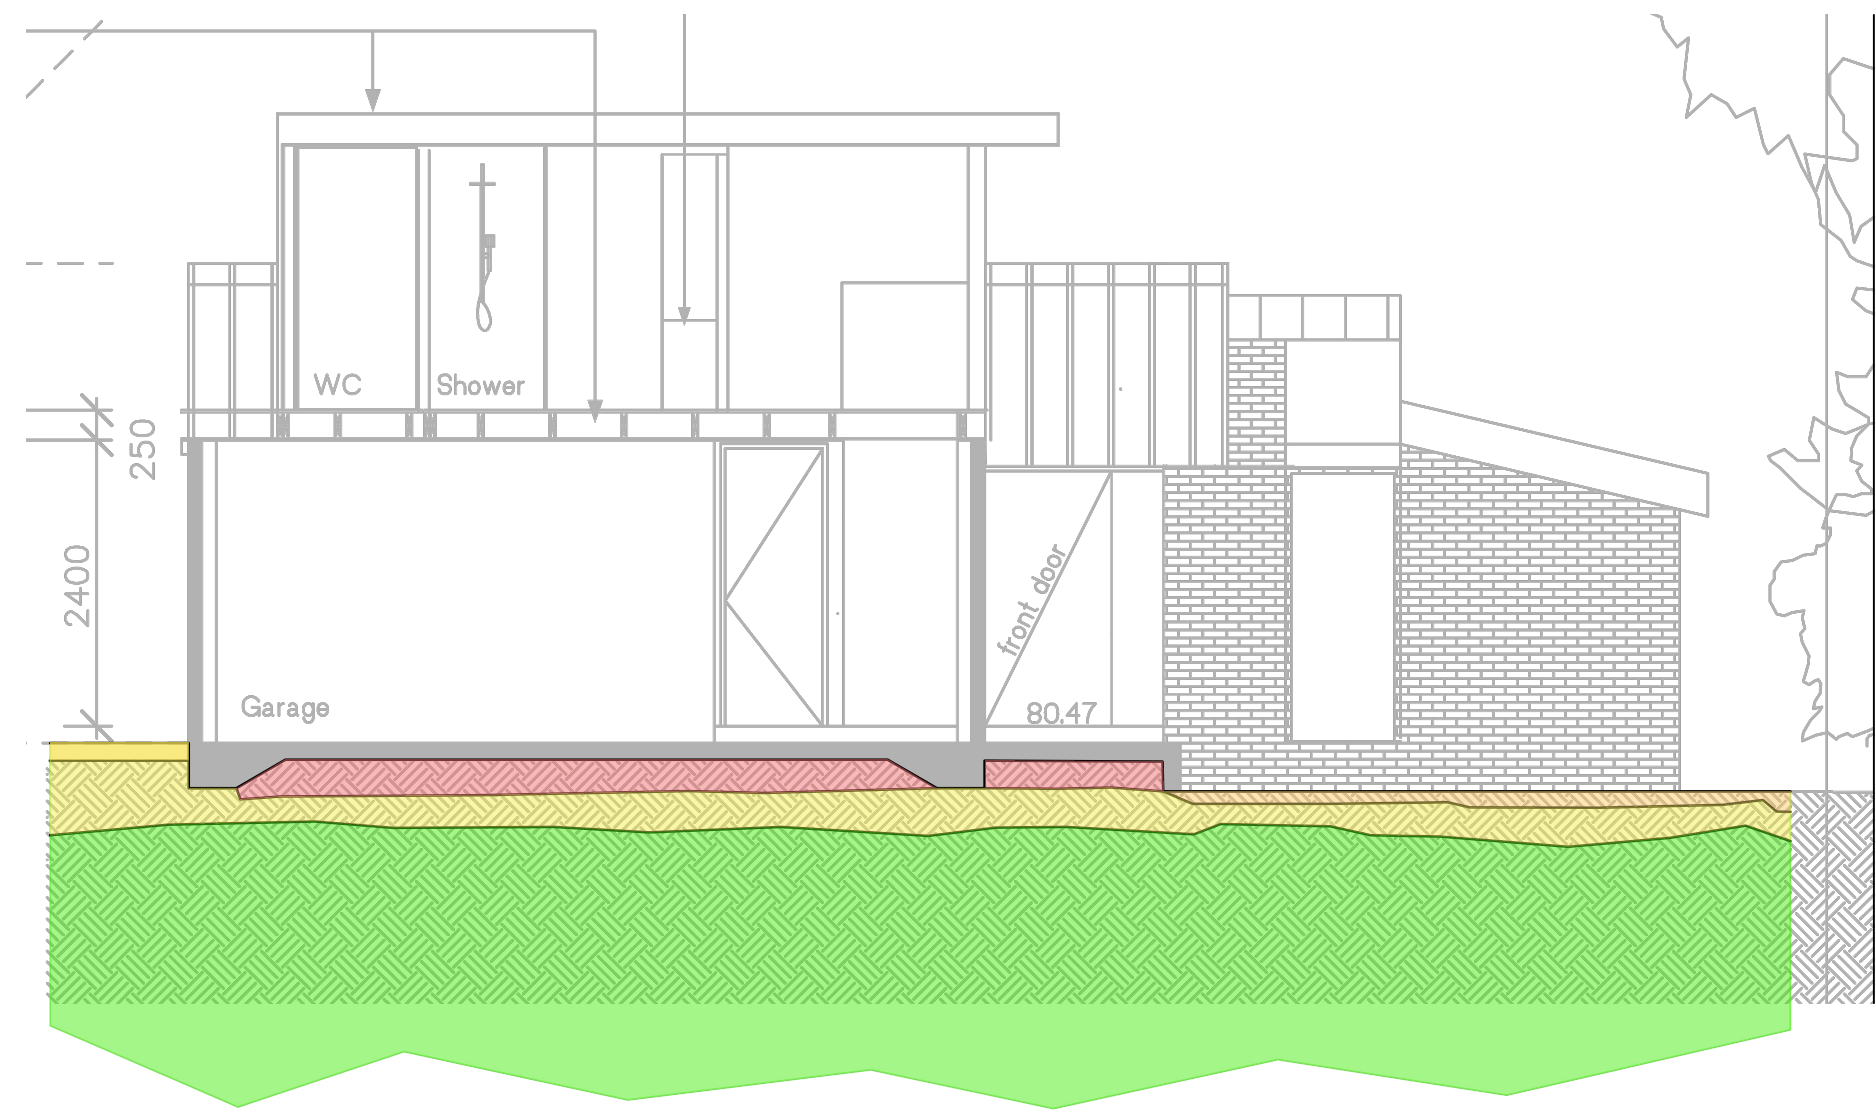
INTERPRETED SUBSURFACE SECTION ONLY.
ACTUAL GROUND CONDITIONS MAY VARY.

- FILL
- SANDY TOP SOIL
- SANDY CLAYS
- HAWKESBURY SANDSTONE BEDROCK

The soil profile consists of sandy topsoil (O & A Horizons) with sandy clays (B Horizon) overlying weathered sandstone bedrock (C Horizon). Based on our observations and the results of testing onsite, we would expect competent weathered sandstone bedrock, to be found within 500mm to 1000mm from current surface levels across the area of proposed works.
