## **Geotechnical Assessment**

**Project:** Alterations & Additions  
6 Jacqueline Close, Bayview NSW

**Ref:** AG 22156  
15 May 2022

For **Alterations & Additions** at  
**6 Jacqueline Close, Bayview NSW**

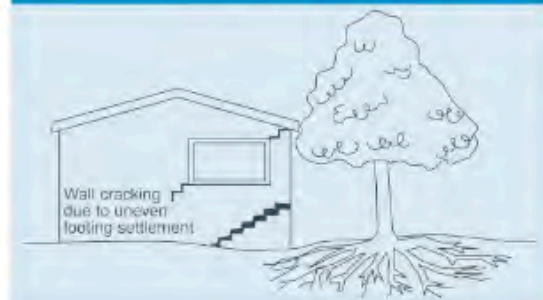
#### Trees can cause shrinkage and damage

As the weather pattern changes and the soil begins to dry out, the external footings will be first affected, beginning with the locations where the sun's effect is strongest. This has the effect of lowering the external footings. The doming is accentuated and cracking reduces or disappears where it occurred because of dishing, but other cracks open up. The roof lines may become convex.
