Preliminary Geotechnical Assessment

Project: Alterations & Additions
81 Cassia Street, Dee Why NSW

Ref: AG 24515
21 November 2024

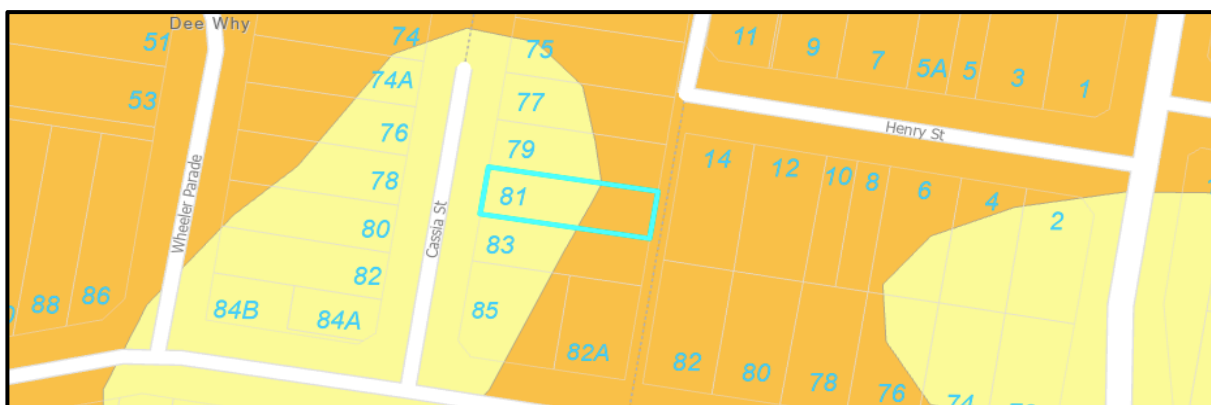
Figure 1. Warringah Landslip Risk Map:
81 Cassia Street, Dee Why NSW (© NBC Maps)

The site is mapped as **Area A & B** subject to specific landslide risk/geotechnical hazard mapping with reference to the Warringah (WLEP) Landslip Risk Map, Northern Beaches Council (**Image 1**).
