PRELIMINARY GEOTECHNICAL ASSESSMENT:

25 Bridgeview Crescent, Forestville

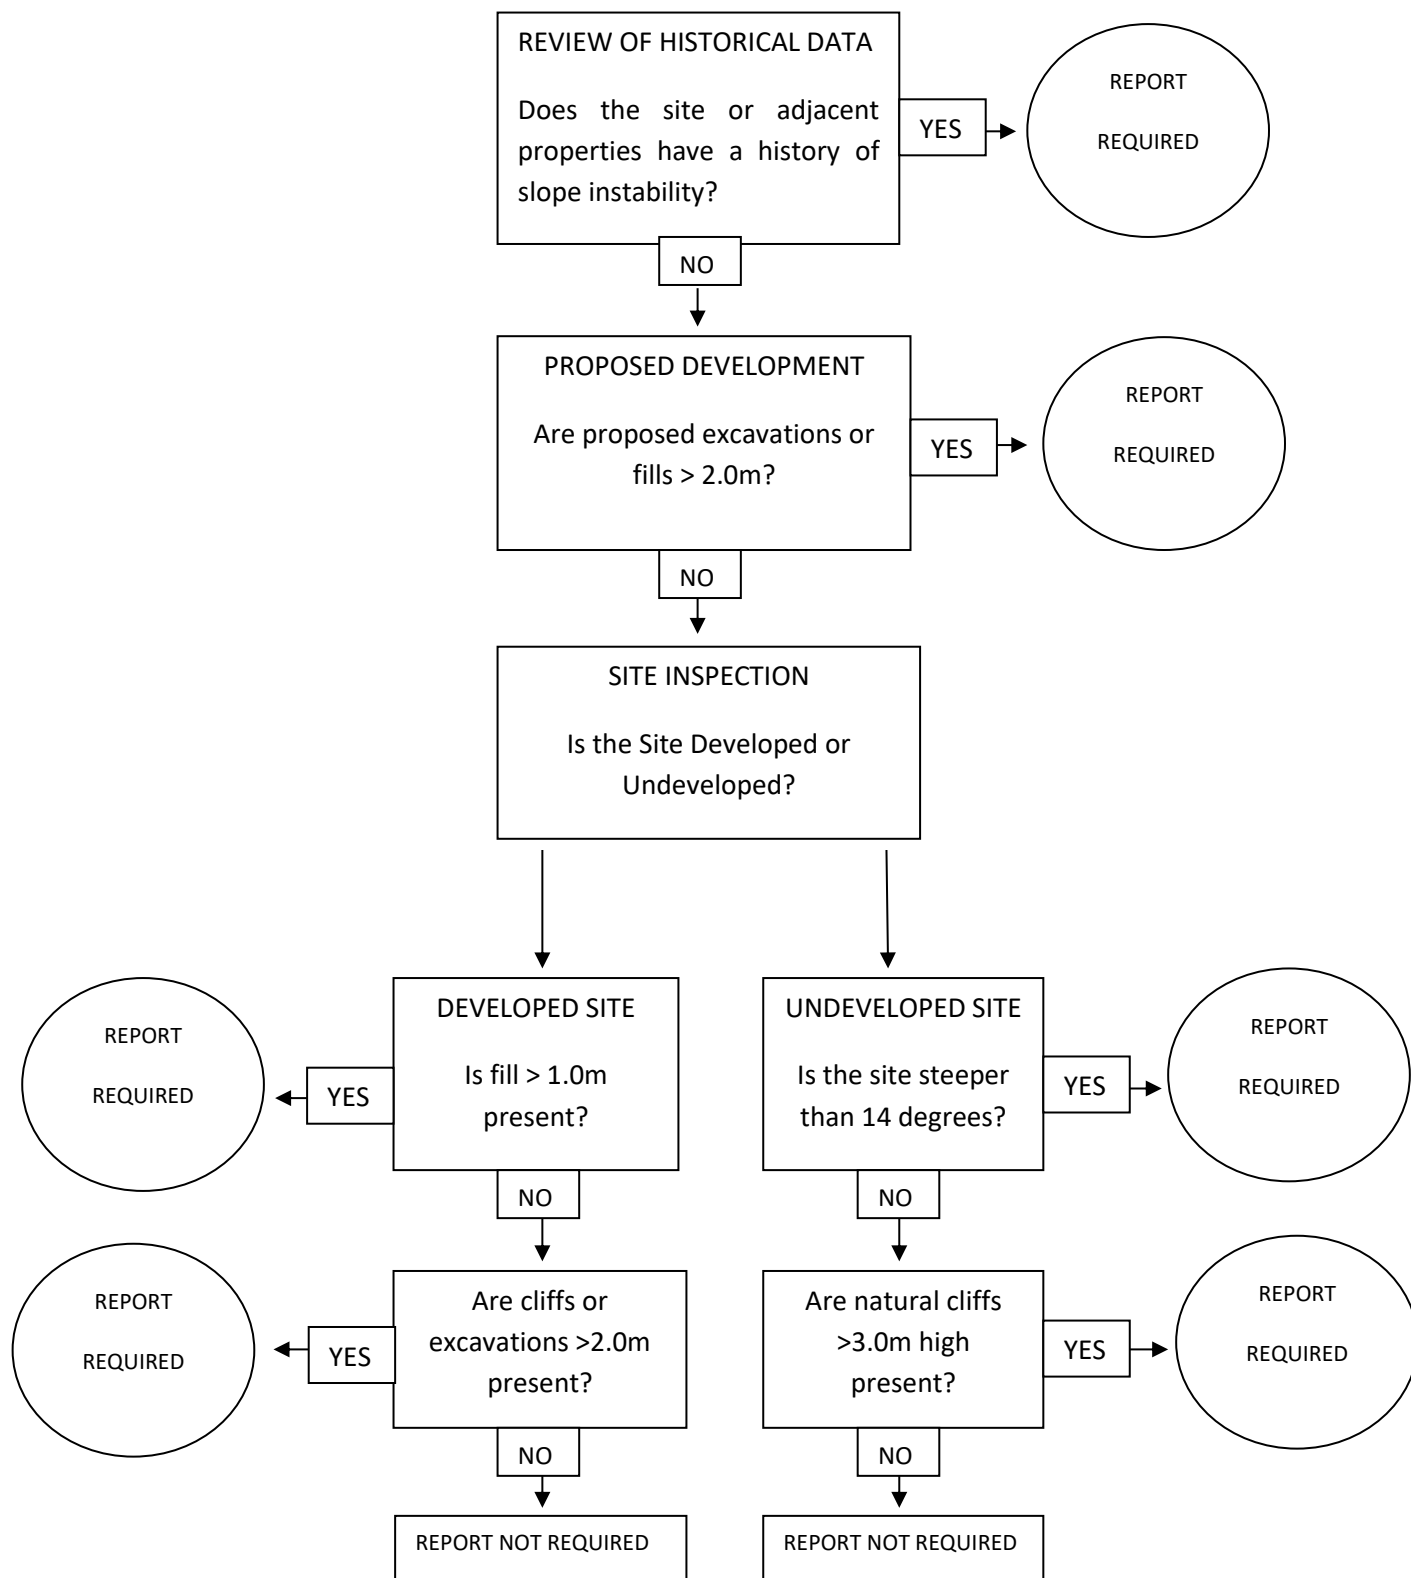
Preliminary Assessment Flow Chart – Norther Beaches Council (Warringah)

The proposed development and site conditions were considered and applied to the Council Flow Chart.
