Geotechnical Assessment

Project: Alterations & Additions
135 Seaforth Crescent, Seaforth NSW

REF: AG 21379
17 November 2021

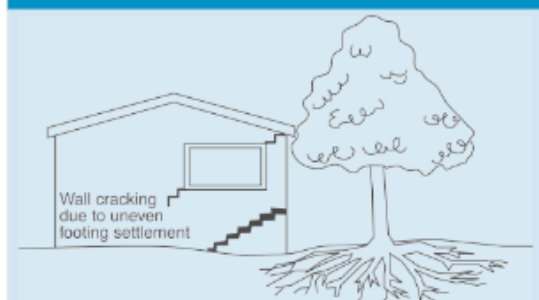
Trees can cause shrinkage and damage

As the weather pattern changes and the soil begins to dry out, the external footings will be first affected, beginning with the locations where the sun's effect is strongest. This has the effect of lowering the external footings. The doming is accentuated and cracking reduces or disappears where it occurred because of dishing, but other cracks open up. The roof lines may become convex.

Doming and dishing are also affected by weather in other ways. In areas where warm, wet summers and cooler dry winters prevail, water migration tends to be toward the interior and doming will be accentuated, whereas where summers are dry and winters are cold and wet, migration tends to be toward the exterior and the underlying propensity is toward dishing.

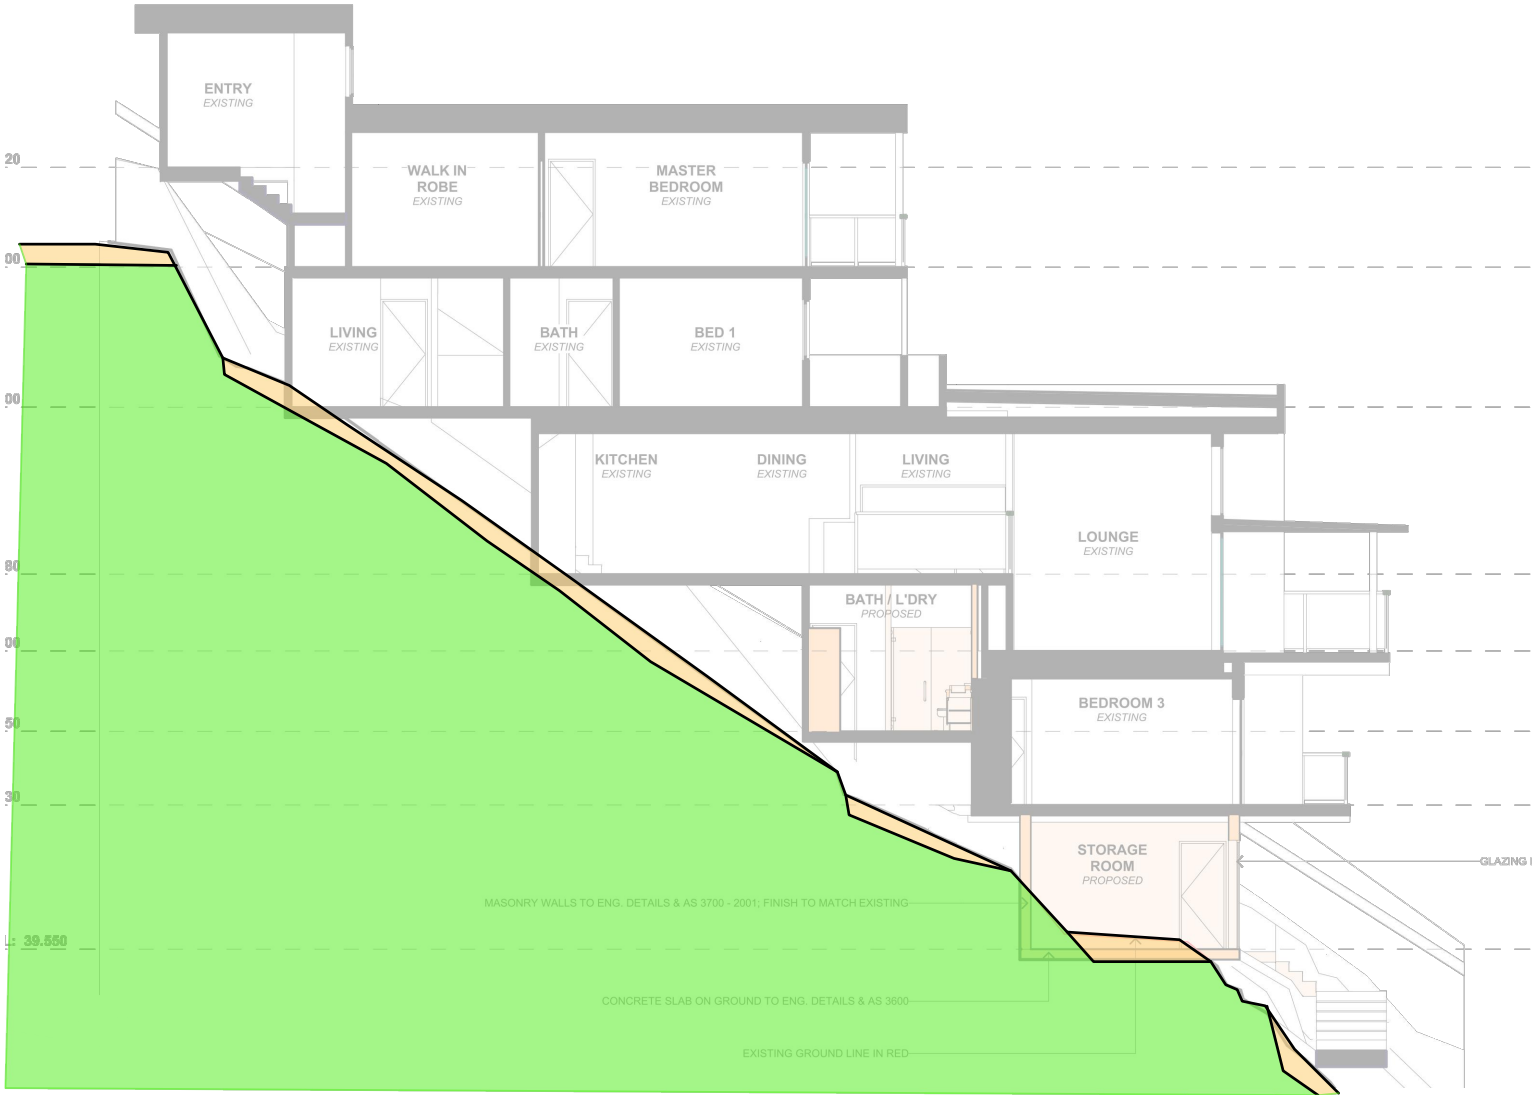
INFERRED GEOLOGICAL SECTION

INTERPRETED SUBSURFACE SECTION ONLY.
ACTUAL GROUND CONDITIONS MAY VARY.

The soil profile consists of shallow uncontrolled sandy fill and silty topsoil (O & A Horizons), sandy clay (B Horizon) and weathered bedrock (C Horizon). Based on our observations and the results of testing on site, we would expect weathered sandstone bedrock to be found within 0.1 to 0.95 metres below current surface levels across the area of the proposed works, where not already exposed.
