Manly DCP 2015 Schedule 11 - Preliminary Assessment of Site Conditions in relation to
4.55 application to modify to DA 43/2016 at 63 Gordon
Street Clontarf

Proposed Driveway Rehabilitation + Pool – 63 Gordon Street, Clontarf, NSW

Geotechnical Assessment

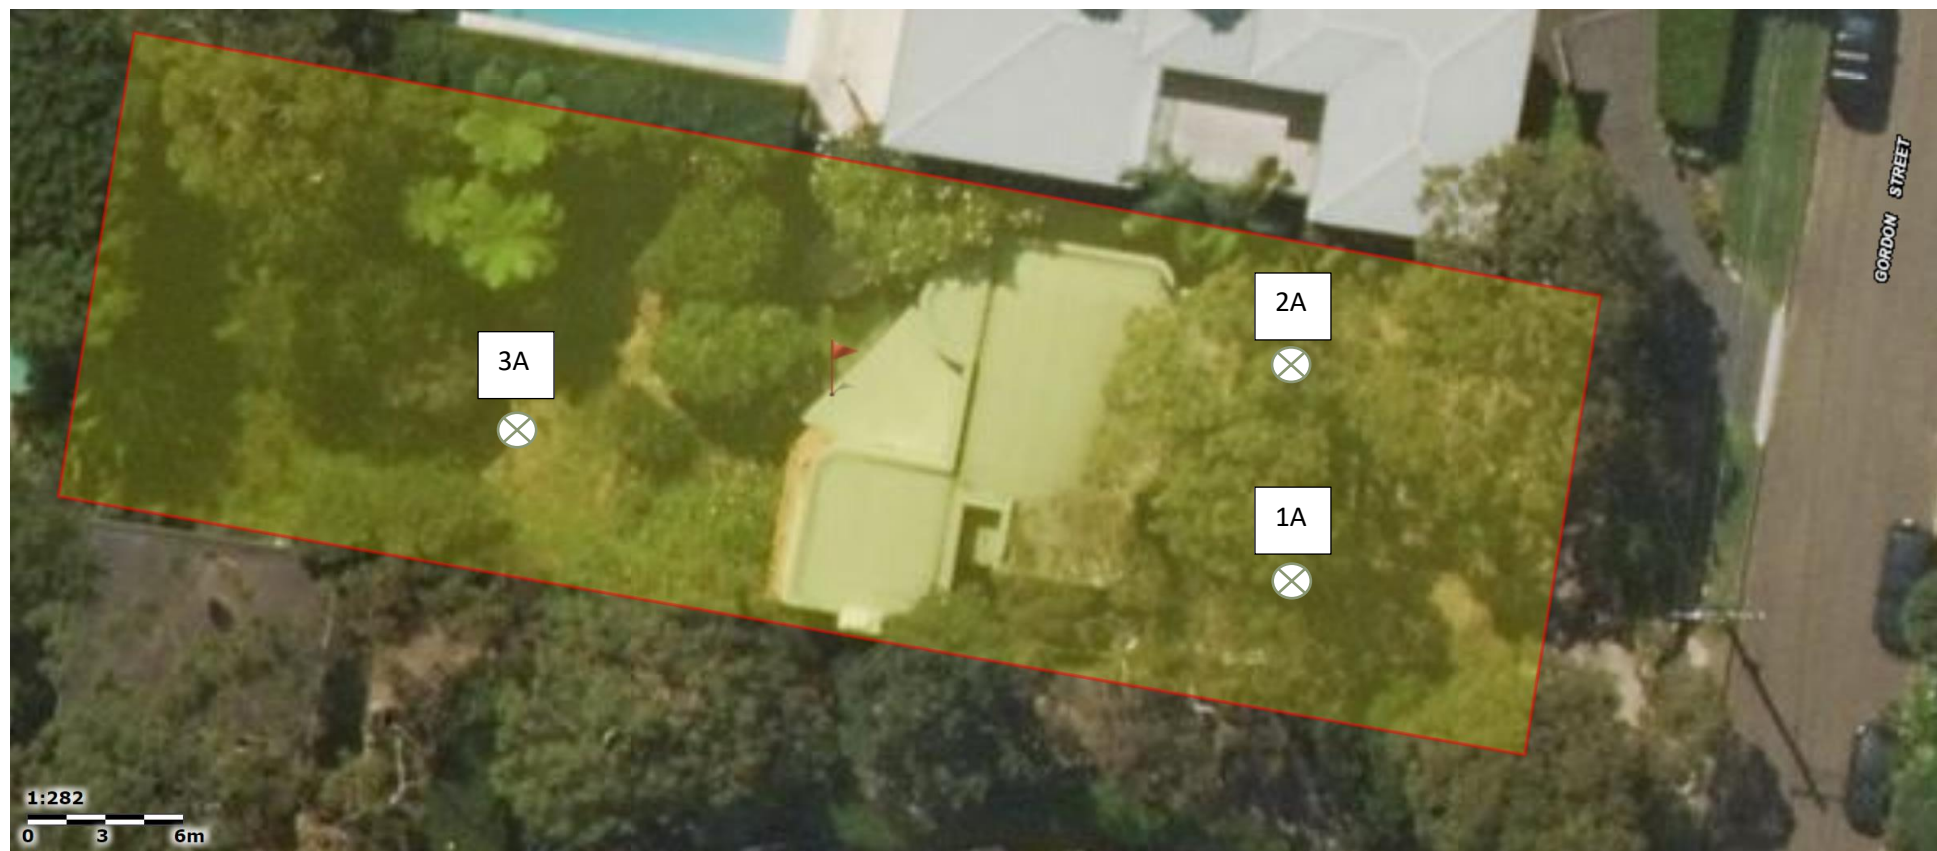
Legend:

Borehole Location - X

The subsurface conditions of the driveway location were investigated by two boreholes designated 1A to 2A. The borehole logs in Appendix A can be referred to for more detail. Investigation boreholes at the driveway site found the subsurface profile to comprise:

The subsurface conditions of the proposed pool location were investigated by one borehole designated 3A. The borehole log in Appendix A can be referred to for more detail. Investigation boreholes at the driveway site found the subsurface profile to comprise:
