PRELIMINARY GEOTECHNICAL REPORT

Landslip Risk – Area B

18 Libya Crescent ALLAMBIE HEIGHTS

17 June 2021

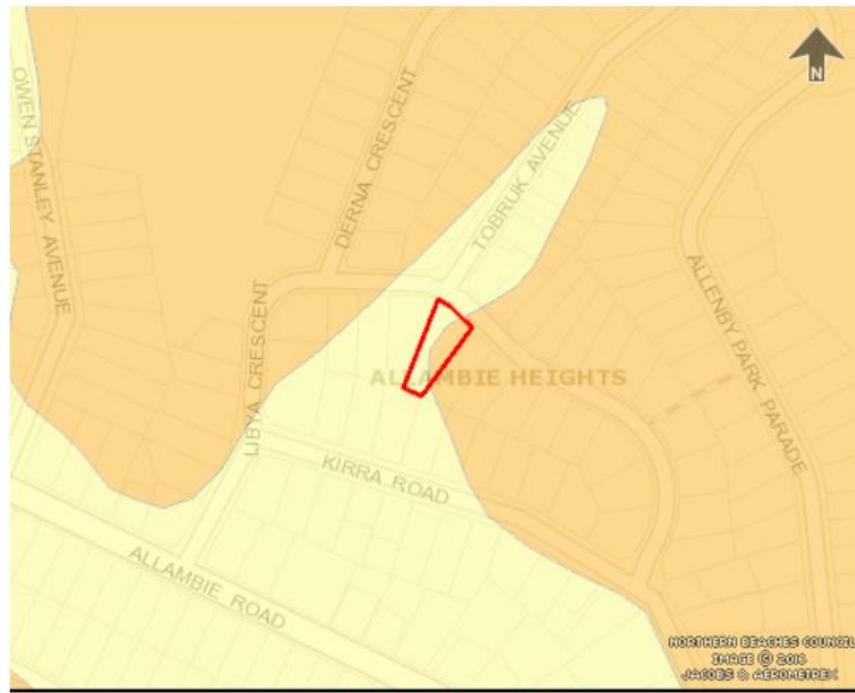
WARRINGAH LANDSLIP RISK MAP

Northern Beaches Council's Landslide Risk Map below indicates that the subject property is bisected by the delineation of Land Slip Risk Class A and Class B. Accordingly, it has been conservatively interpreted that the requirements of the more stringent of the two classes, being Class B, is appropriate for this development application.

- Area A - Slope less than 5 degrees
- Area B - Flanking Slopes from 5 to 25 degrees
- Area C - Slopes more than 25 degrees
- Area D - Collaroy Plateau Area Flanking Slopes 5 to 15 degrees
- Area E - Collaroy Plateau Area Slopes more than 15 degrees

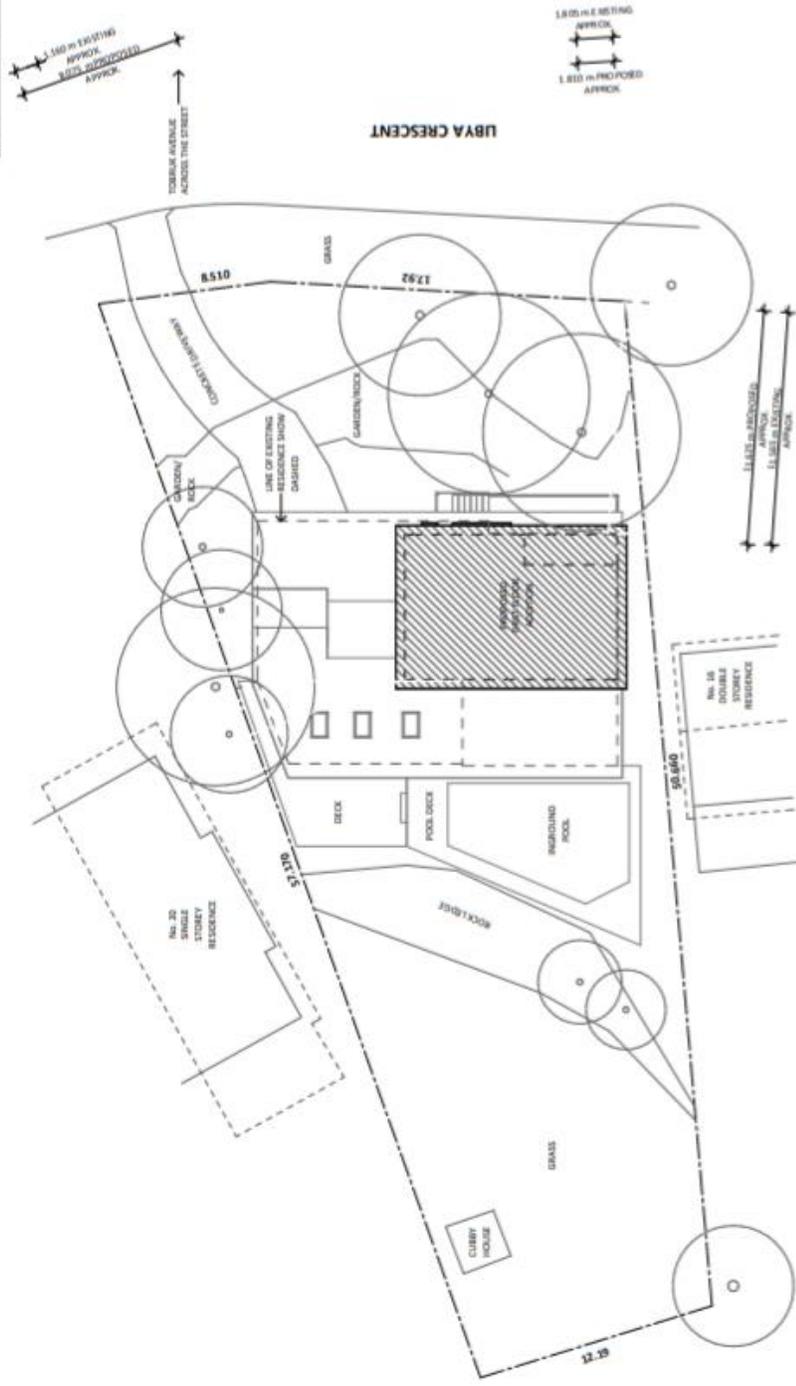
SITE PLAN 1 : 200

Appendix A – Cape Cod Site Plan - drawing 2

SITE PLAN

- 2.1 The proposed development is the addition of a second level to part of the existing residence.
- 2.2 Details of the proposed development are shown on seven drawings prepared by Cape Cod Australia (Job No 8082). The Site (Survey) Plan, being Cape Cod's drawing 2, is included as Appendix A.
- 2.3 As the proposed development comprises building above the existing residence, no excavations or fills are either shown on the plans or required.
- 2.4 The site shows no evidence or indications of historical ground movement that could have occurred since the original cottage was developed. I am not aware of any historical instability on the property.

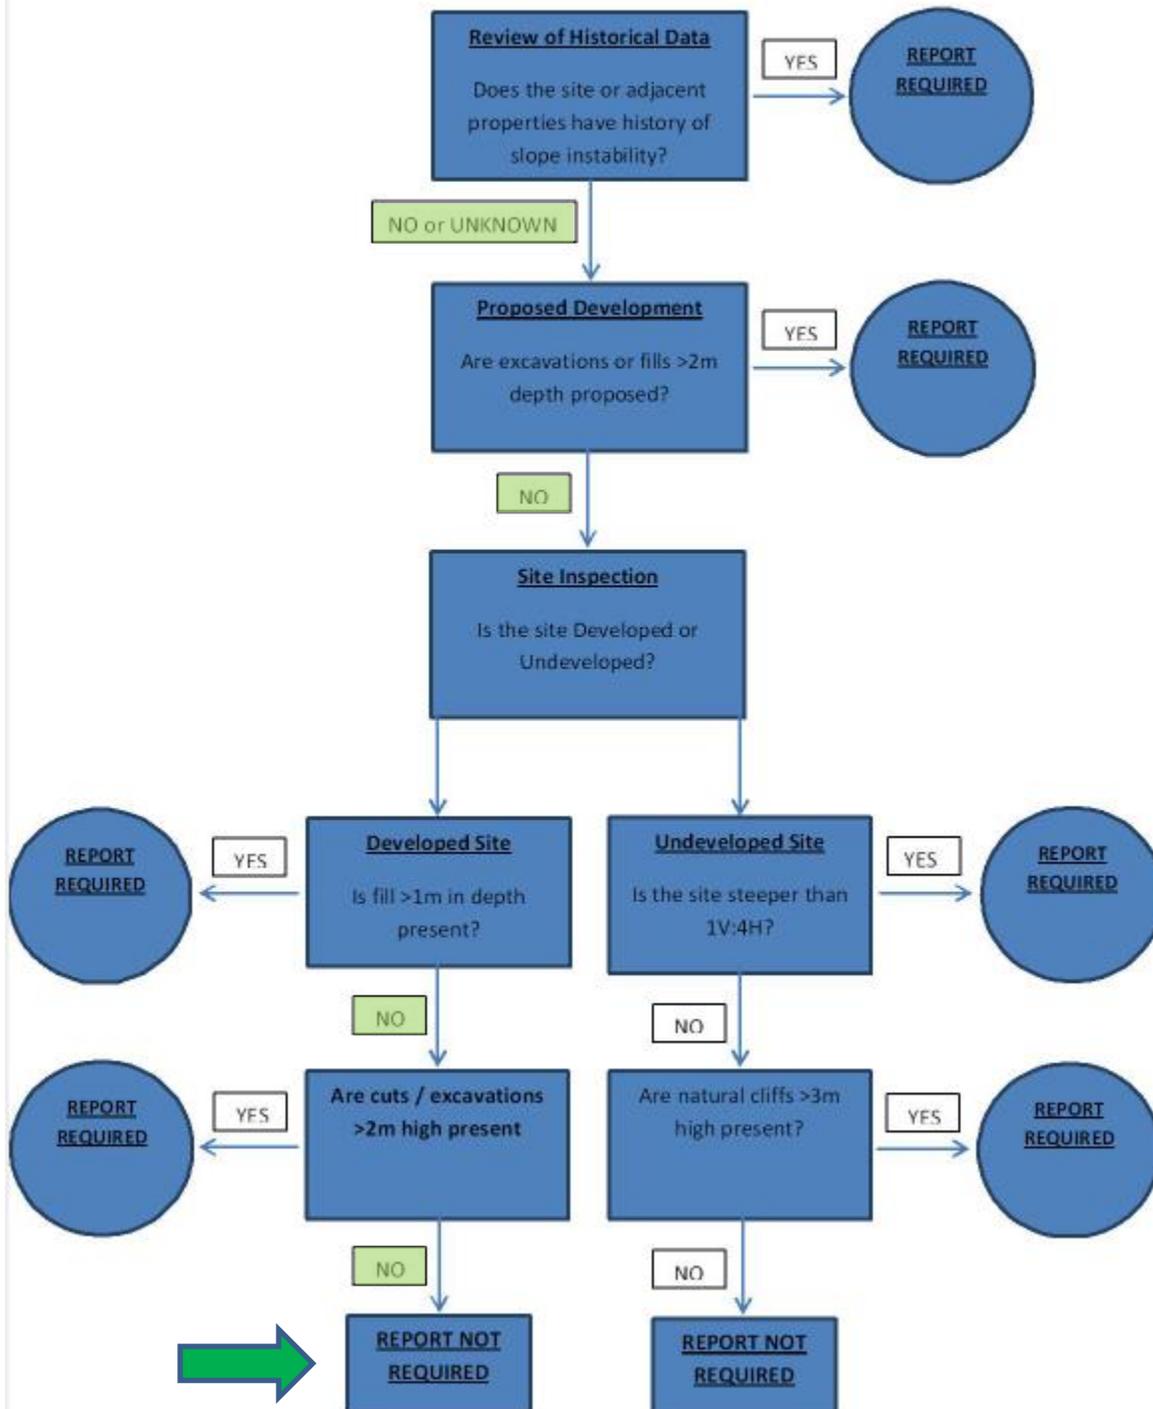
CHECKLIST FOR COUNCIL'S ASSESSMENT OF SITE CONDITIONS AND NEED FOR GEOTECHNICAL REPORT IN GEOTECHNICAL CLASS B AND D

Appendix B

The proposed development and site conditions were considered and applied to the NBC LEP Section E10 flow chart (Appendix B), entitled '*Checklist for Council's assessment of Site Conditions and need for Geotechnical Report in Geotechnical Class B and D*'.
