## **PRELIMINARY GEOTECHNICAL ASSESSMENT:**

### **54 Kenneth Road, Manly Vale**

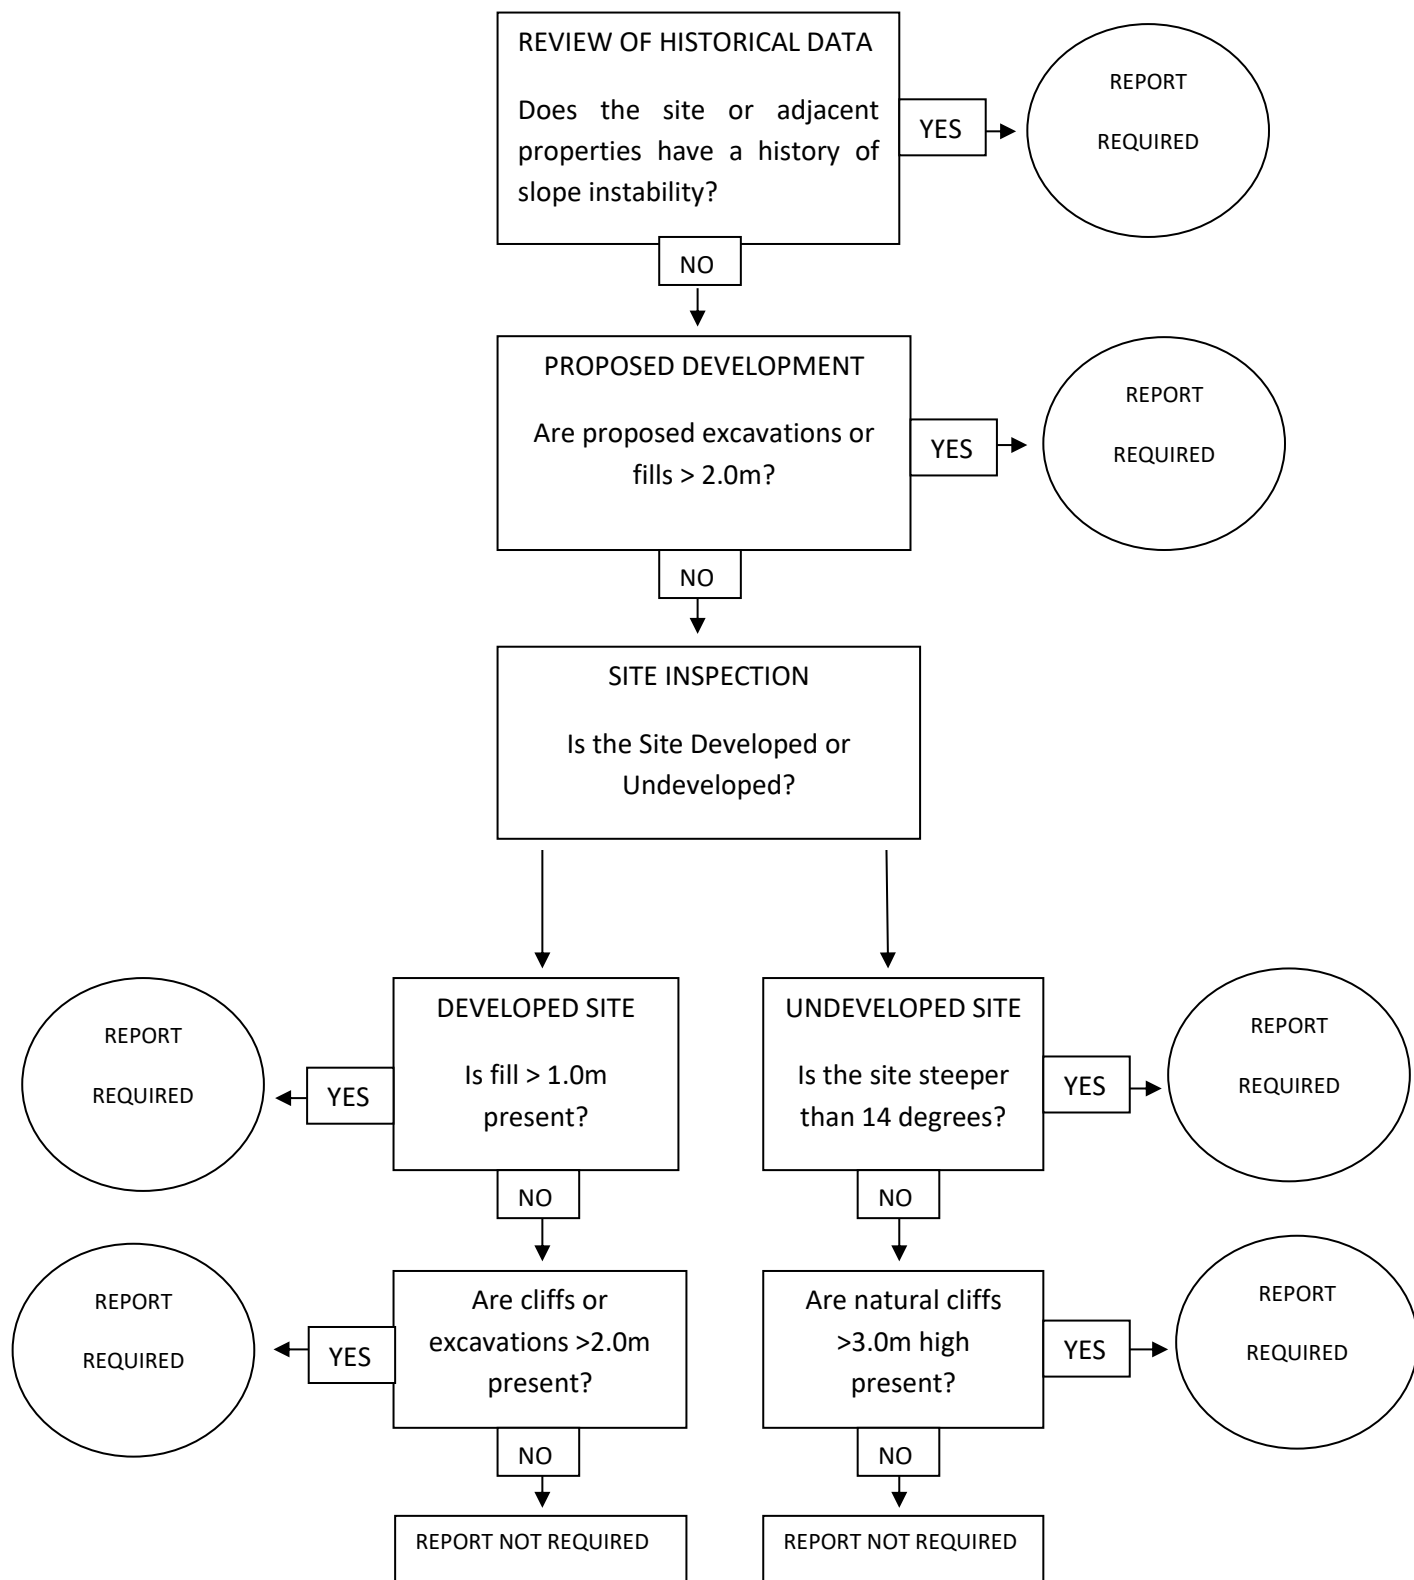
## Preliminary Assessment Flow Chart – Northern Beaches Council (Warringah)

The proposed development and site conditions were considered and applied to the Council Flow Chart.
