Preliminary Geotechnical Assessment

Project: Alterations & Additions
1058 Barrenjoey Road, Palm Beach NSW

REF: AG 21054
12 March 2021

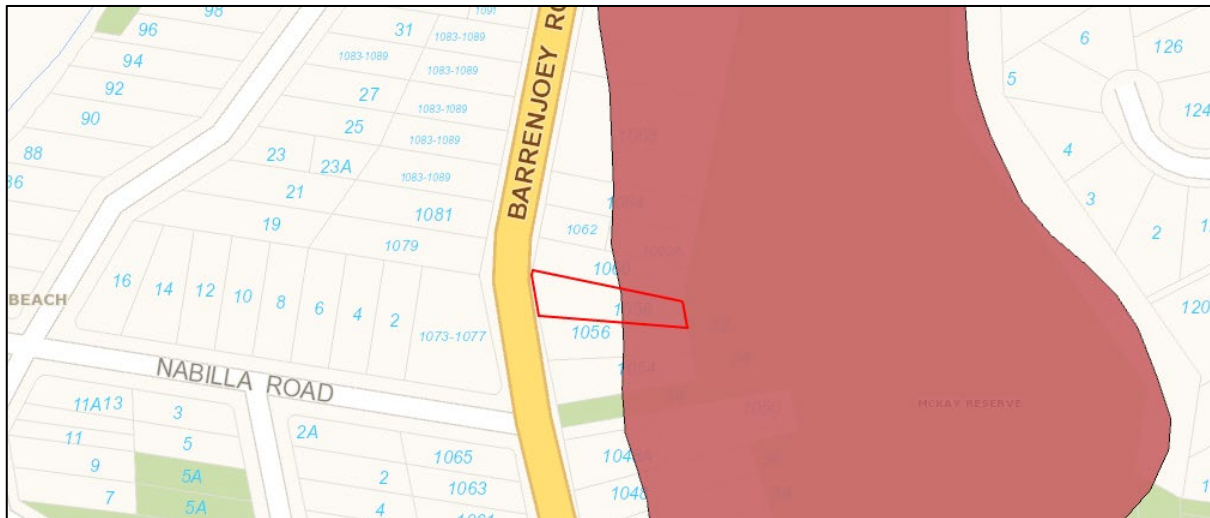
Image 1. Pittwater Geotechnical Hazard Map:
1058 Barrenjoey Road, Palm Beach NSW (© NBC)

The site is mapped as **Geotechnical Hazard H1** subject to specific landslip risk/geotechnical hazard mapping with reference to the Pittwater Geotechnical Hazard Map (**Image 1**).

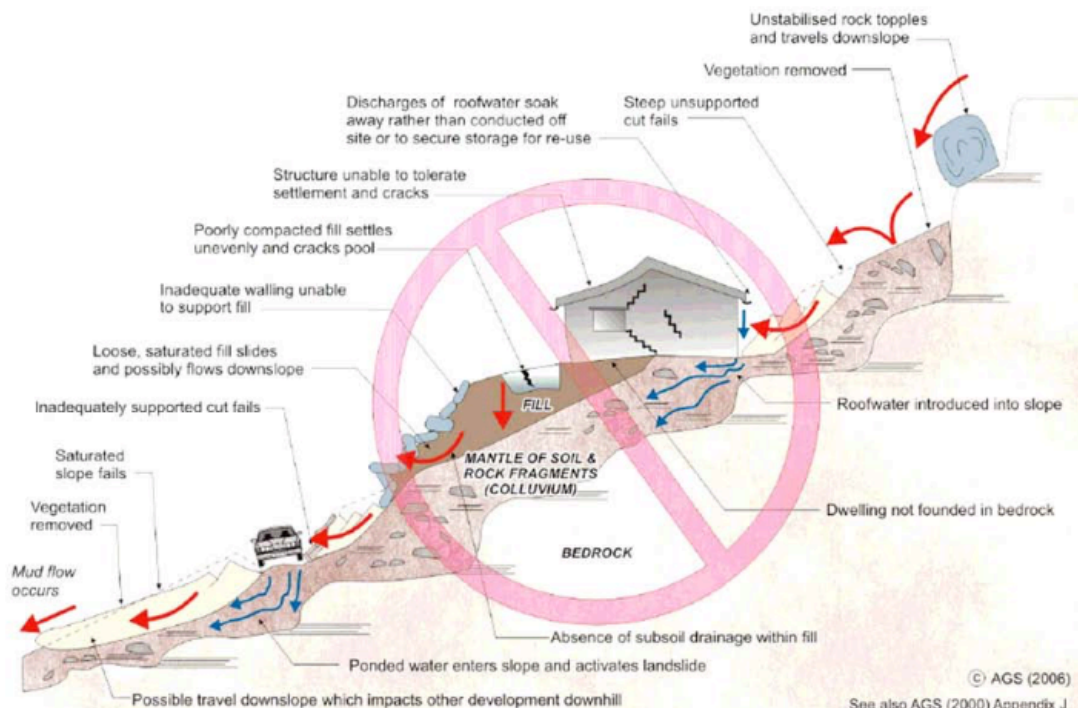
EXAMPLES OF **POOR** HILLSIDE PRACTICE

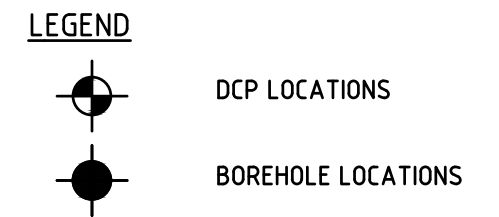
Site Plan | Testing Locations

<div> <div>ASCENT</div><div>GEOTECHNICAL CONSULTING</div></div>	ABN: 71 621 428 402 www.ascentgeo.com.au (02) 9913 3179 admin@ascentgeo.com.au 1457 Pittwater Road North Narrabeen NSW 2101	CLIENT: HILARY & STEPHEN DARKE	SITE PLAN/GROUND TEST LOCATIONS AT 1058 BARRENJOEY ROAD PALM BEACH NSW	DATE: 10/03/2021
							SCALE: AS SHOWN @ A3			
							DRAWING TITLE: SITE PLAN			
A	10.03.21	PRELIMINARY ISSUE	VT	BM						DRAWING NO: AG21054- S1
REV	DATE	REVISION DESCRIPTION	REV BY	CHKD

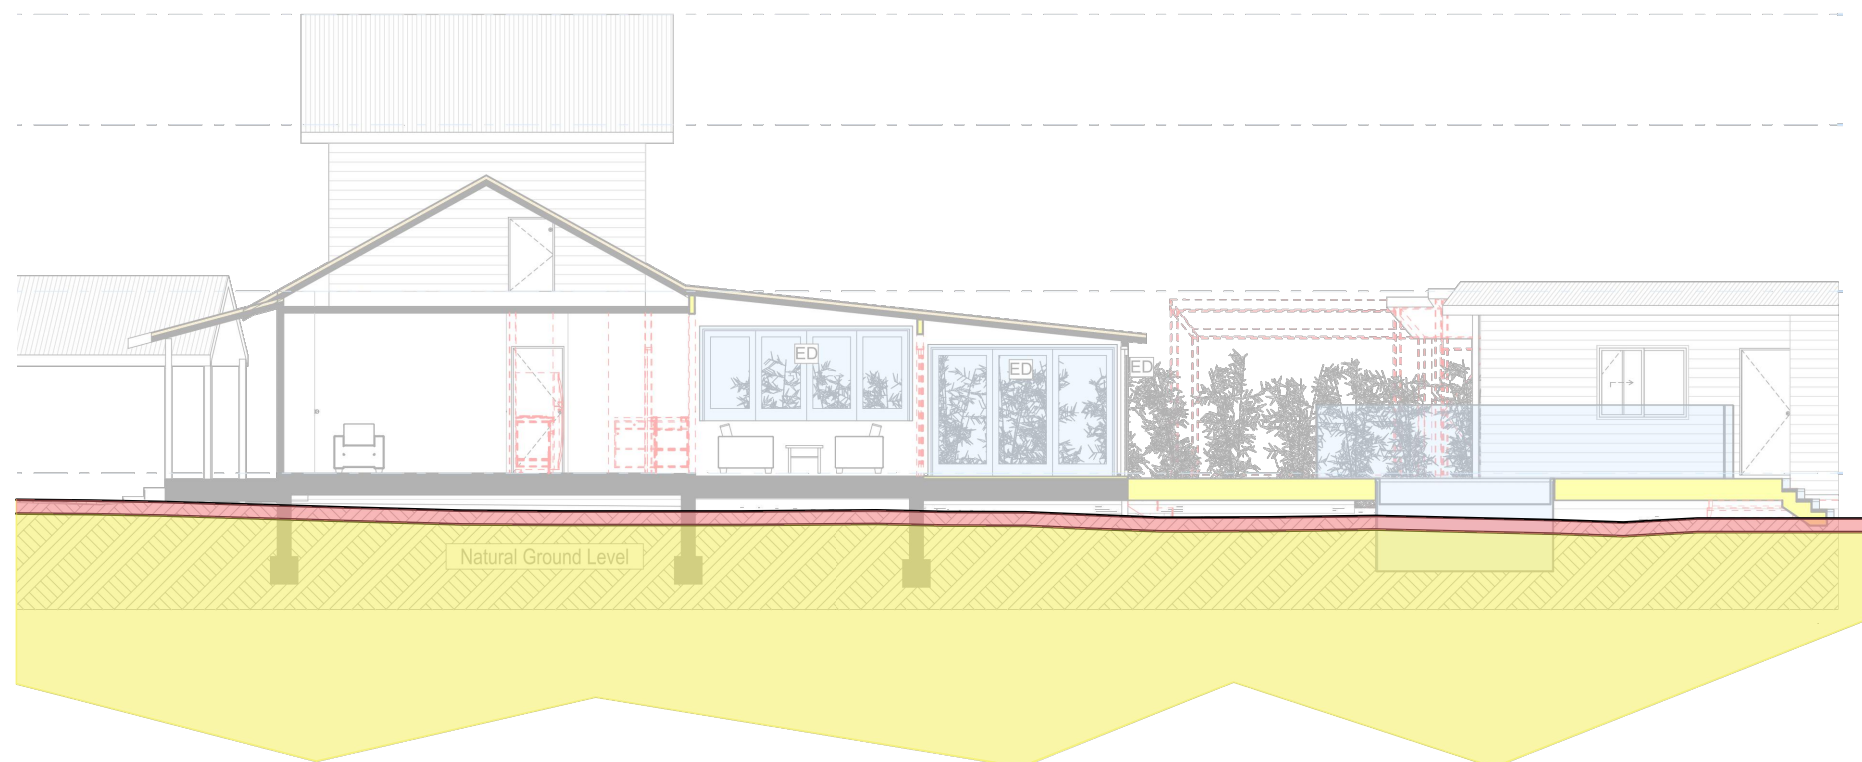
INFERRED GEOLOGICAL SECTION
SCALE NTS

INTERPRETED SUBSURFACE SECTION ONLY.
ACTUAL GROUND CONDITIONS MAY VARY.
