Preliminary Geotechnical Assessment

Project: Alterations & Additions

57 Lantana Avenue, Wheeler Heights NSW

Ref: AG 22512

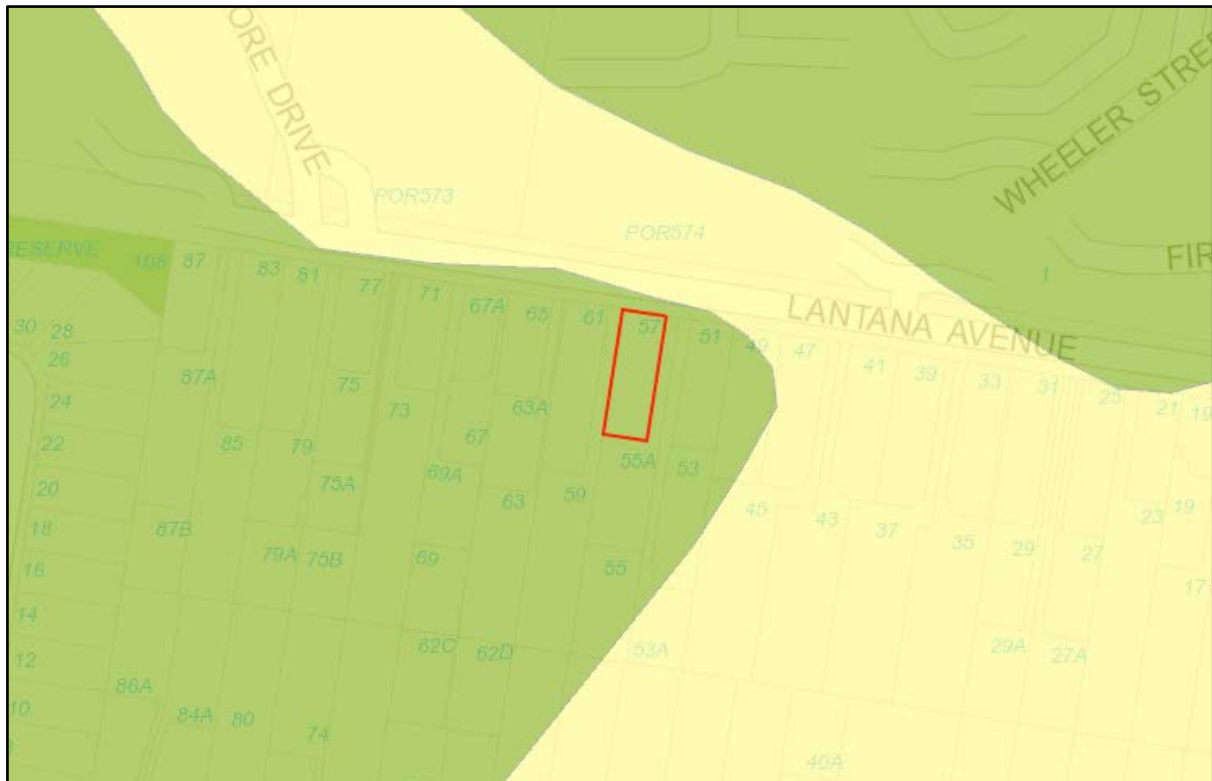
Image 1. Warringah Landslip Risk Map:
57 Lantana Avenue, Wheeler Heights NSW (© NBC Maps)

The site is mapped as **Area D** subject to specific landslip risk/geotechnical hazard mapping with reference to the Warringah (WLEP) Landslip Risk Map, Northern Beaches Council (**Image 1**).

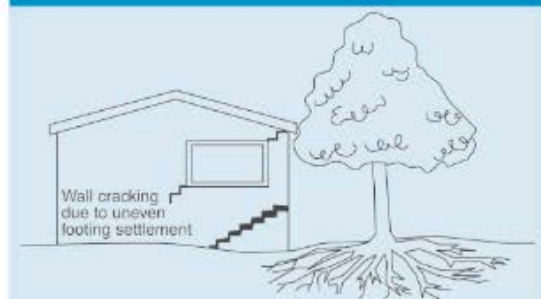
Trees can cause shrinkage and damage

As the weather pattern changes and the soil begins to dry out, the external footings will be first affected, beginning with the locations where the sun's effect is strongest. This has the effect of lowering the external footings. The doming is accentuated and cracking reduces or disappears where it occurred because of dishing, but other cracks open up. The roof lines may become convex.
