## **Geotechnical Assessment**

**Project:** Alterations & Additions  
4B Waiwera Avenue, North Manly NSW

**REF: AG 21105**  
16 April 2021

For Alterations and Additions at  
**4B Waiwera Avenue, North Manly**

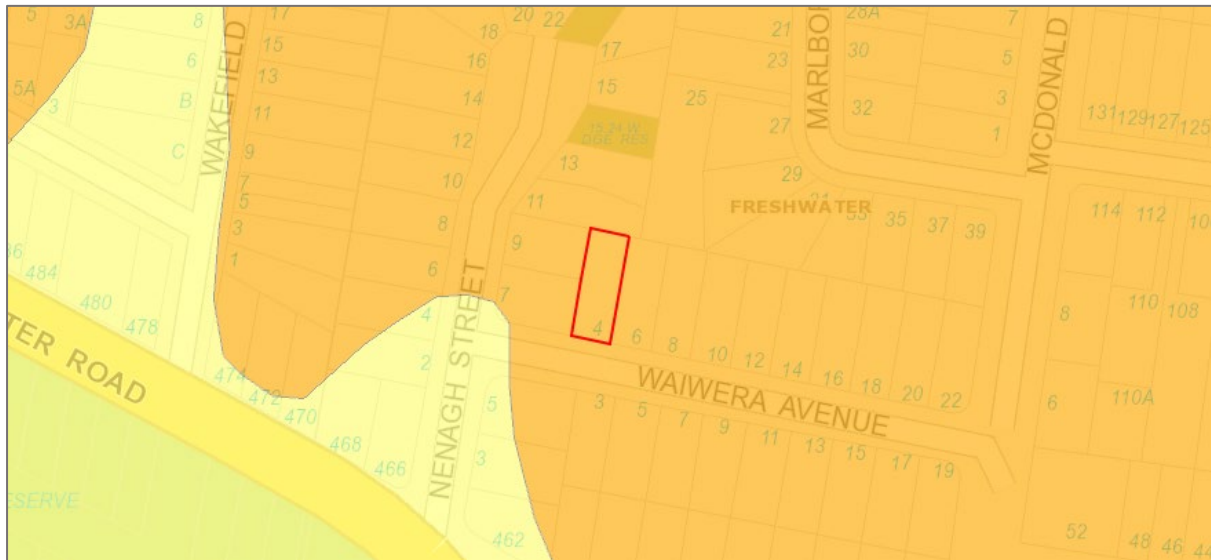
**Image 1.** Warringah Landslip Risk Map:  
4B Waiwera Avenue, North Manly (© NBC Maps)

- The site is mapped as **Area B** subject to specific landslip risk/geotechnical hazard mapping with reference to the Warringah Landslip Risk Map (**Image 1**).
