# Preliminary Geotechnical Assessment

**Project:** Alterations & Additions  
57 Parni Place, Frenchs Forest NSW

**Ref:** AG 25234  
29 May 2025

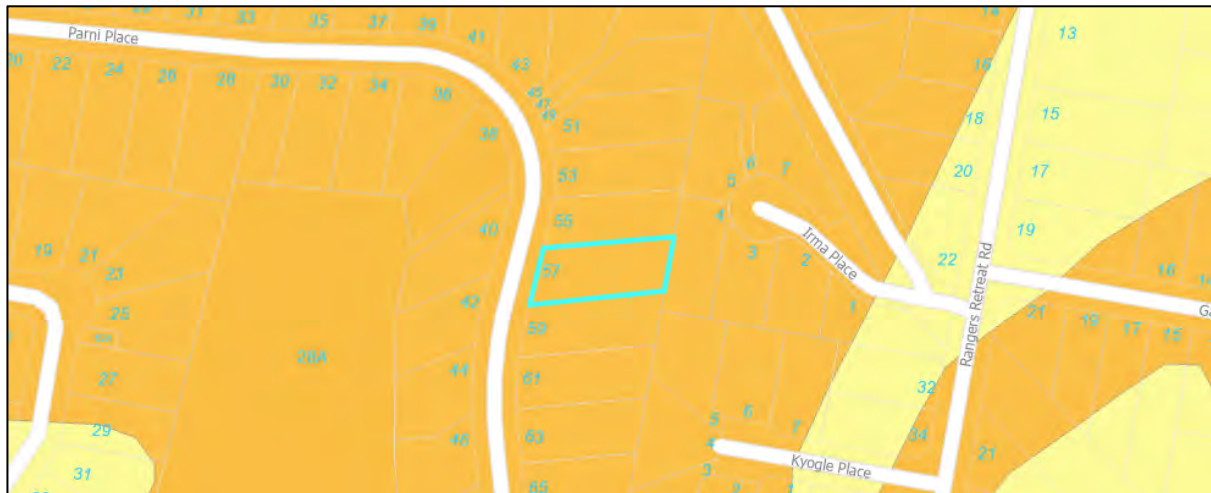
**Figure 1.** Warringah Landslip Risk Map:  
57 Parni Place, Frenchs Forest NSW (© NBC Maps)

The site is mapped as **Area B** subject to specific landslip risk/geotechnical hazard mapping with reference to the Warringah (WLEP) Landslip Risk Map, Northern Beaches Council (**Image 1**).
