Bayview Golf Club

Acid Sulfate Soil Assessment:  
Green Renovation Works  
Bayview Golf Course, Cabbage Tree  
Road, Bayview, NSW

P2309440JR02V01  
April 2023

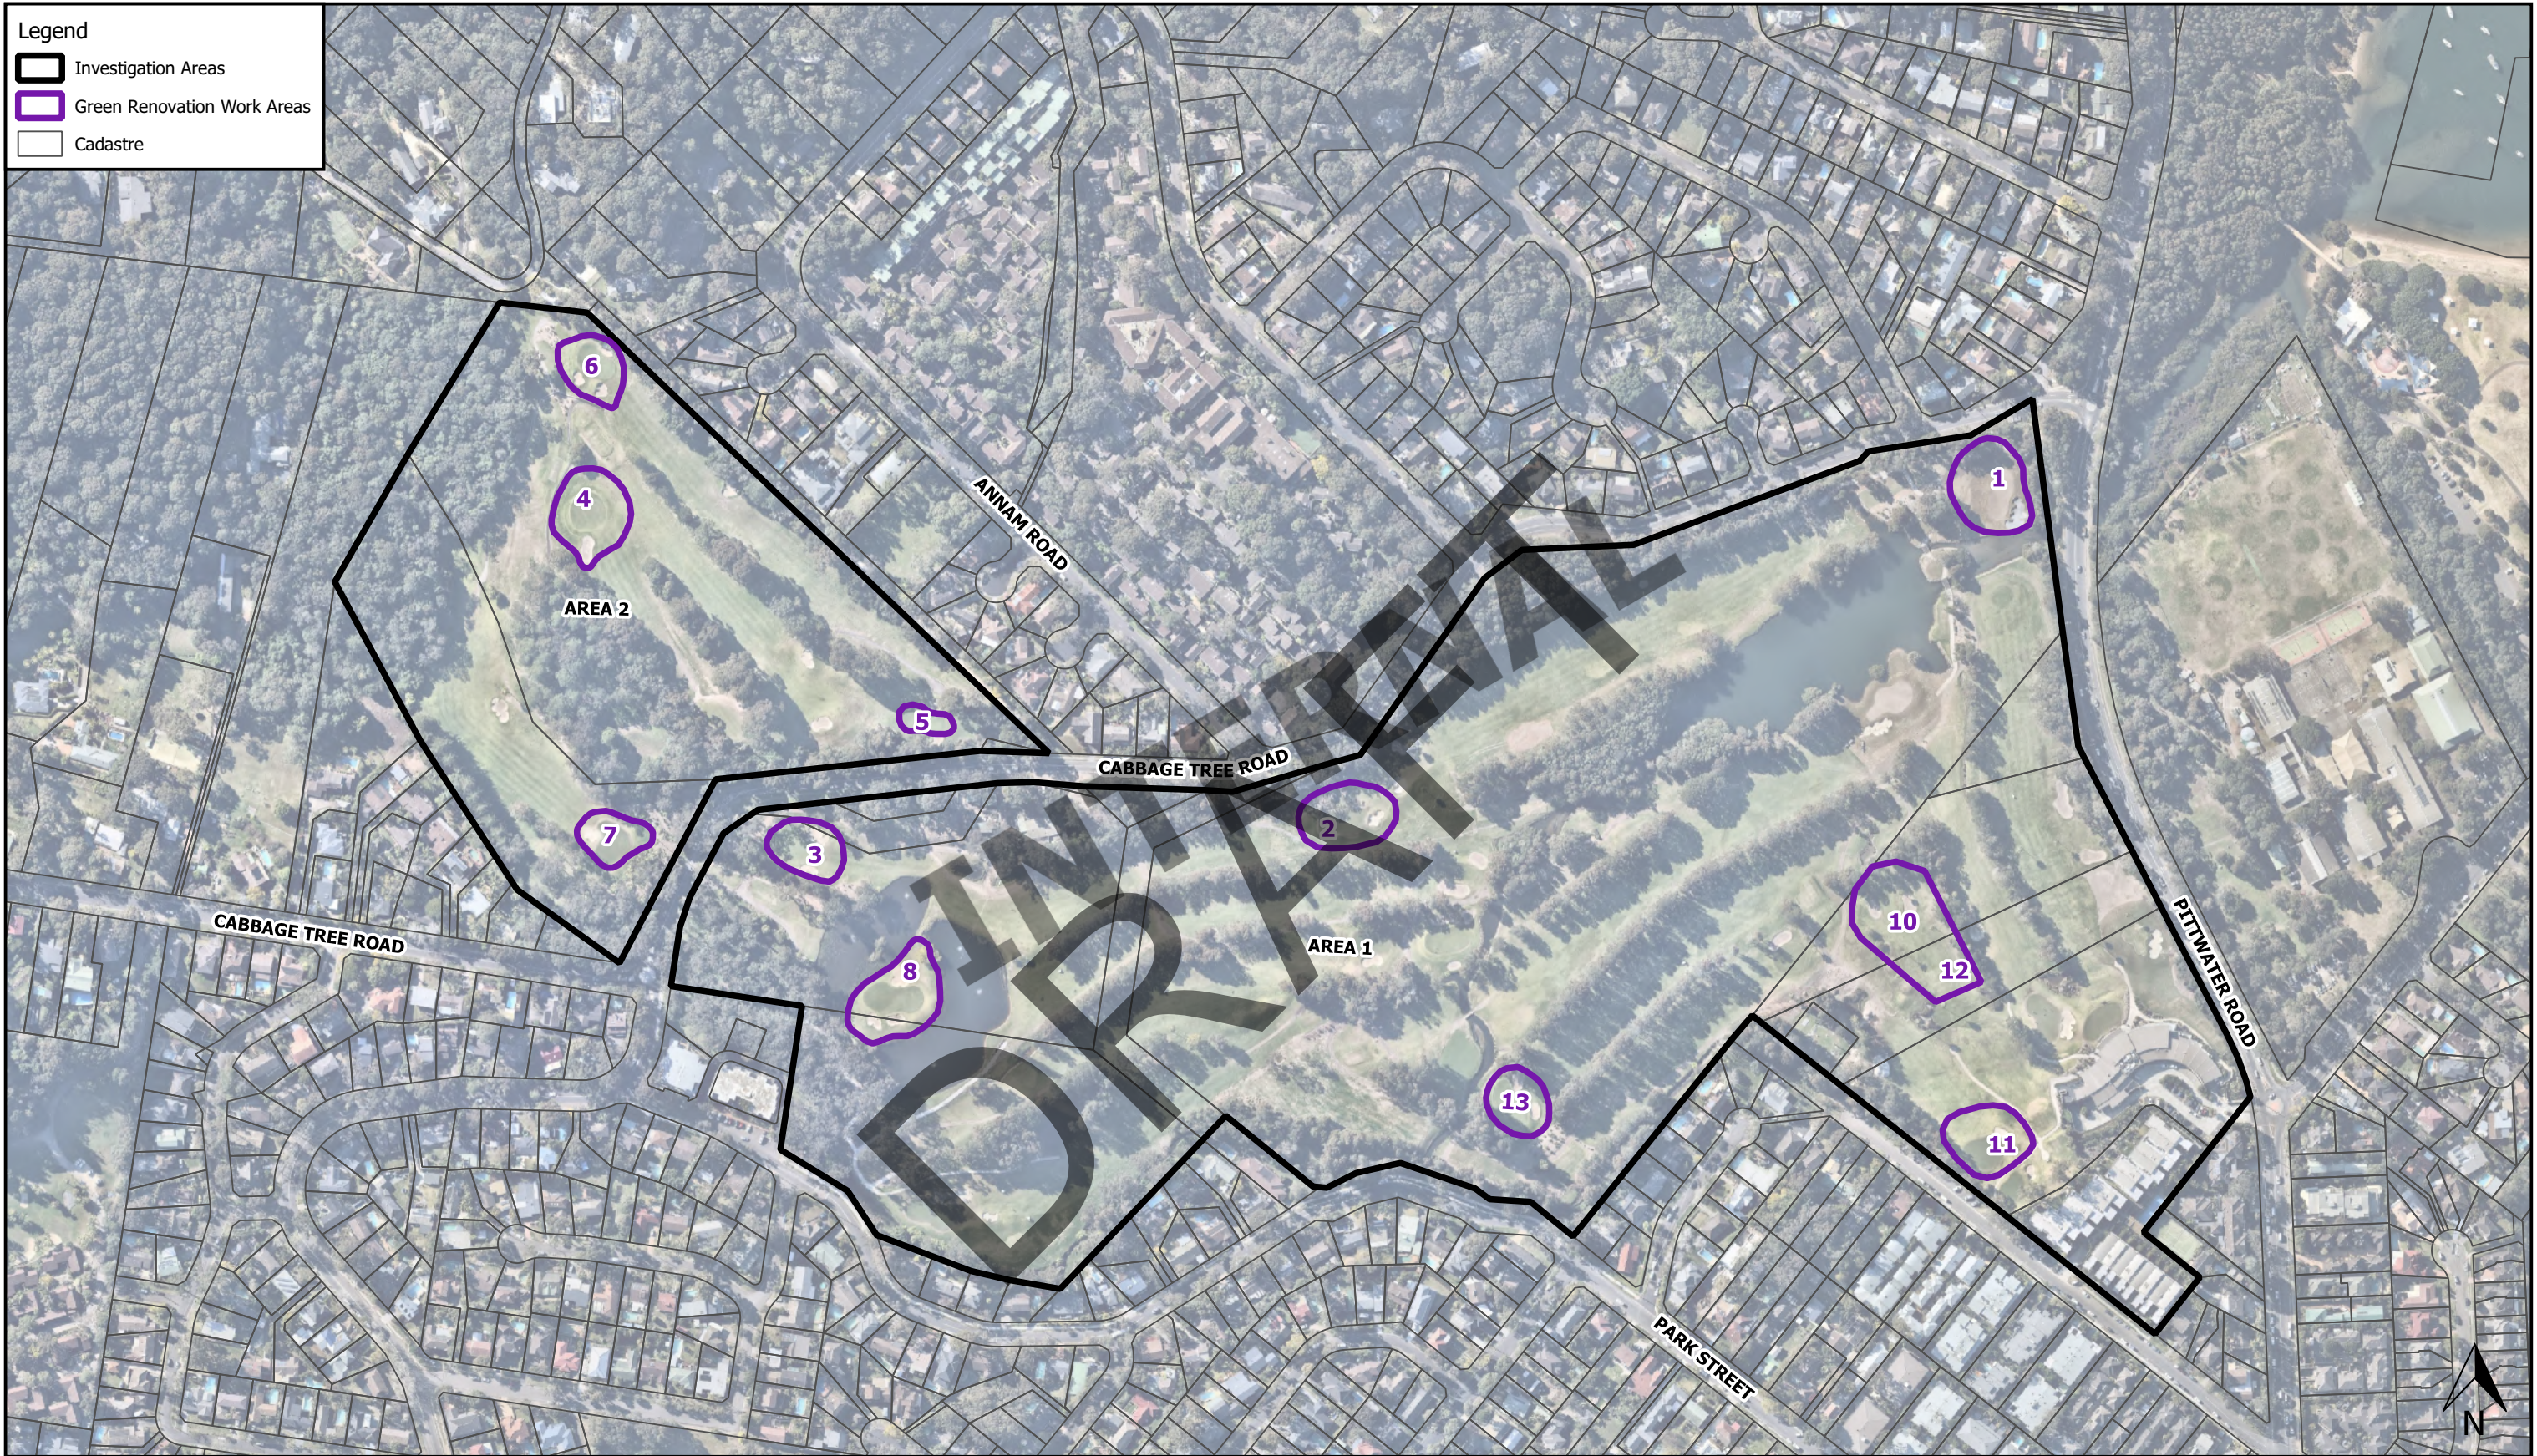
**Site Layout**

GE01	Map
Cabbage Tree Road, Bayview, NSW	Site
Geotechnical and Acid Sulphate Soils Assessment	Project
Geotechnical Assessment Reporting	Sub-Project
Bayview Golf Club	Client
31/03/2023	Date

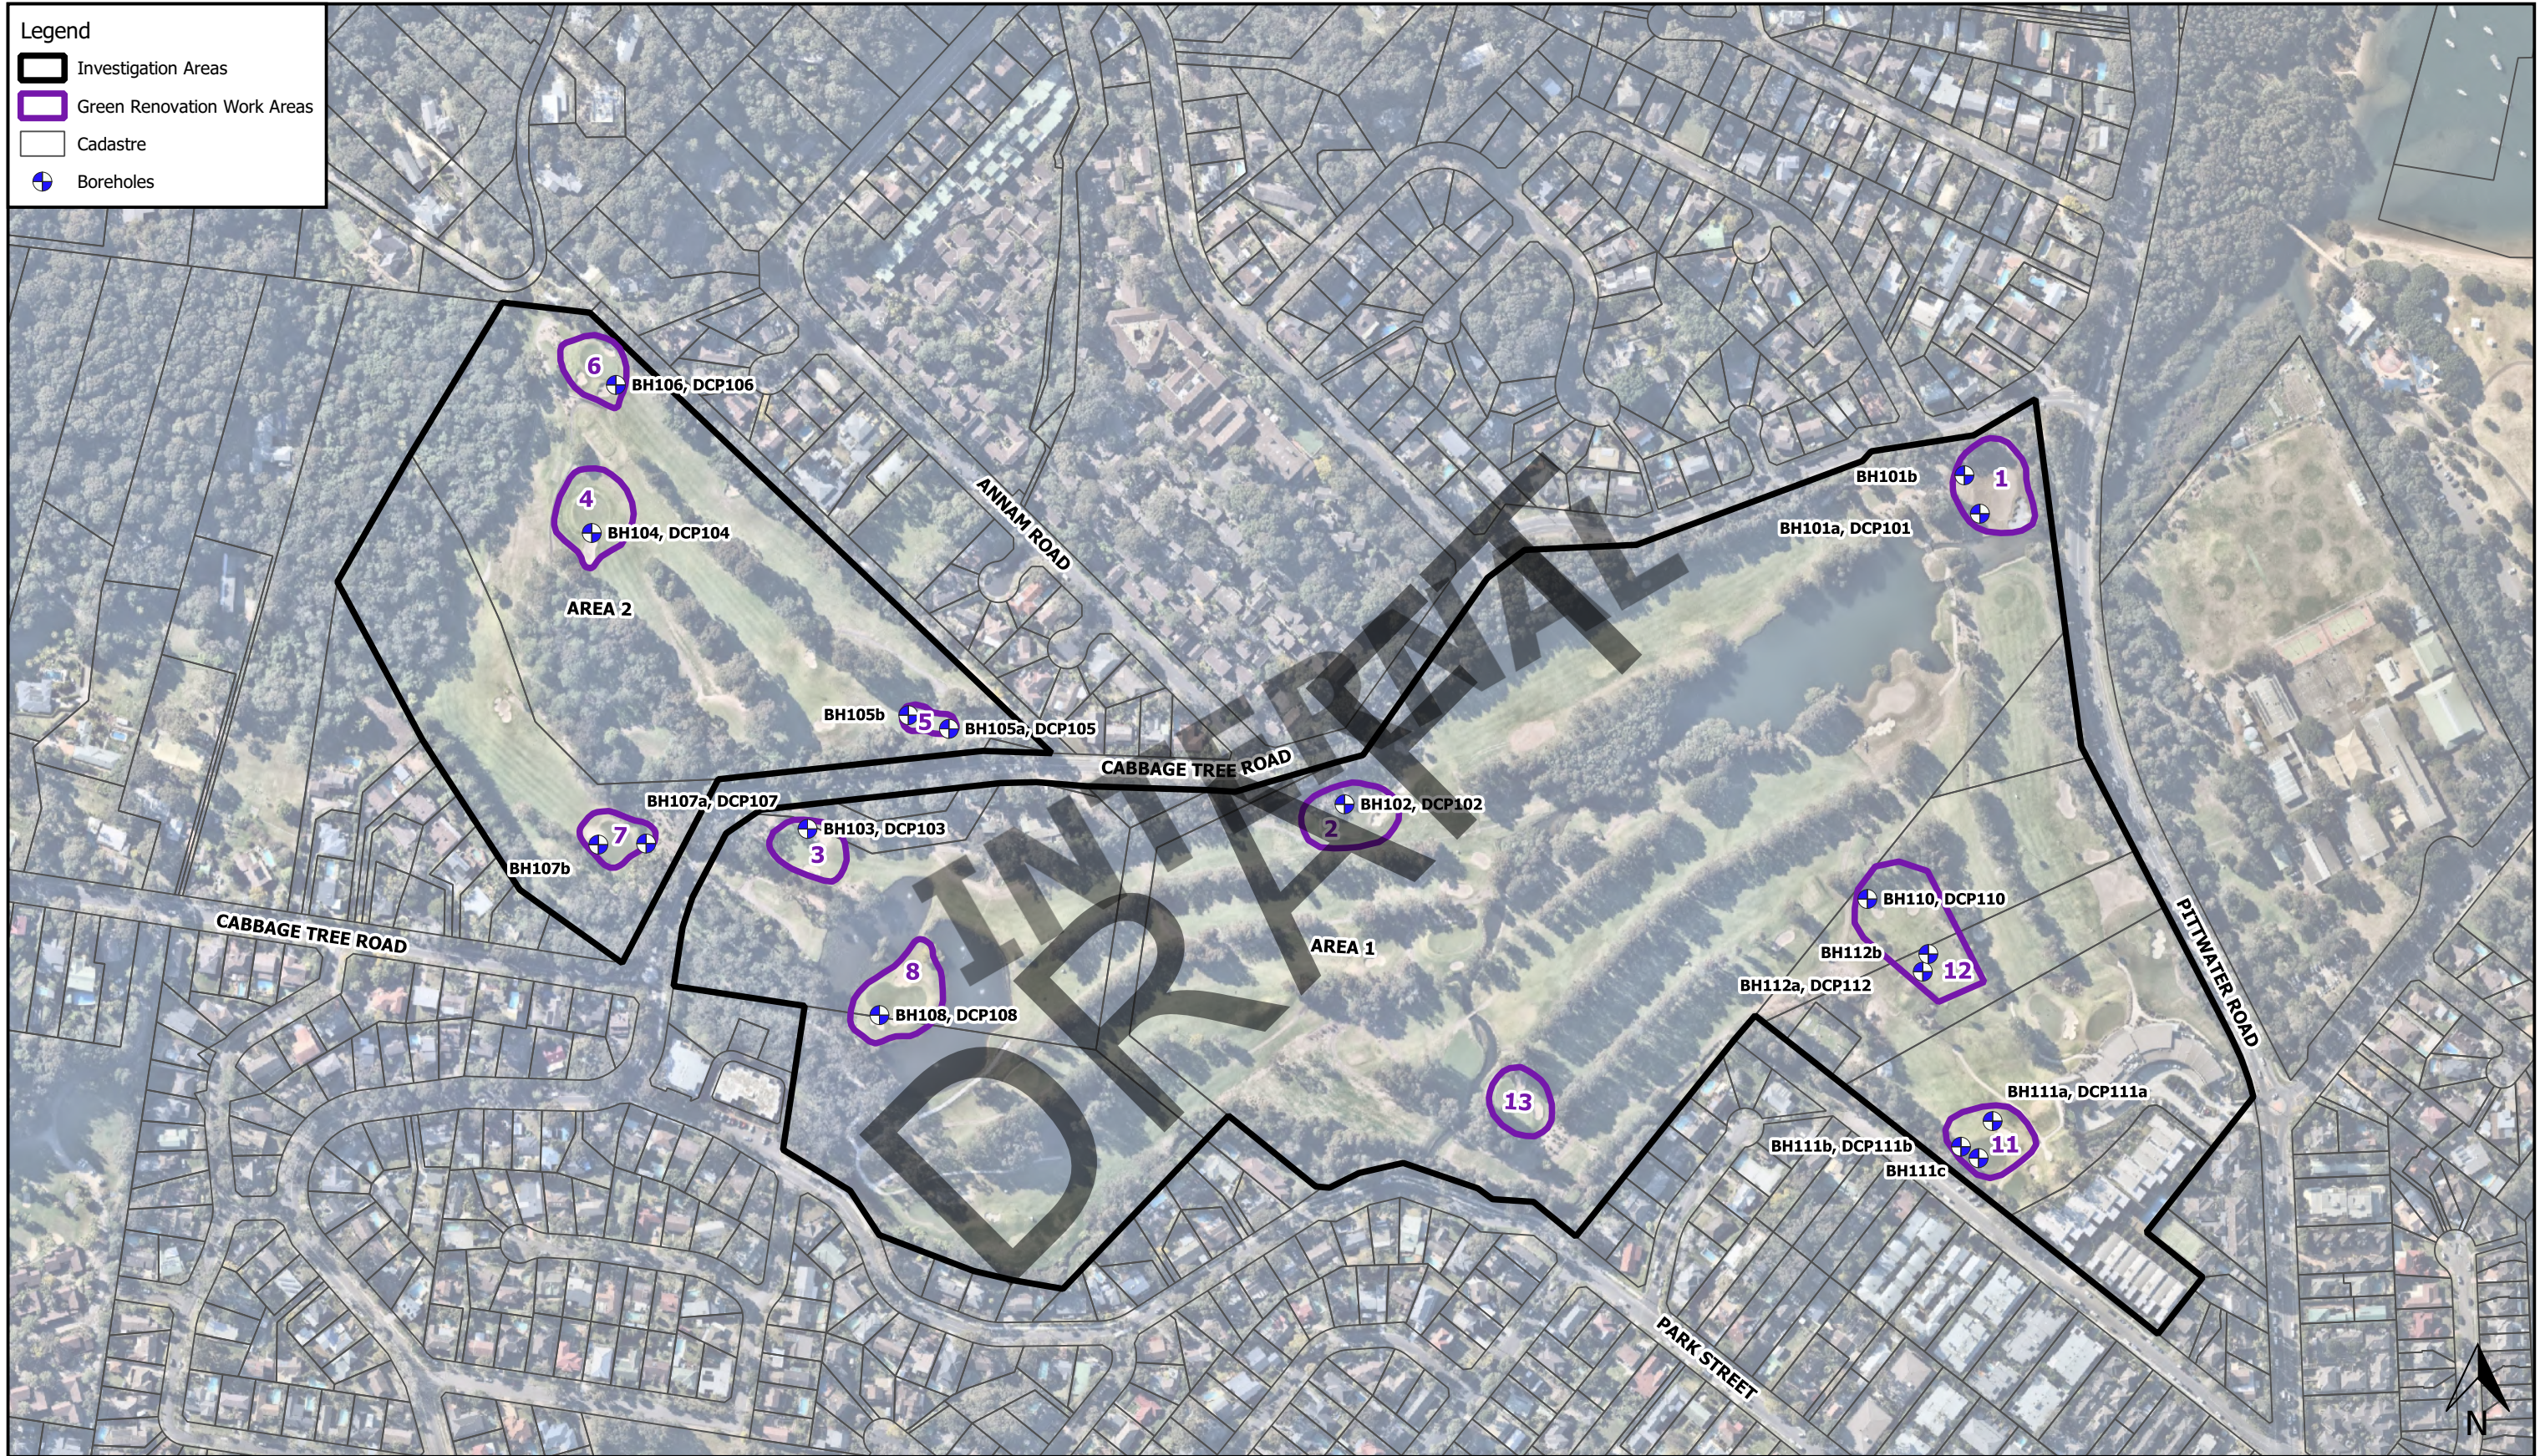
Map Title / Figure:  
**Borehole Location Plan**

- Investigation Areas
- Green Renovation Work Areas
- Cadastre
- + Boreholes

<b>GE02</b>	Map
Cabbage Tree Road, Bayview, NSW	Site
Geotechnical and Acid Sulphate Soils Assessment	Project
Geotechnical Assessment Reporting	Sub-Project
Bayview Golf Club	Client
31/03/2023	Date
