REPORT ON GEOTECHNICAL SITE ASSESSMENT

PROPOSED NEW SWIMMING POOL

20 NARRABEEN PARK PARADE, WARRIEWOOD, NSW

Project No.: 2020-180.1

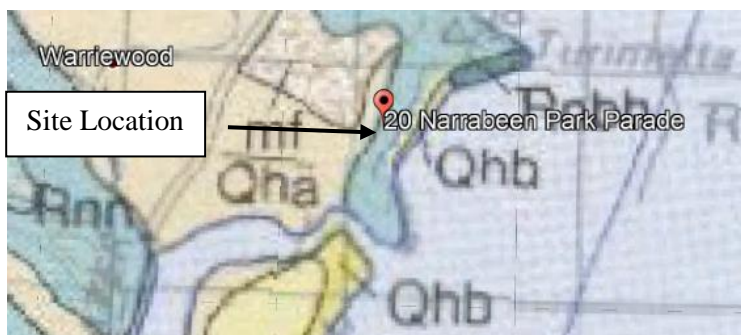
Extract of Sydney: 1:100 000 – Geology underlying the site

Reference to the Sydney 1:100,000 Geological Series sheet (9130) indicates that the site is underlain by Newport Formation (Upper Narrabeen Group) rock (Rnn) which is of middle Triassic Age. The Newport Formation typically comprises interbedded laminite, shale and quartz to lithic quartz sandstones and pink clay pellet sandstones.
