Geotechnical Assessment

Project: Alterations & Additions
6 Kempbridge Avenue, Seaforth NSW

REF: AG 20284
10 November 2020

For Alterations and Additions at
6 Kempbridge Avenue, Seaforth NSW

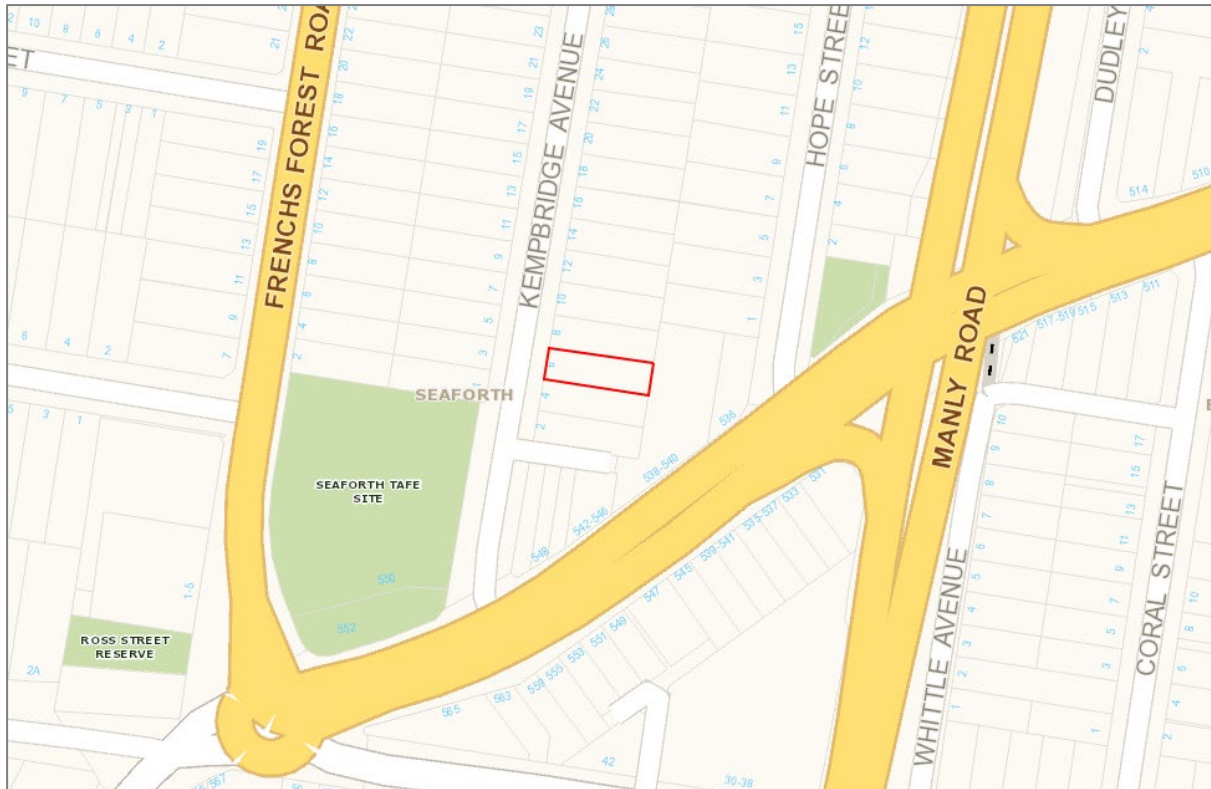
Image 2. MLEP Geotechnical Landslide Risk Map
– 6 Kempbridge Avenue, Seaforth NSW

- No evidence of significant soil creep, tension cracks or landslip instability were identified across the site or on adjacent properties, as viewed from the subject site, at the time of our inspection.
- Minor cracking was observed within the mortar of the front concrete block wall adjacent to the road reserve. The age of this wall is unknown and the timing of the cracking is unclear. The wall appeared stable at the time of our inspection.
- The property is unclassified with respect to landslide risk with reference to Northern Beaches Council MLEP Landslip Risk Map Sheet (**Image 2** below).

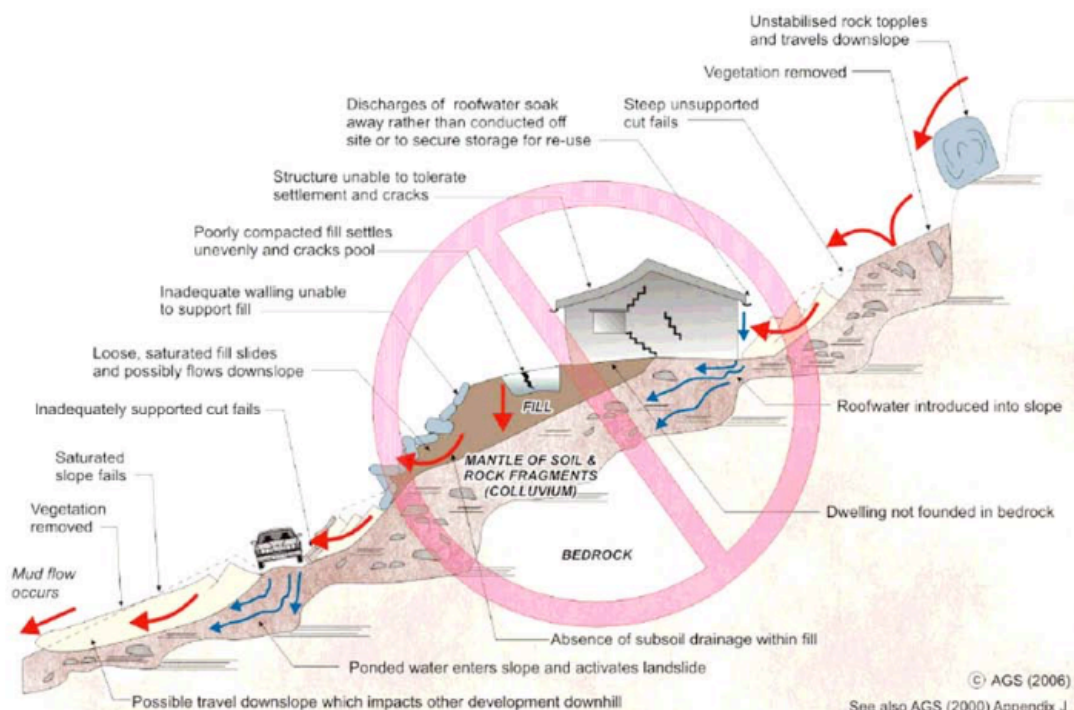
EXAMPLES OF **POOR** HILLSIDE PRACTICE

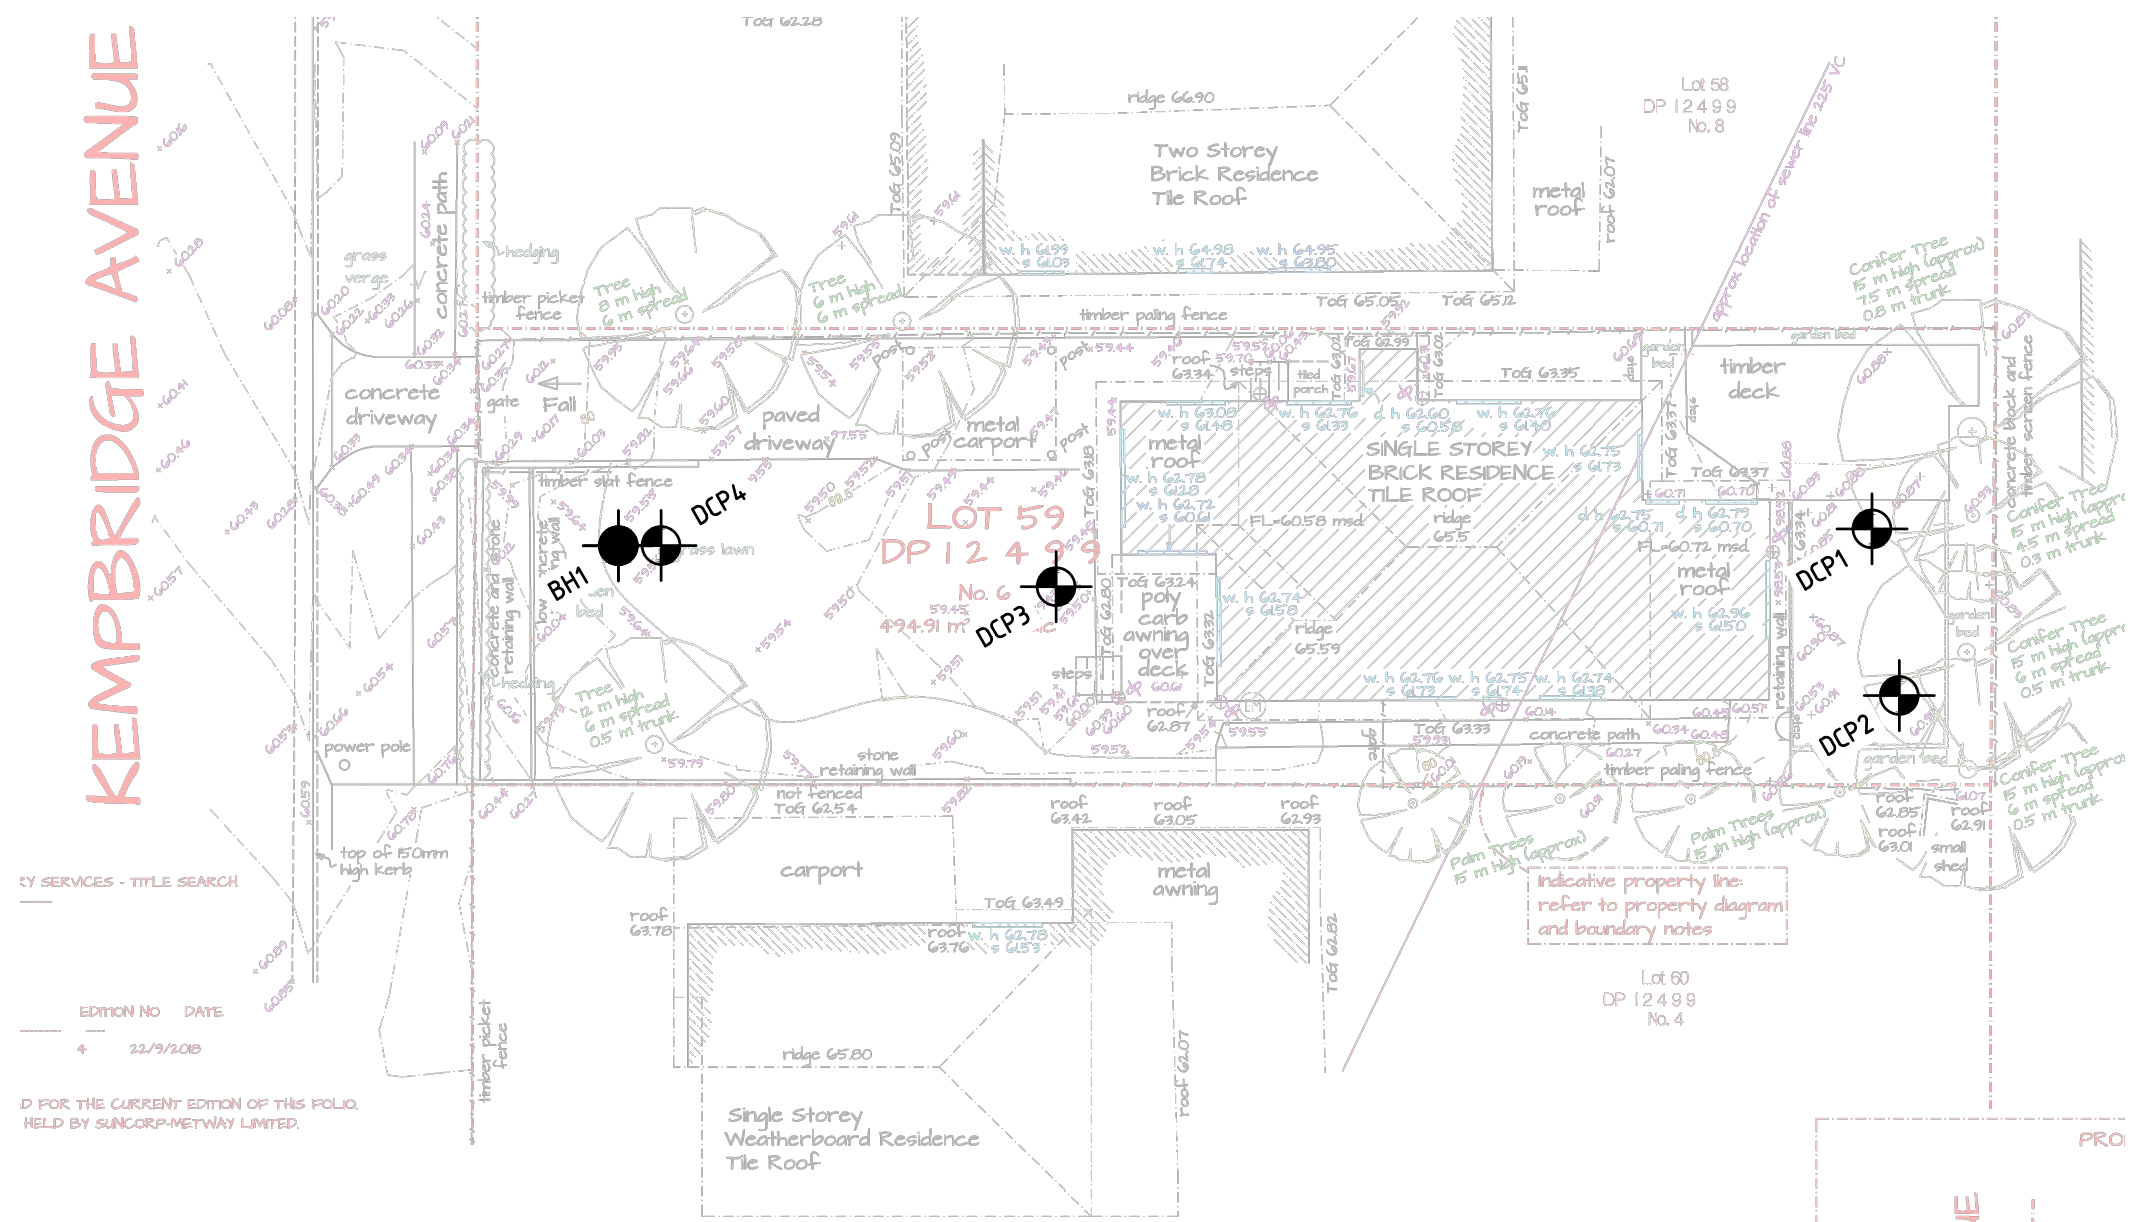
DCP LOCATIONS

BOREHOLE LOCATION

SITE PLAN/GROUND TEST LOCATIONS

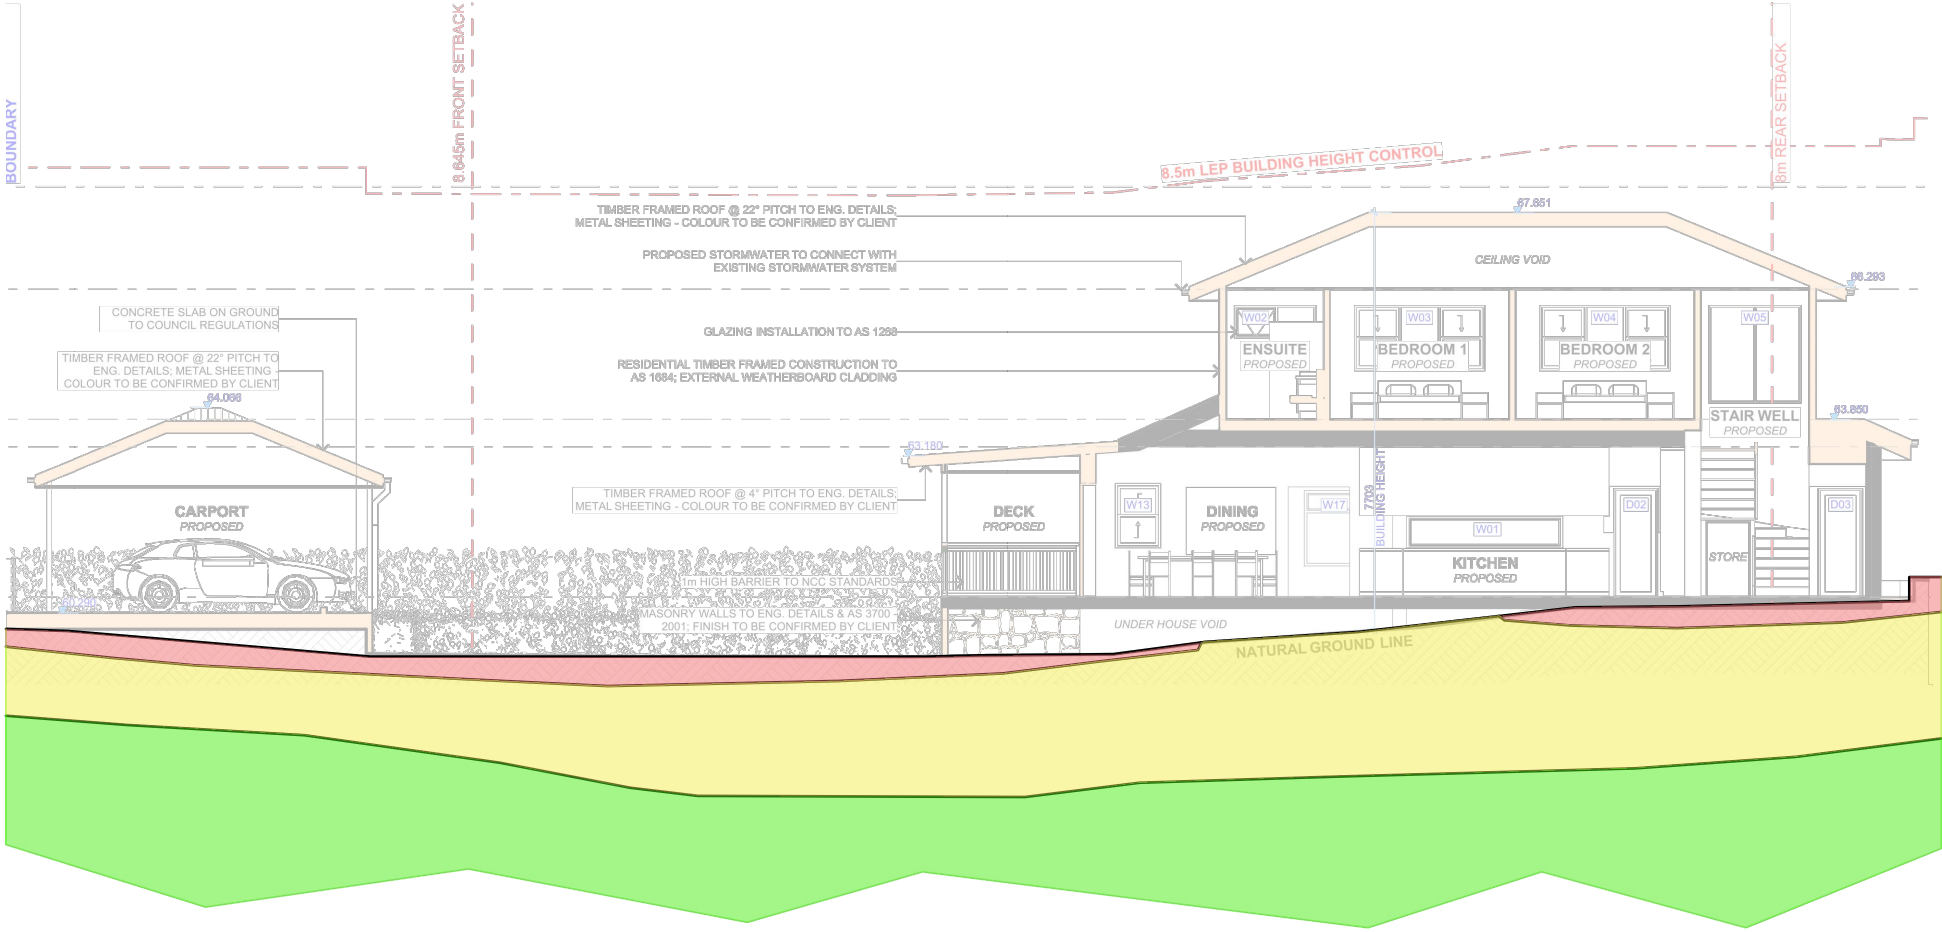
INTERPRETED SUBSURFACE SECTION ONLY.
ACTUAL GROUND CONDITIONS MAY VARY.

INFERRED GEOLOGICAL SECTION
SCALE NTS

The soil profile consists of shallow uncontrolled fill and silty sandy topsoil (O & A Horizons), sandy clay (B Horizon), and extremely weathered sandstone bedrock (C Horizon). Based on our observations and the results of testing onsite, we would expect competent weathered bedrock to be found within 900–3100mm from current surface levels across the site.
