## APPENDIX A – INSPECTION PHOTOGRAPHS

SEA WALL CONSTRUCTION

RISK ASSESSMENT REPORT

25-33 ROBERTSON ROAD, SCOTLAND ISLAND NSW

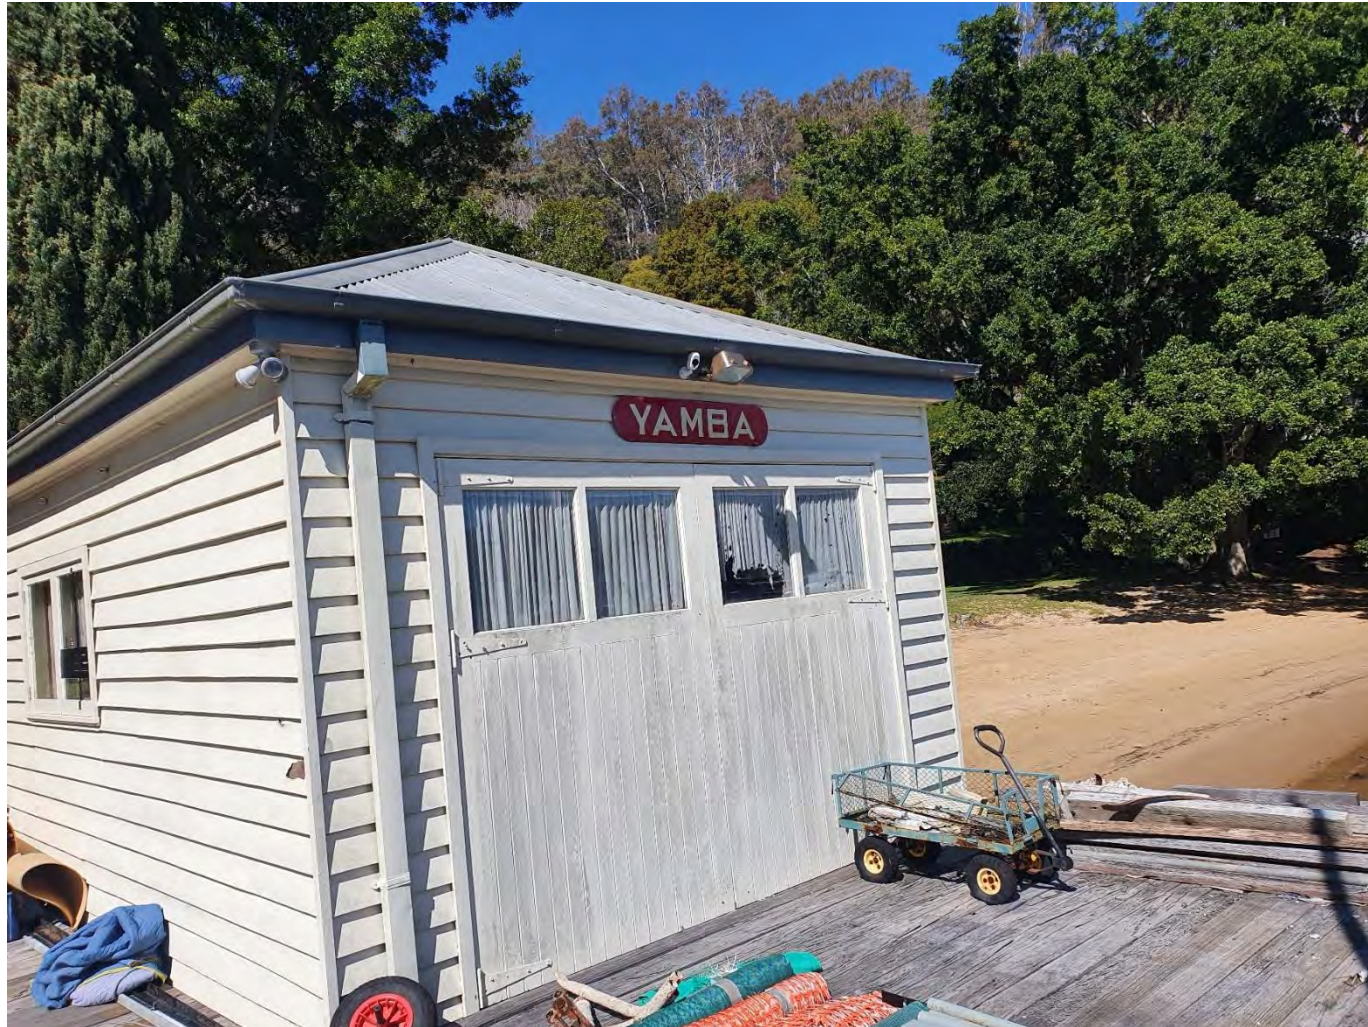
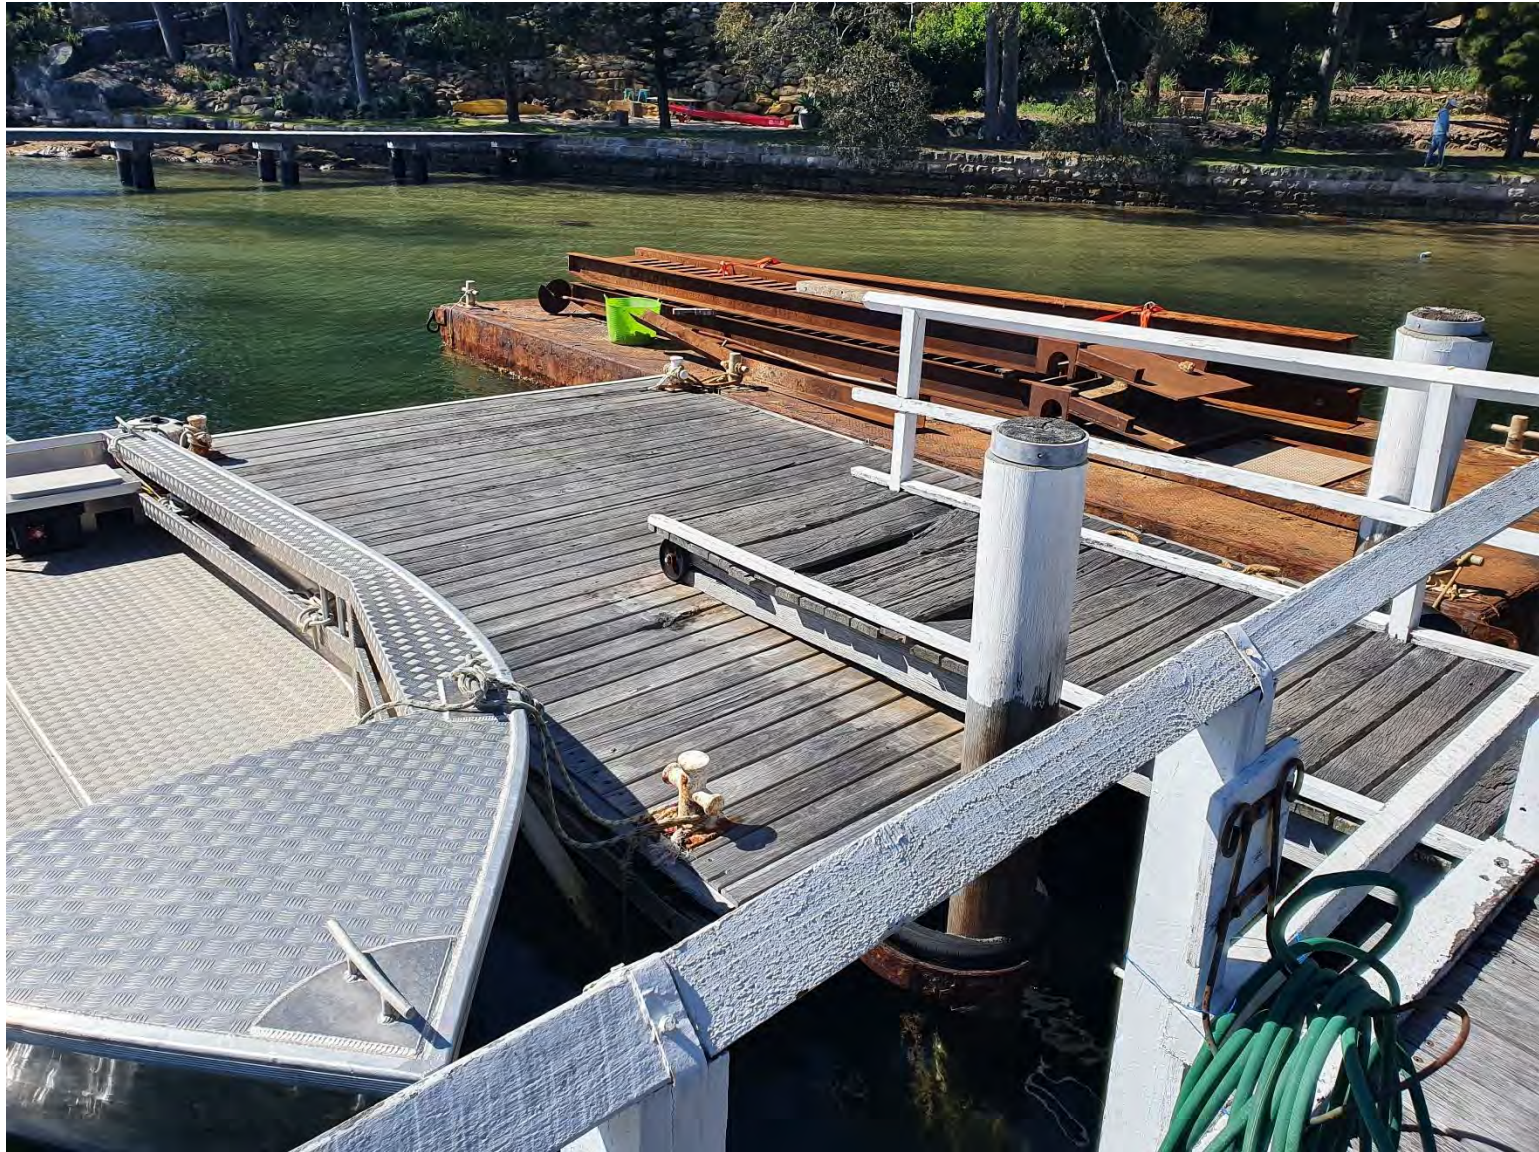
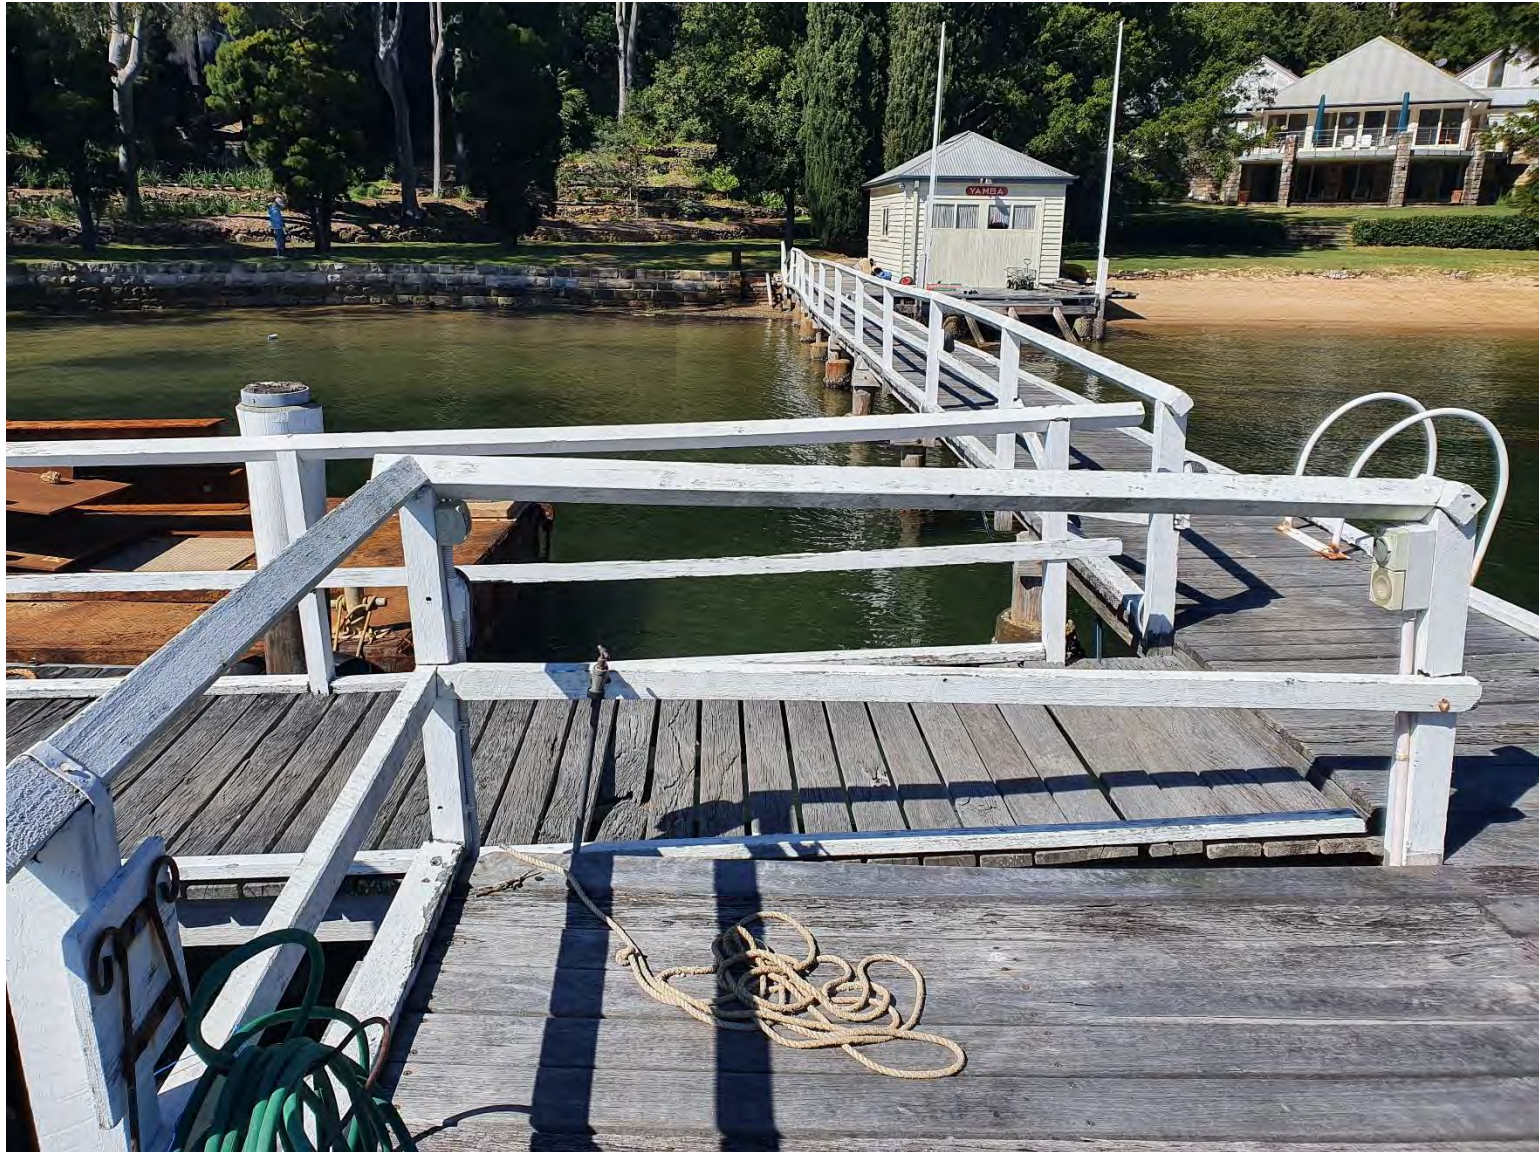
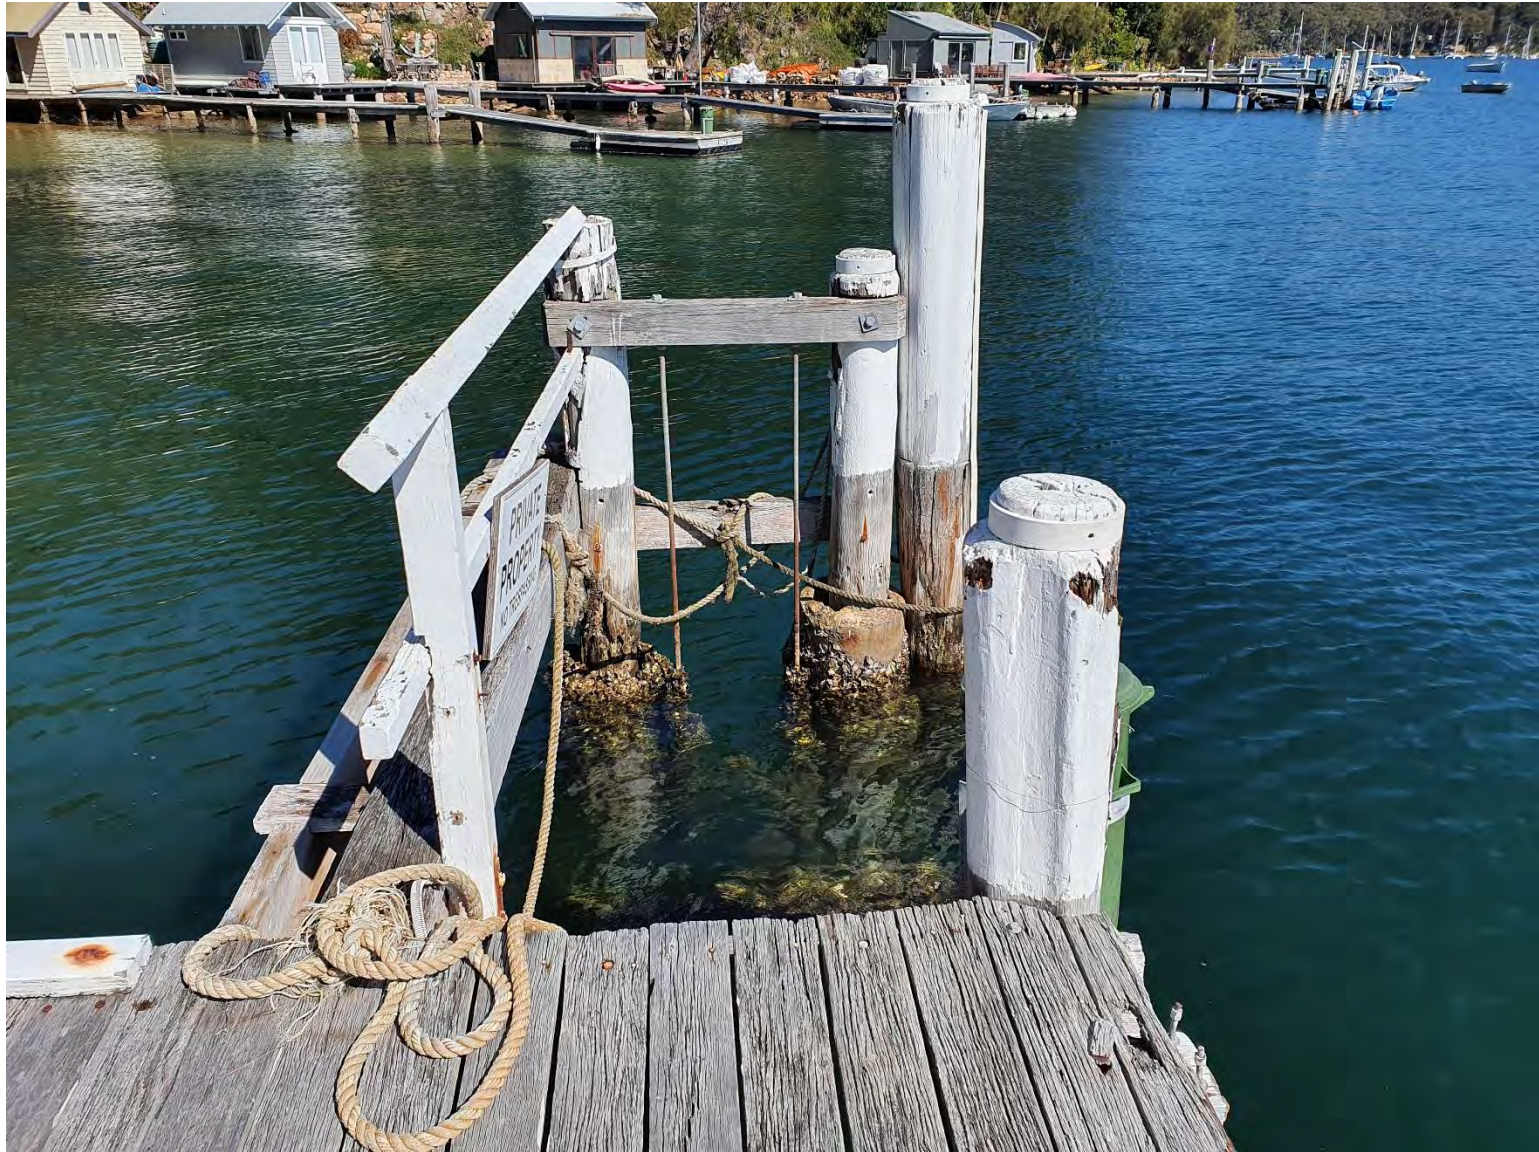
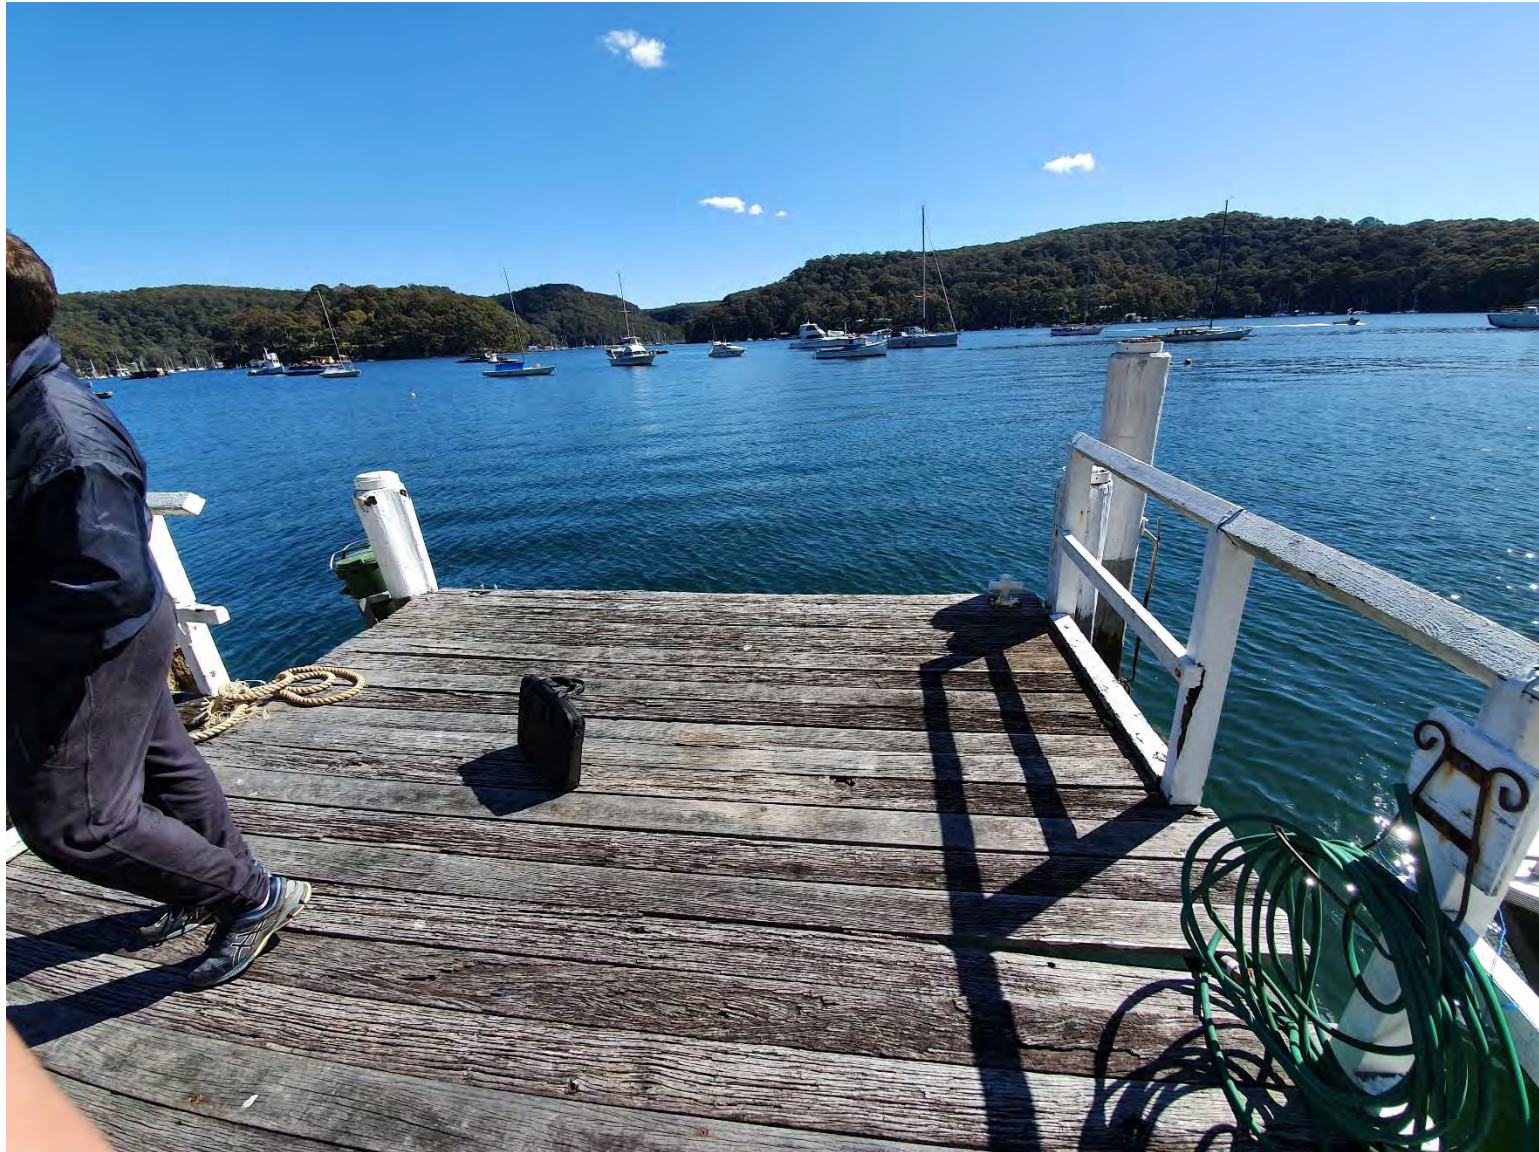
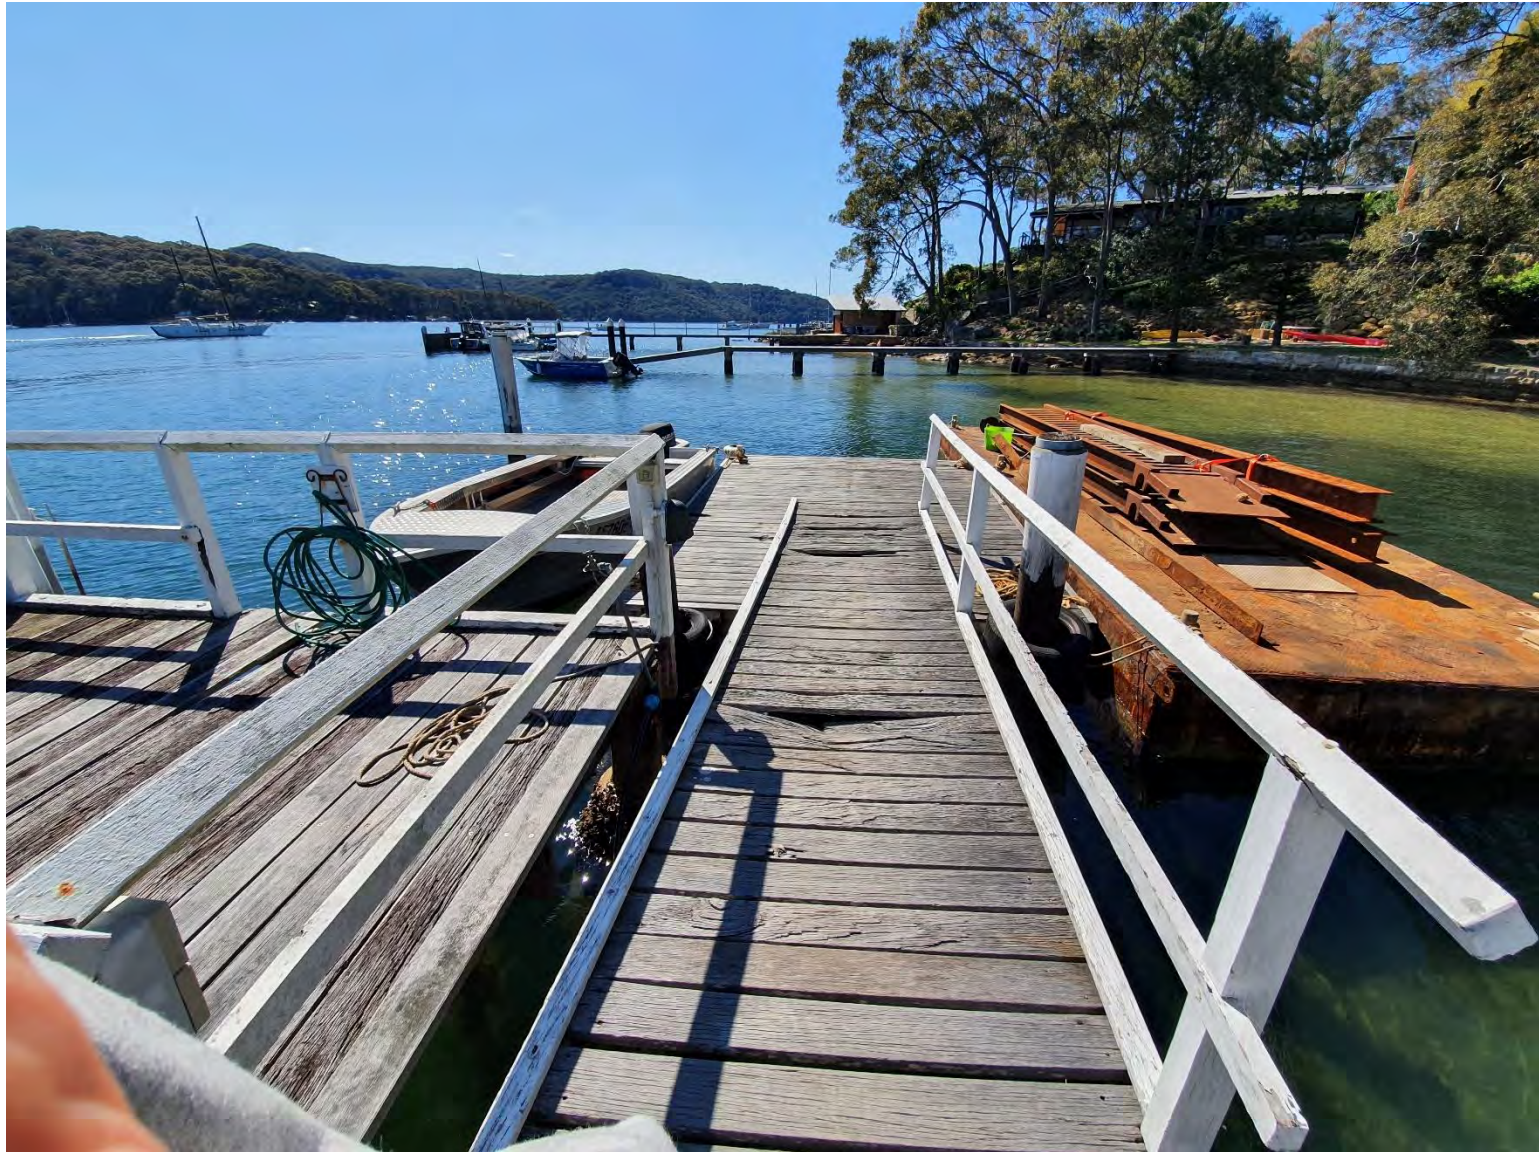
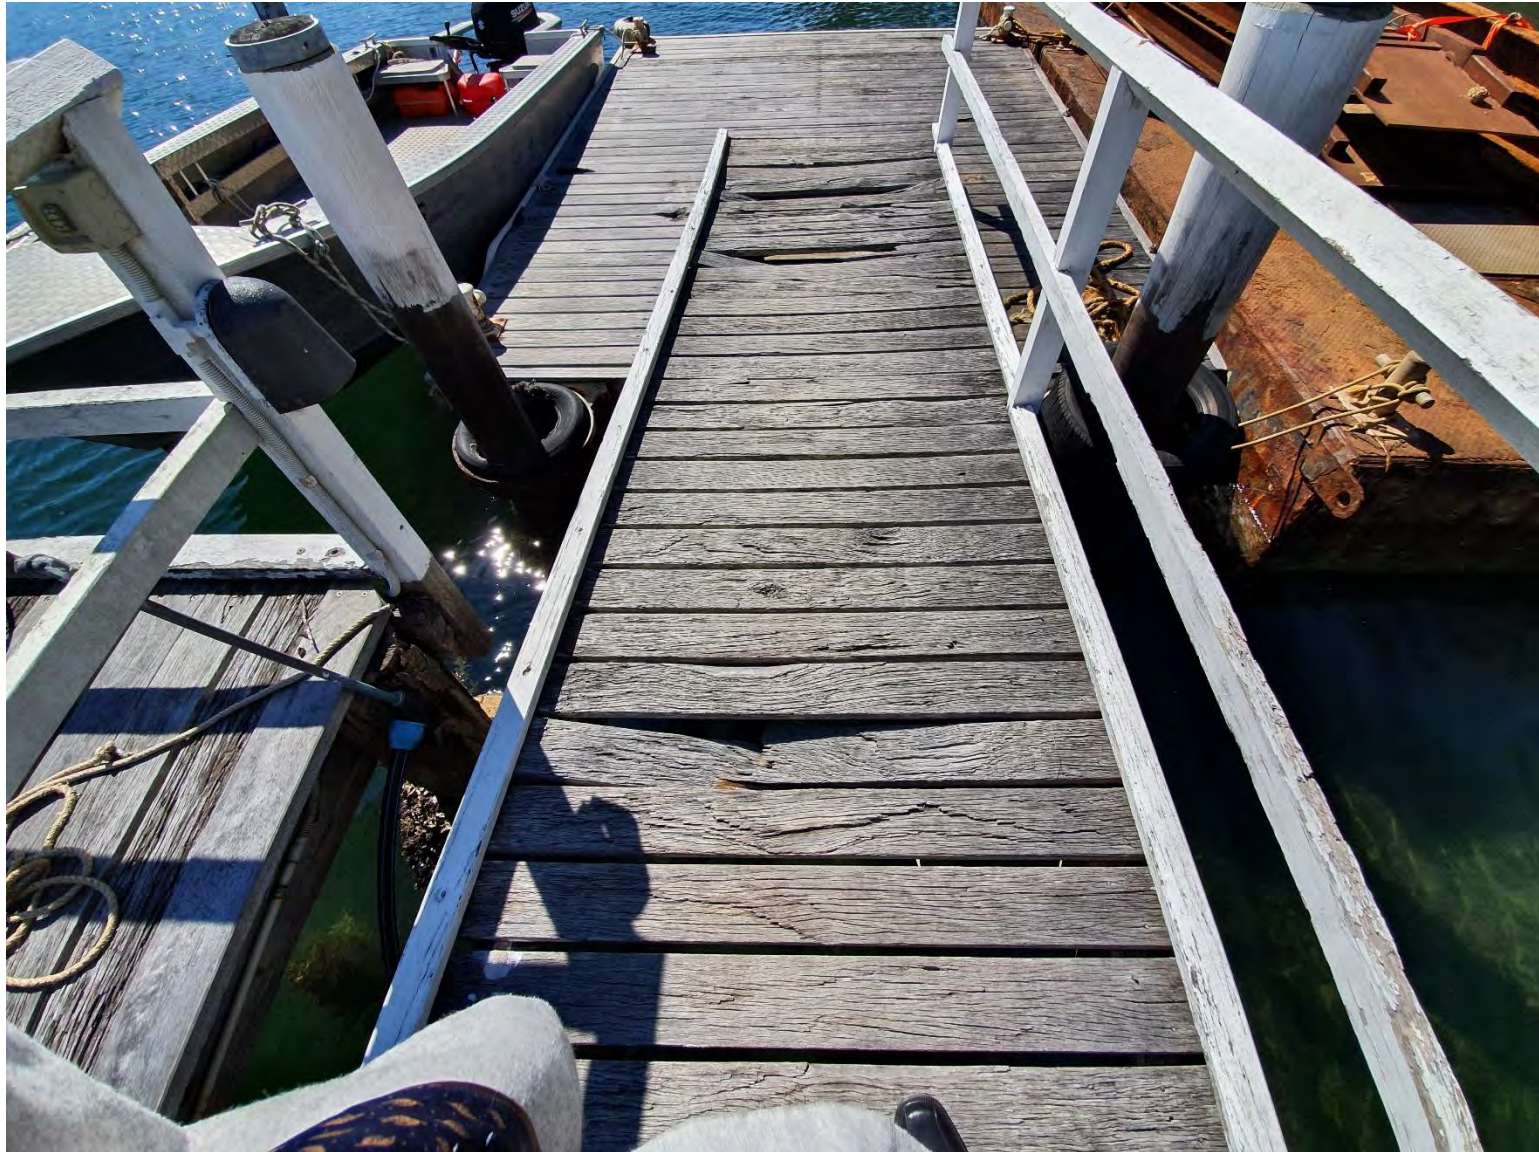
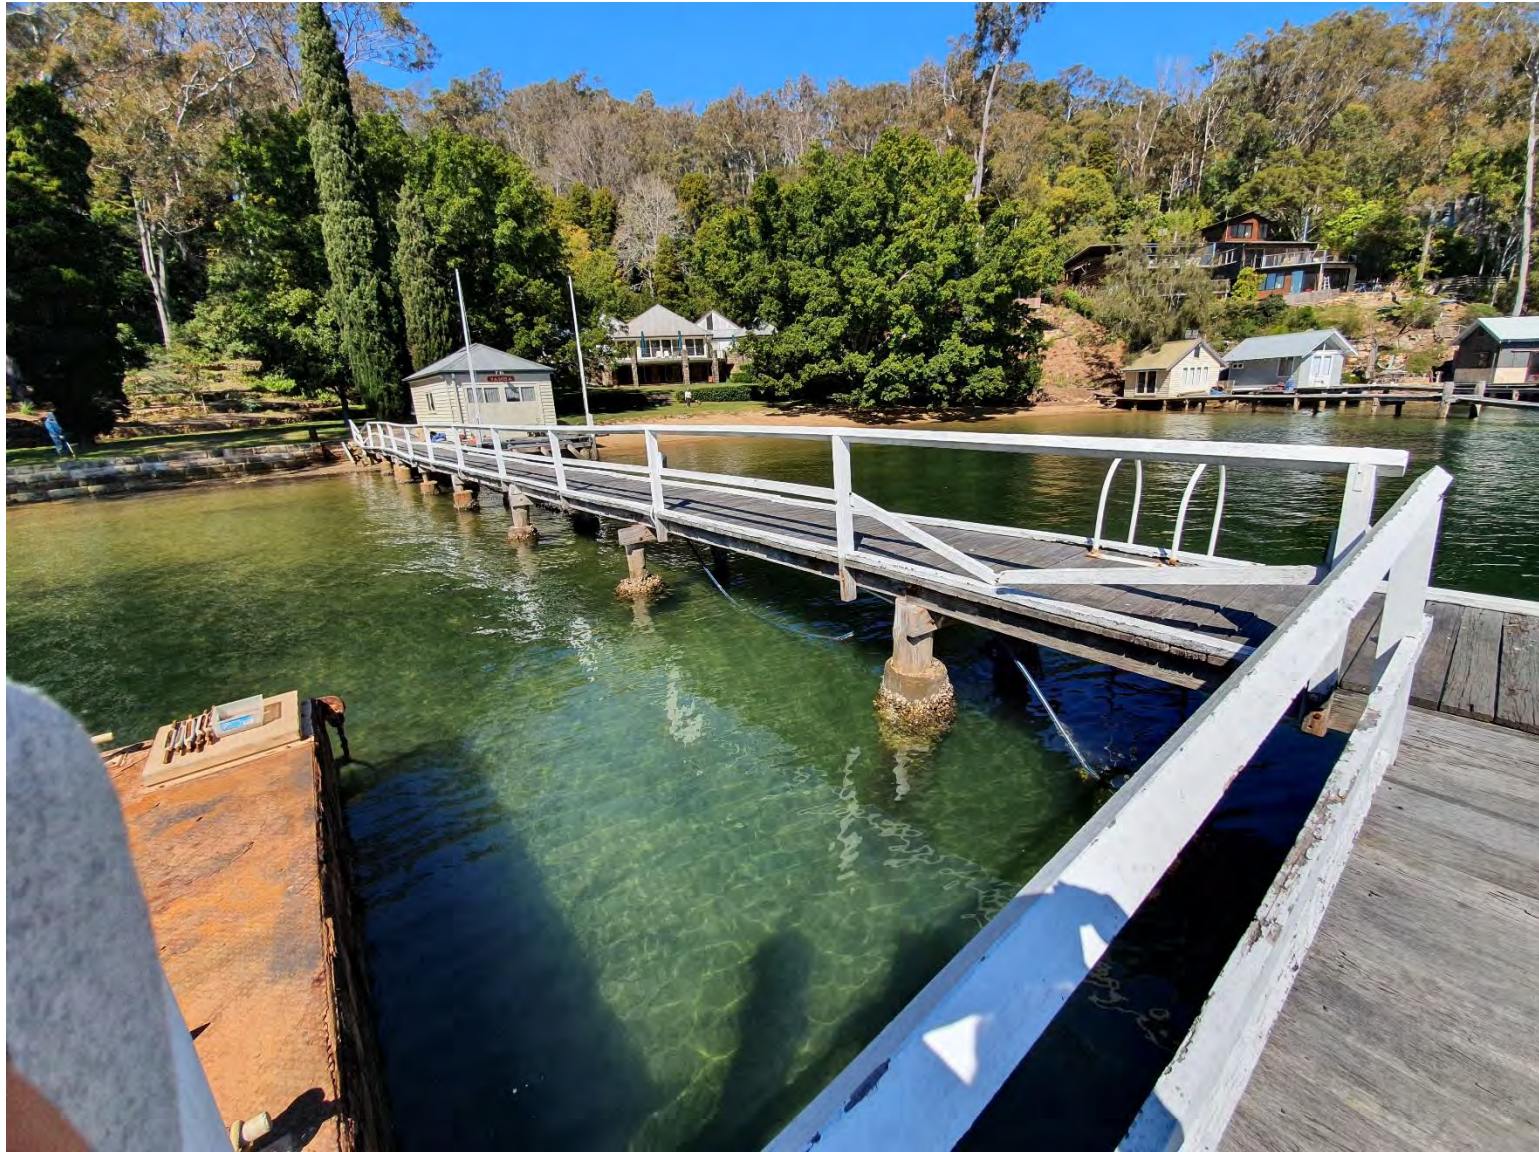
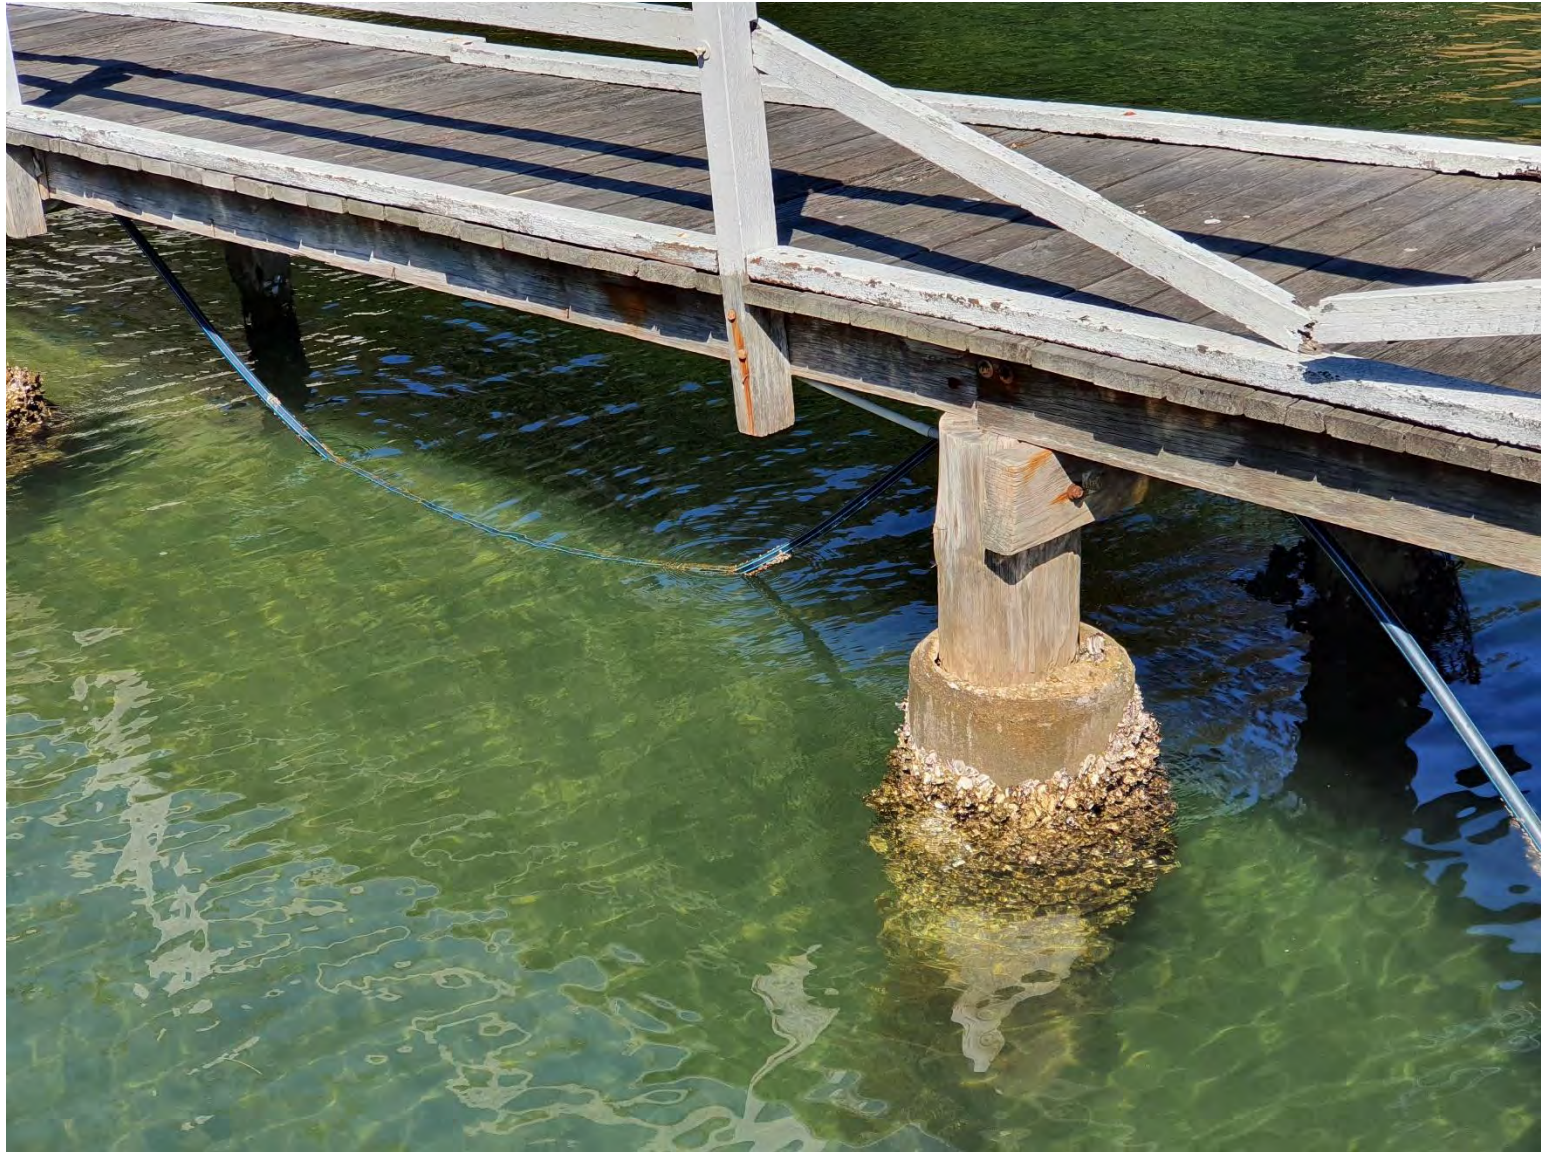
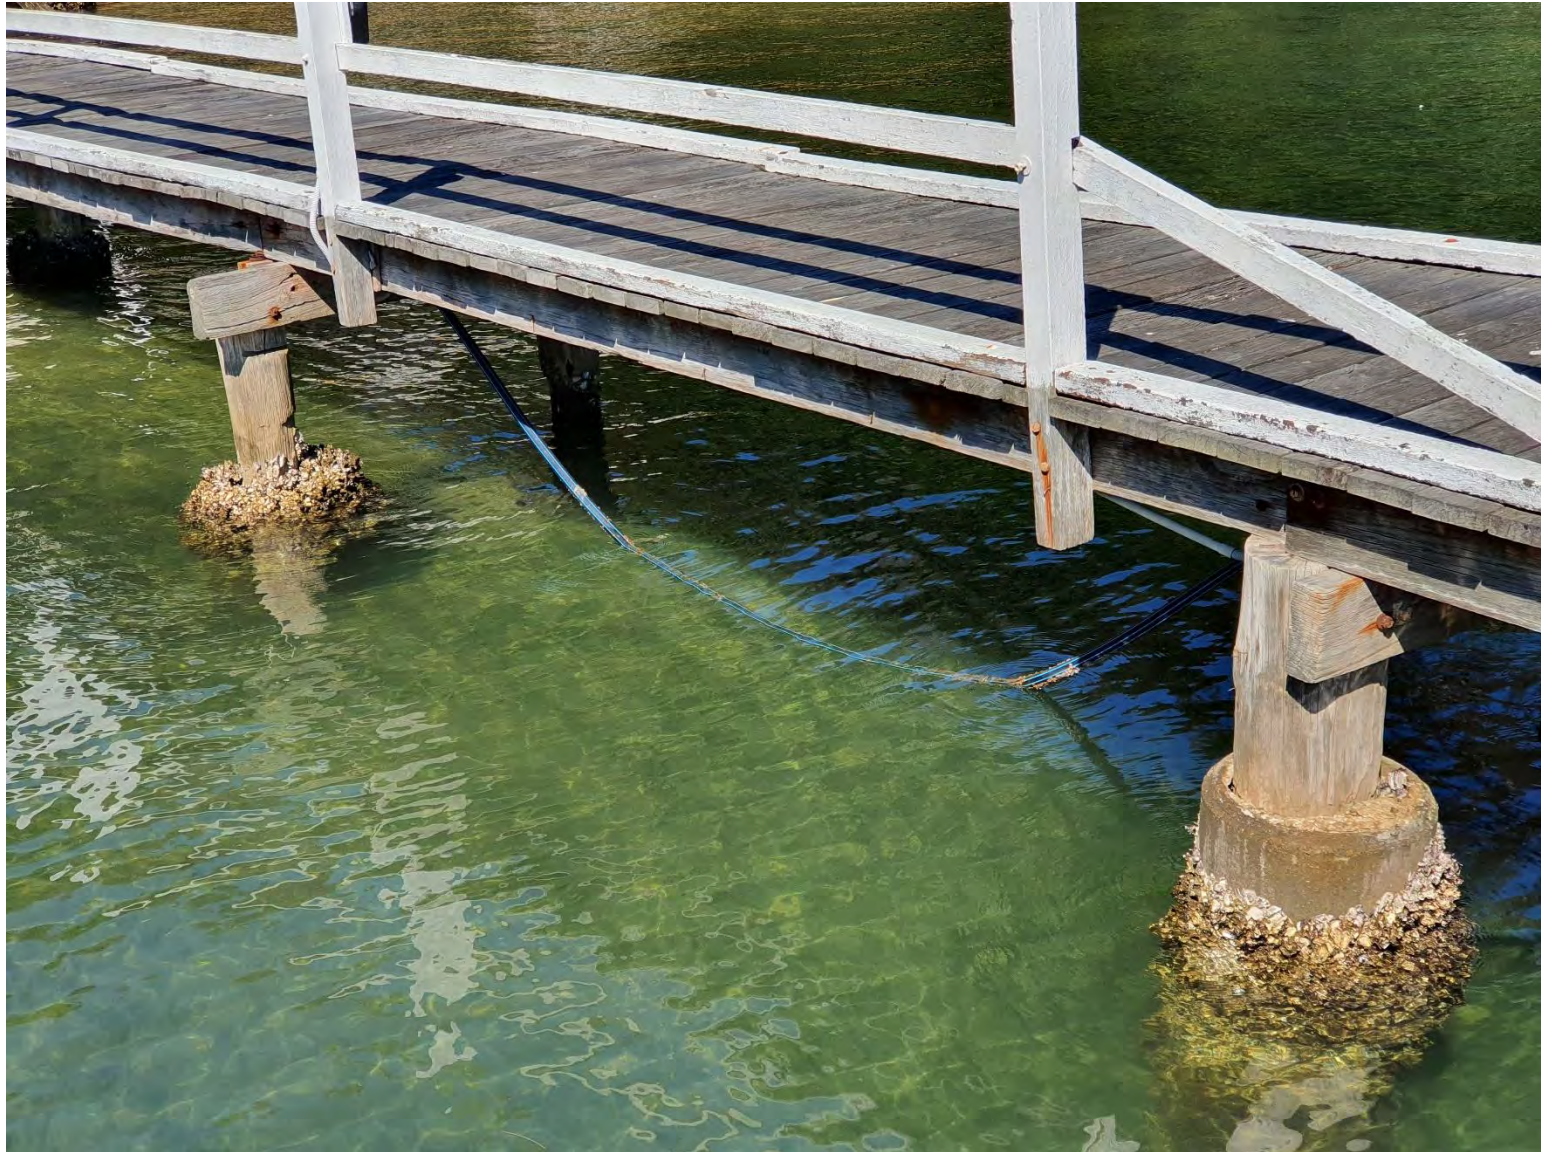
| Location | Photo Description | Photo Ref |
|---|---|---|
| Yamba Jetty and Boatshed | Photo displaying the general condition of Yamba wharf. This is on the neighbouring property and was used as a landing. Jetty shows signs of significant degradation, cracking, and warping of members. Jetty is being redesigned. This includes the top of the deck and the supporting pylons. | 1-23 |

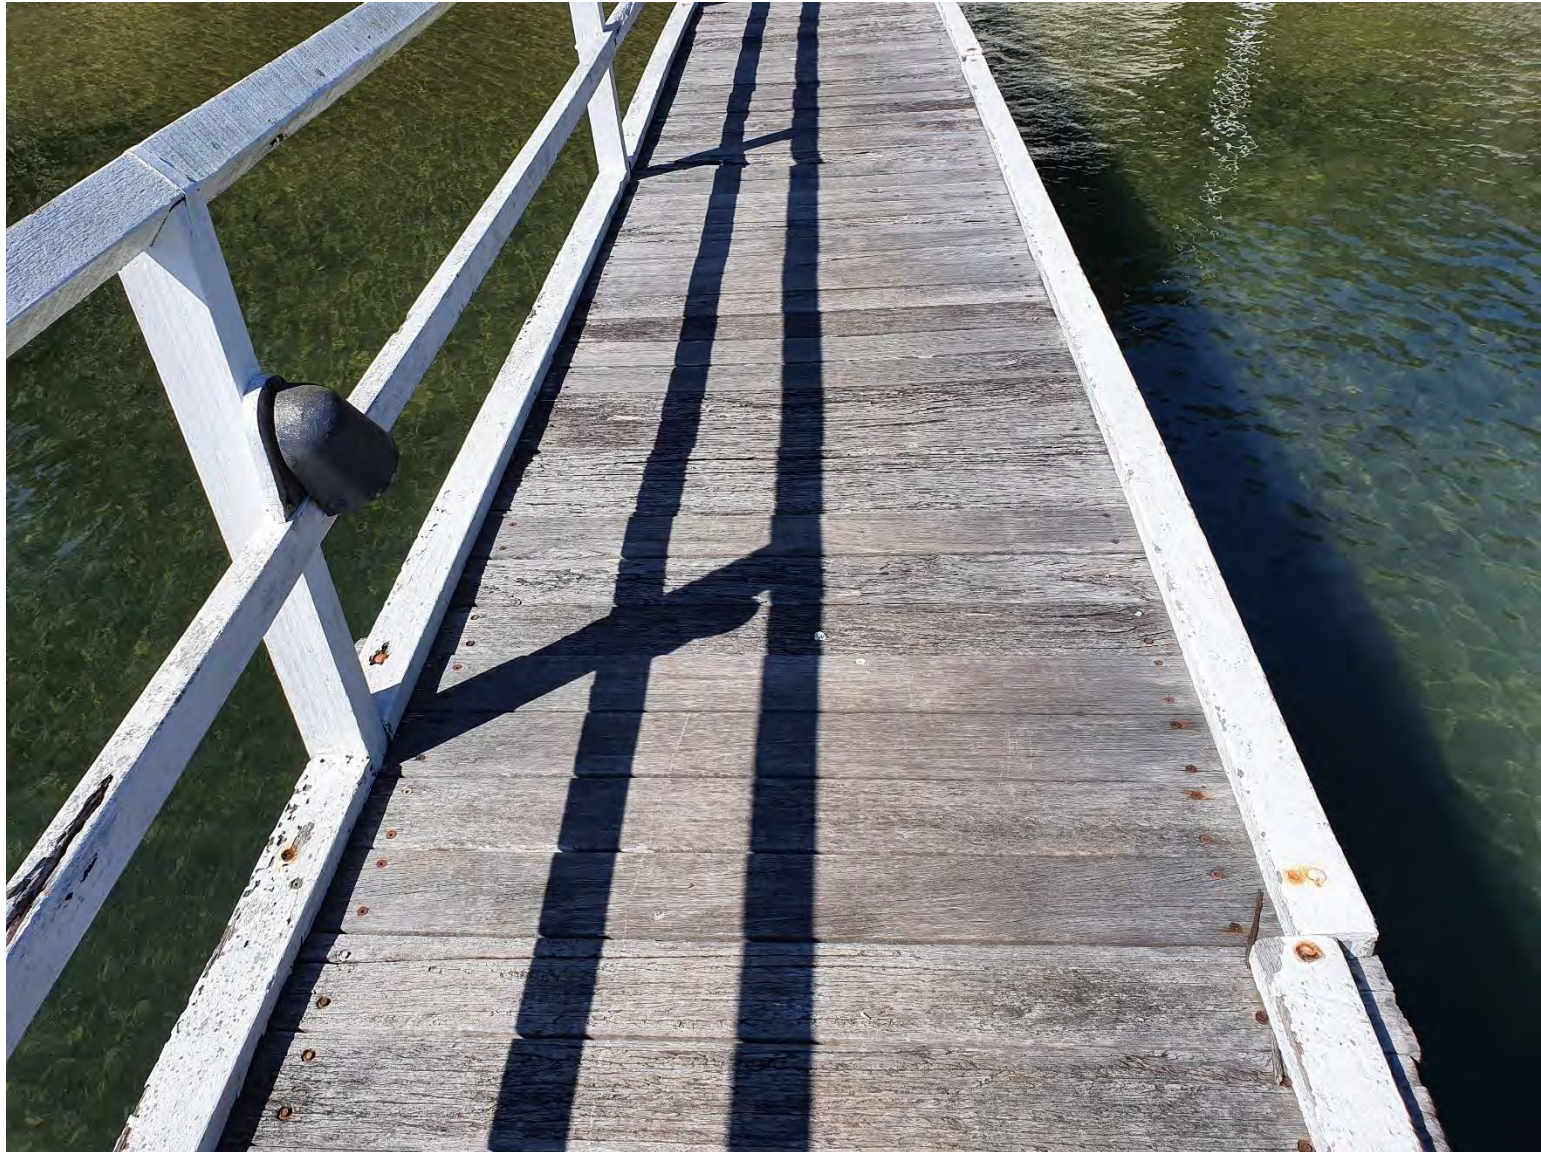
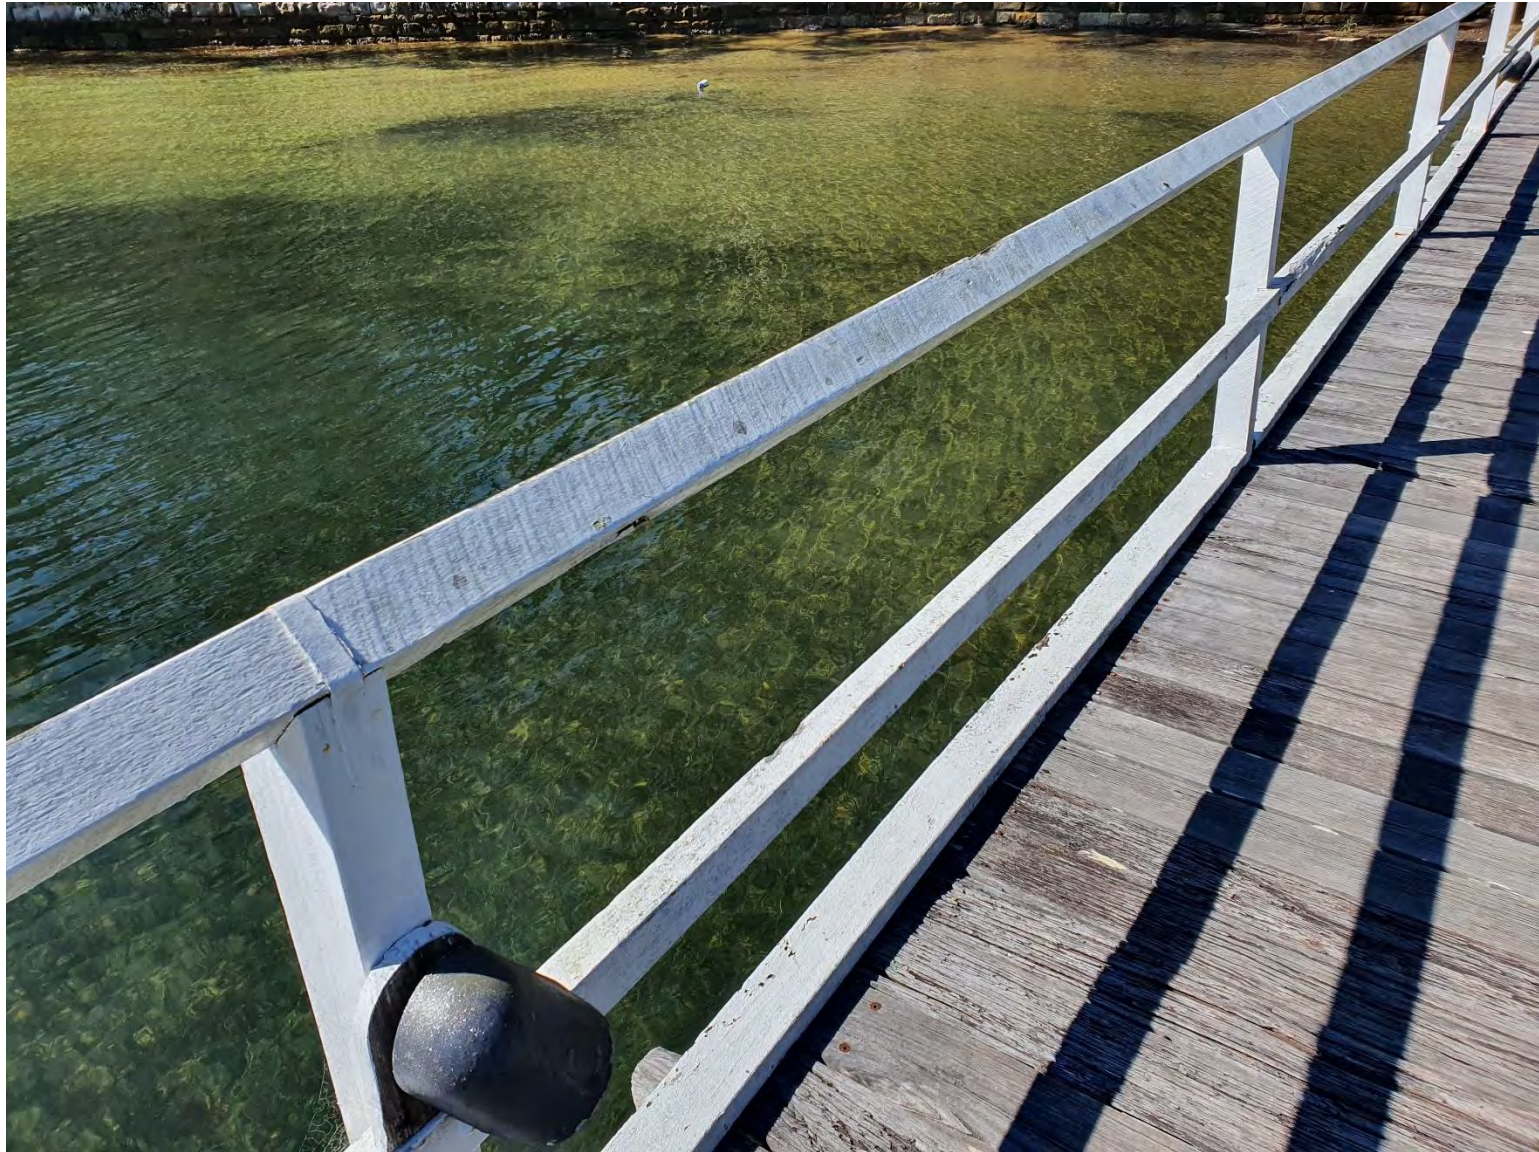
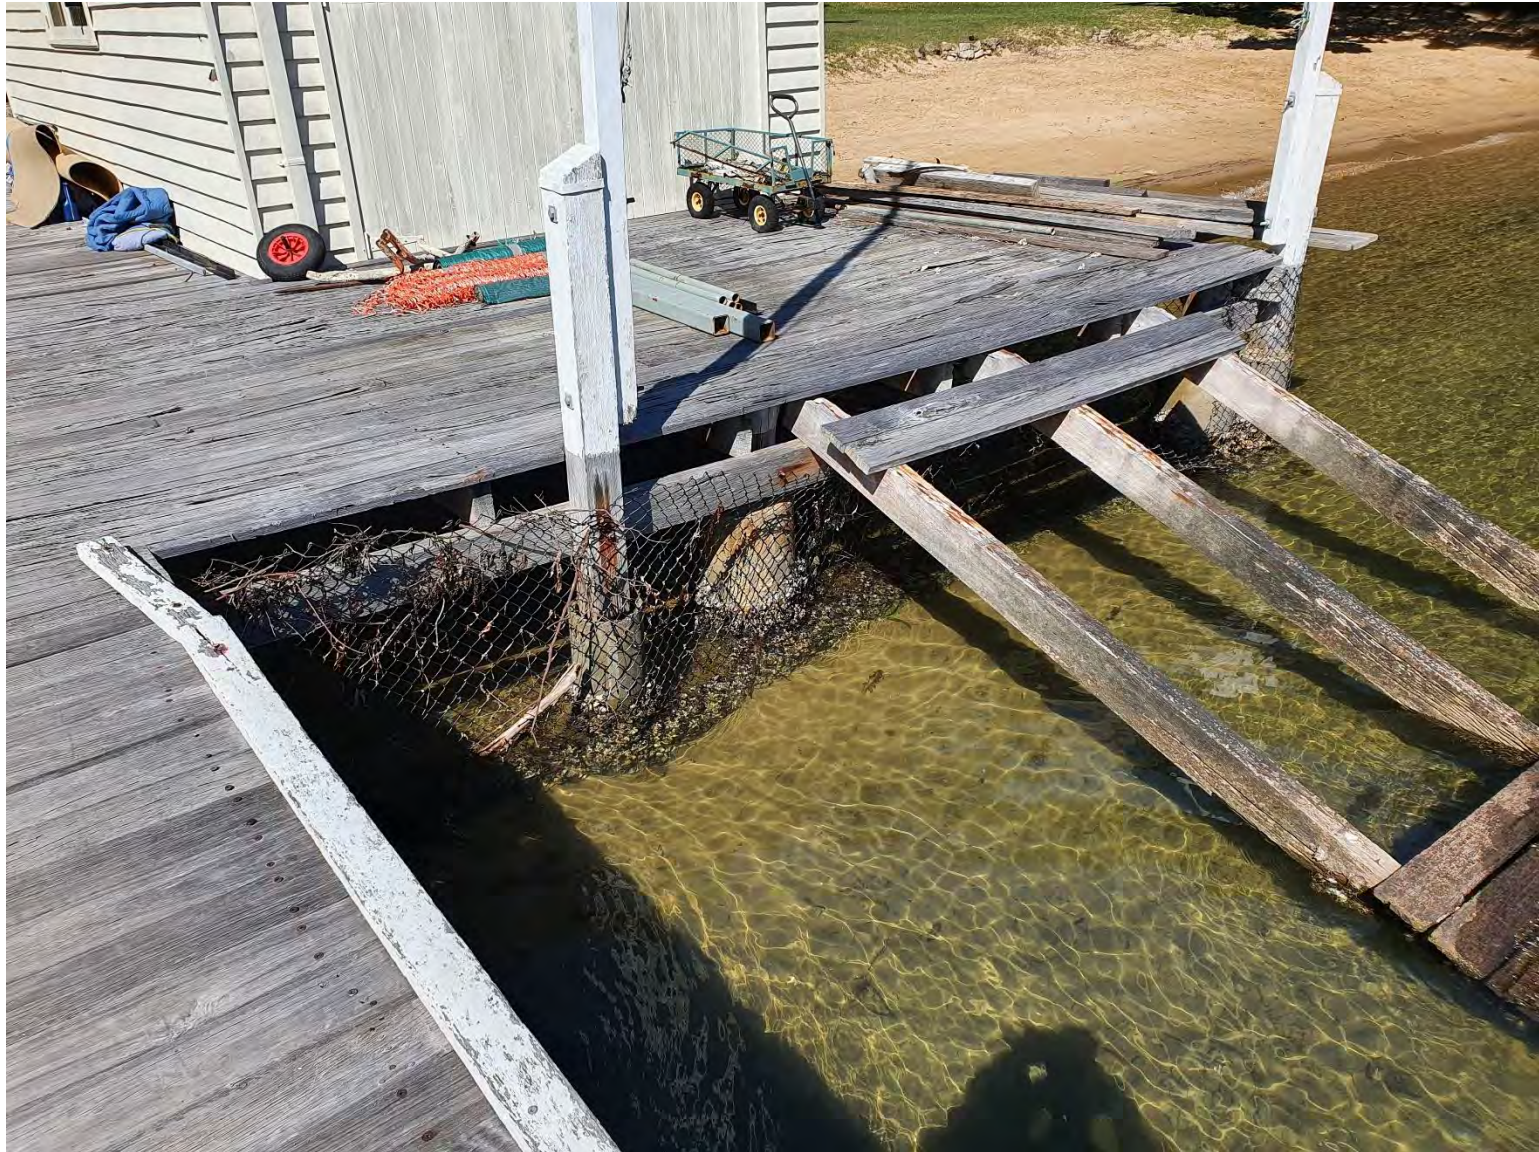
| Location | Photo Description | Photo Ref |
|---|---|---|
| | Photo displaying the general condition of the Yamba wharf boat ramp. Ramp has show significant degradation and warping of the members. | 24-28 |
