## APPENDIX A – INSPECTION PHOTOGRAPHS

SEA WALL CONSTRUCTION

RISK ASSESSMENT REPORT

25-33 ROBERTSON ROAD, SCOTLAND ISLAND NSW

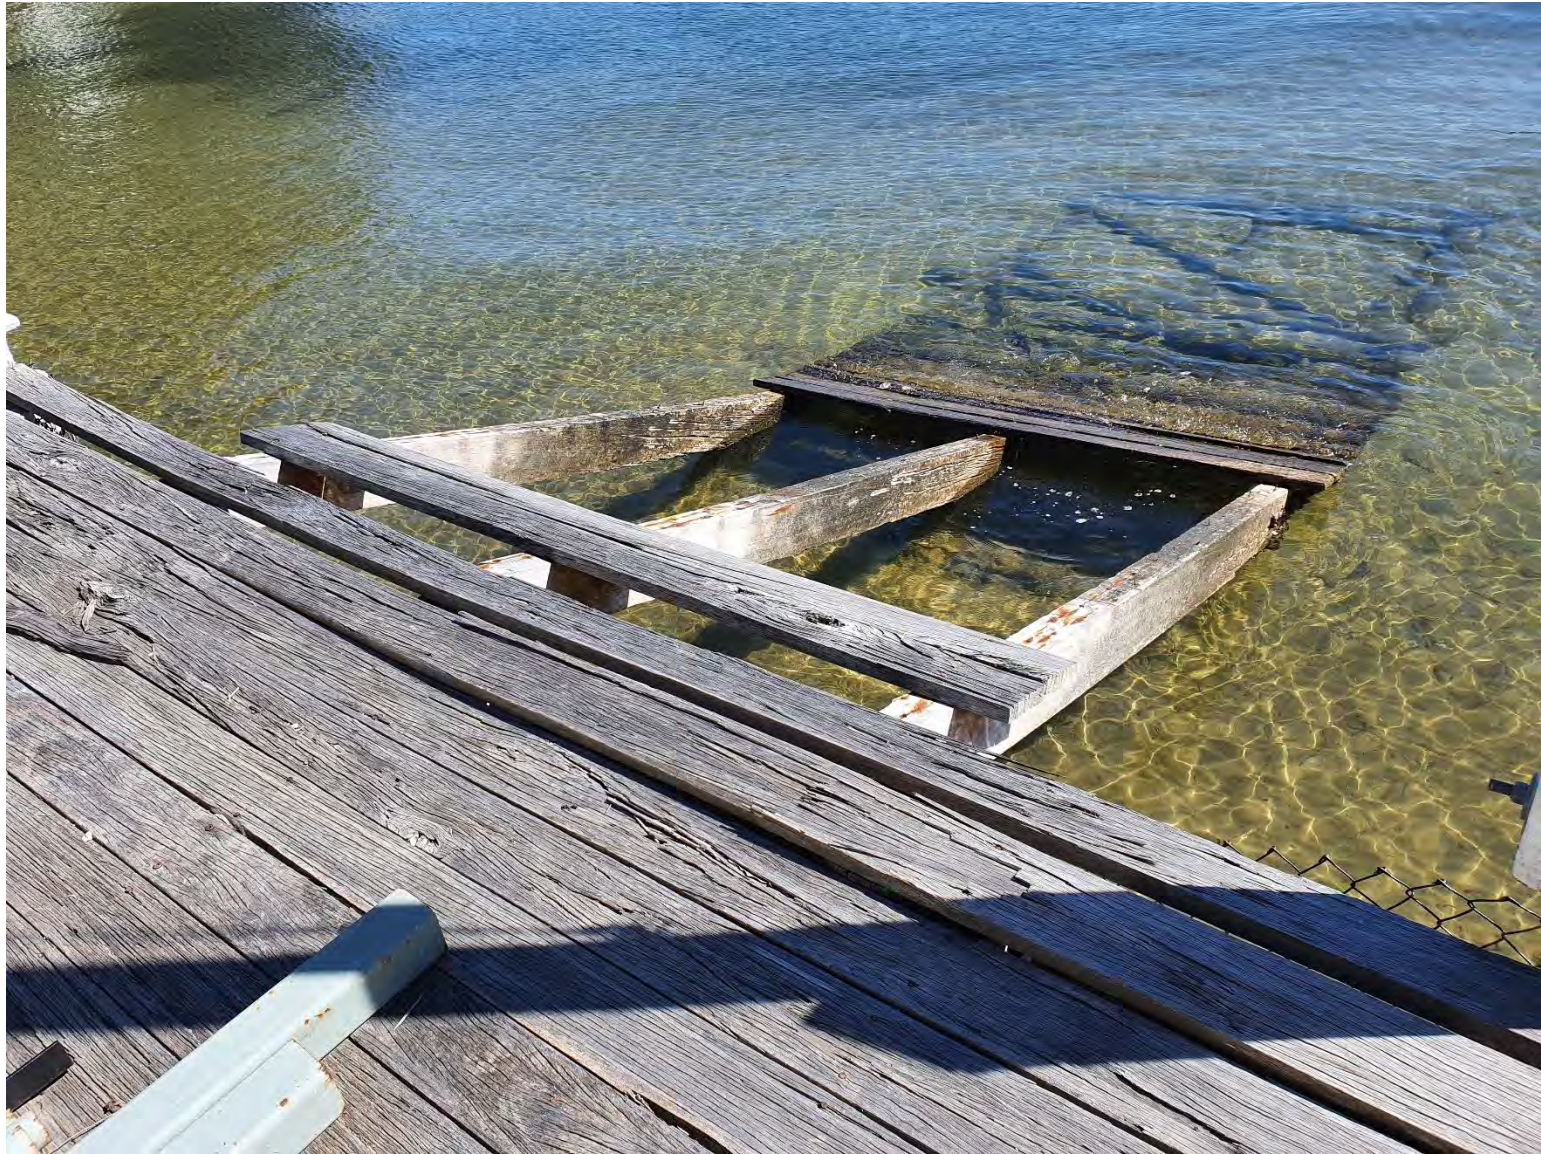
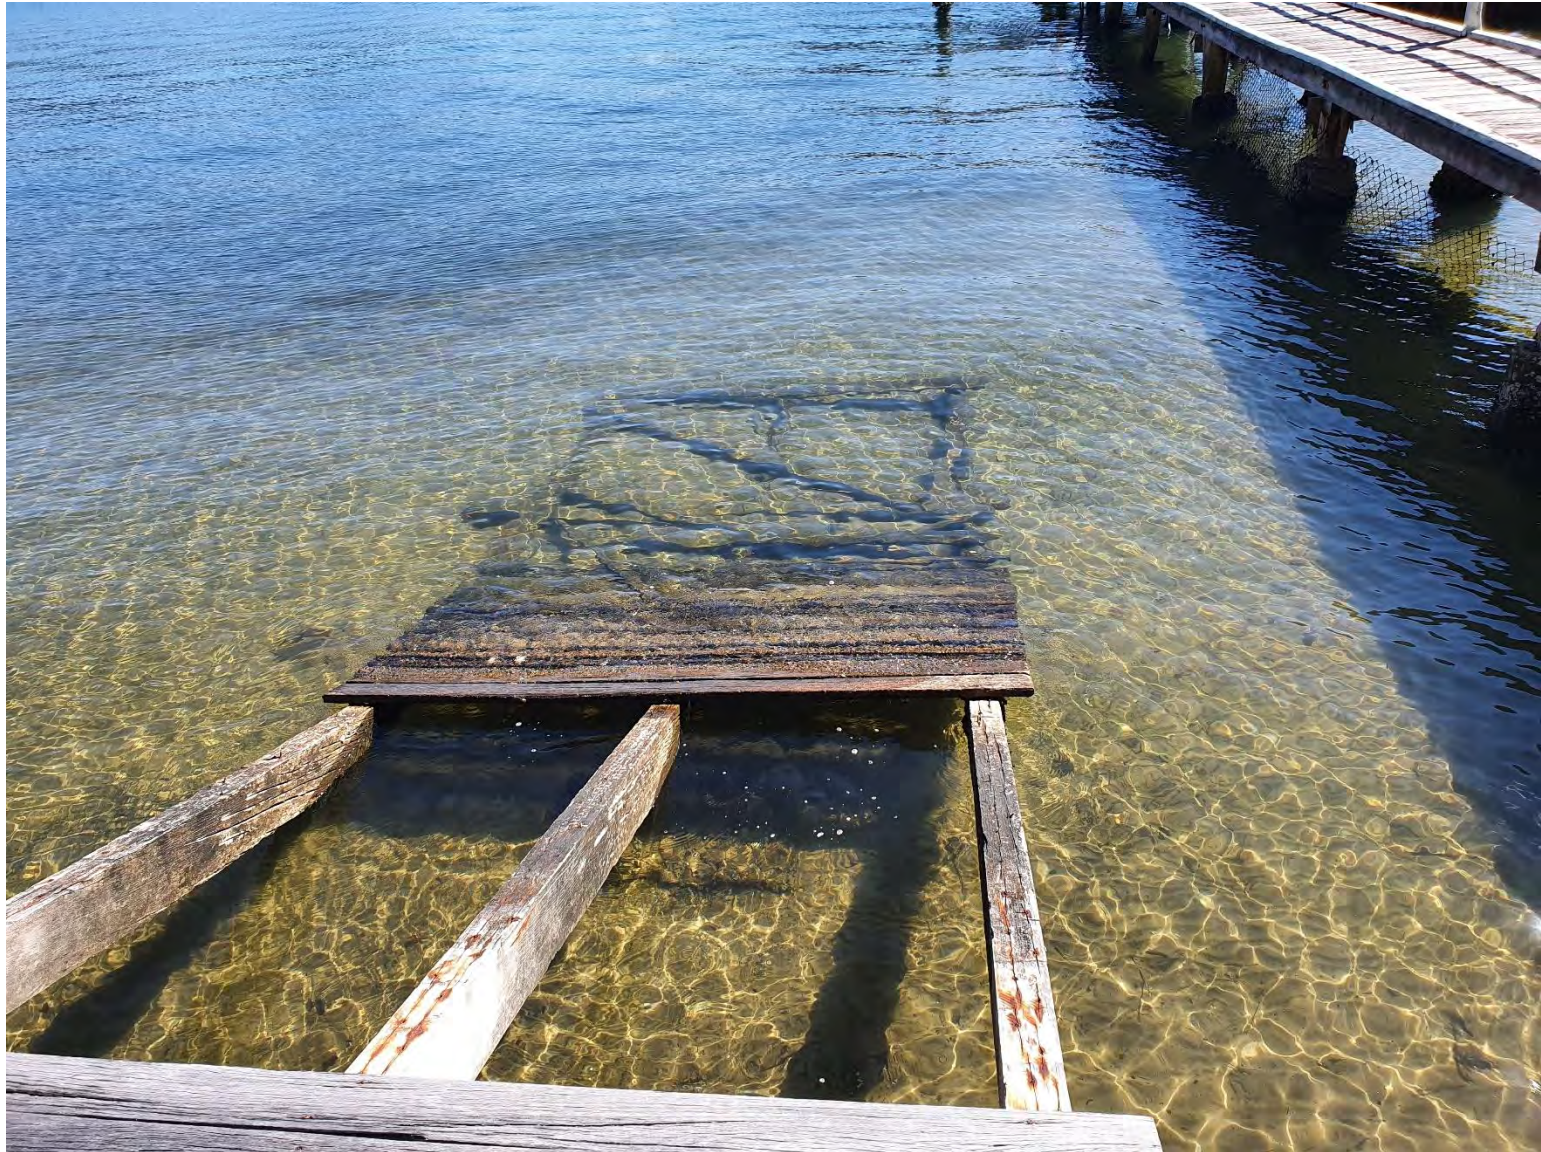
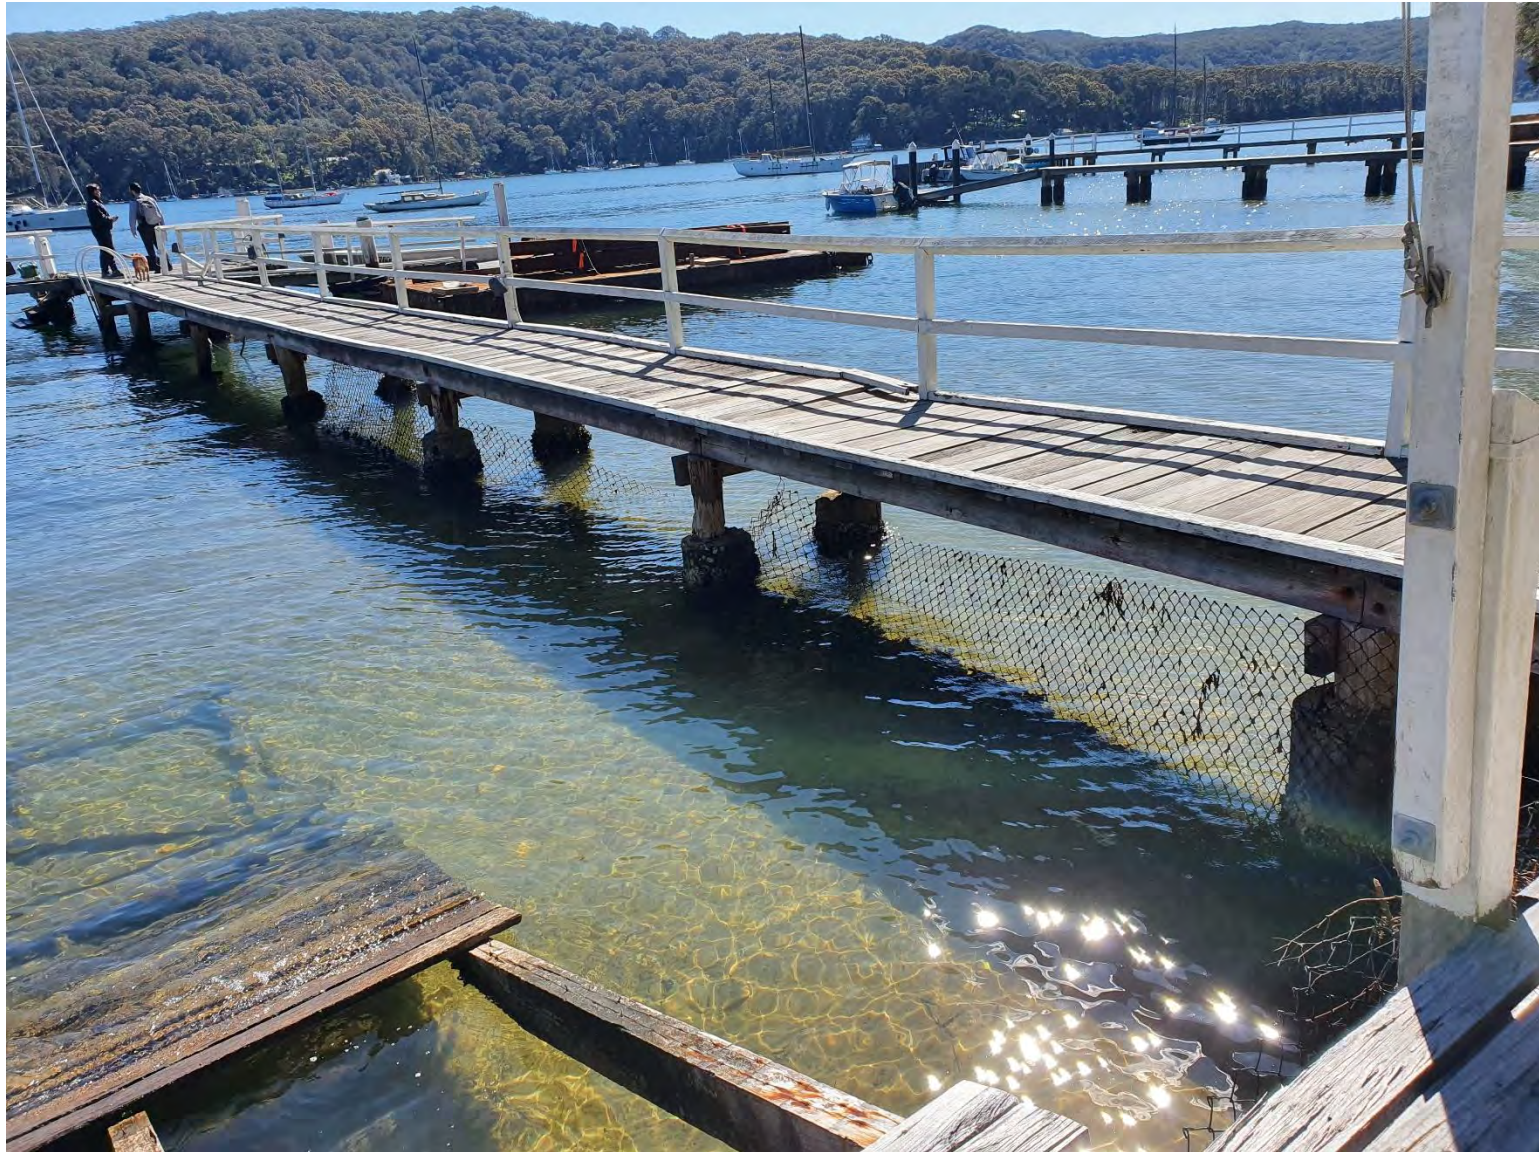
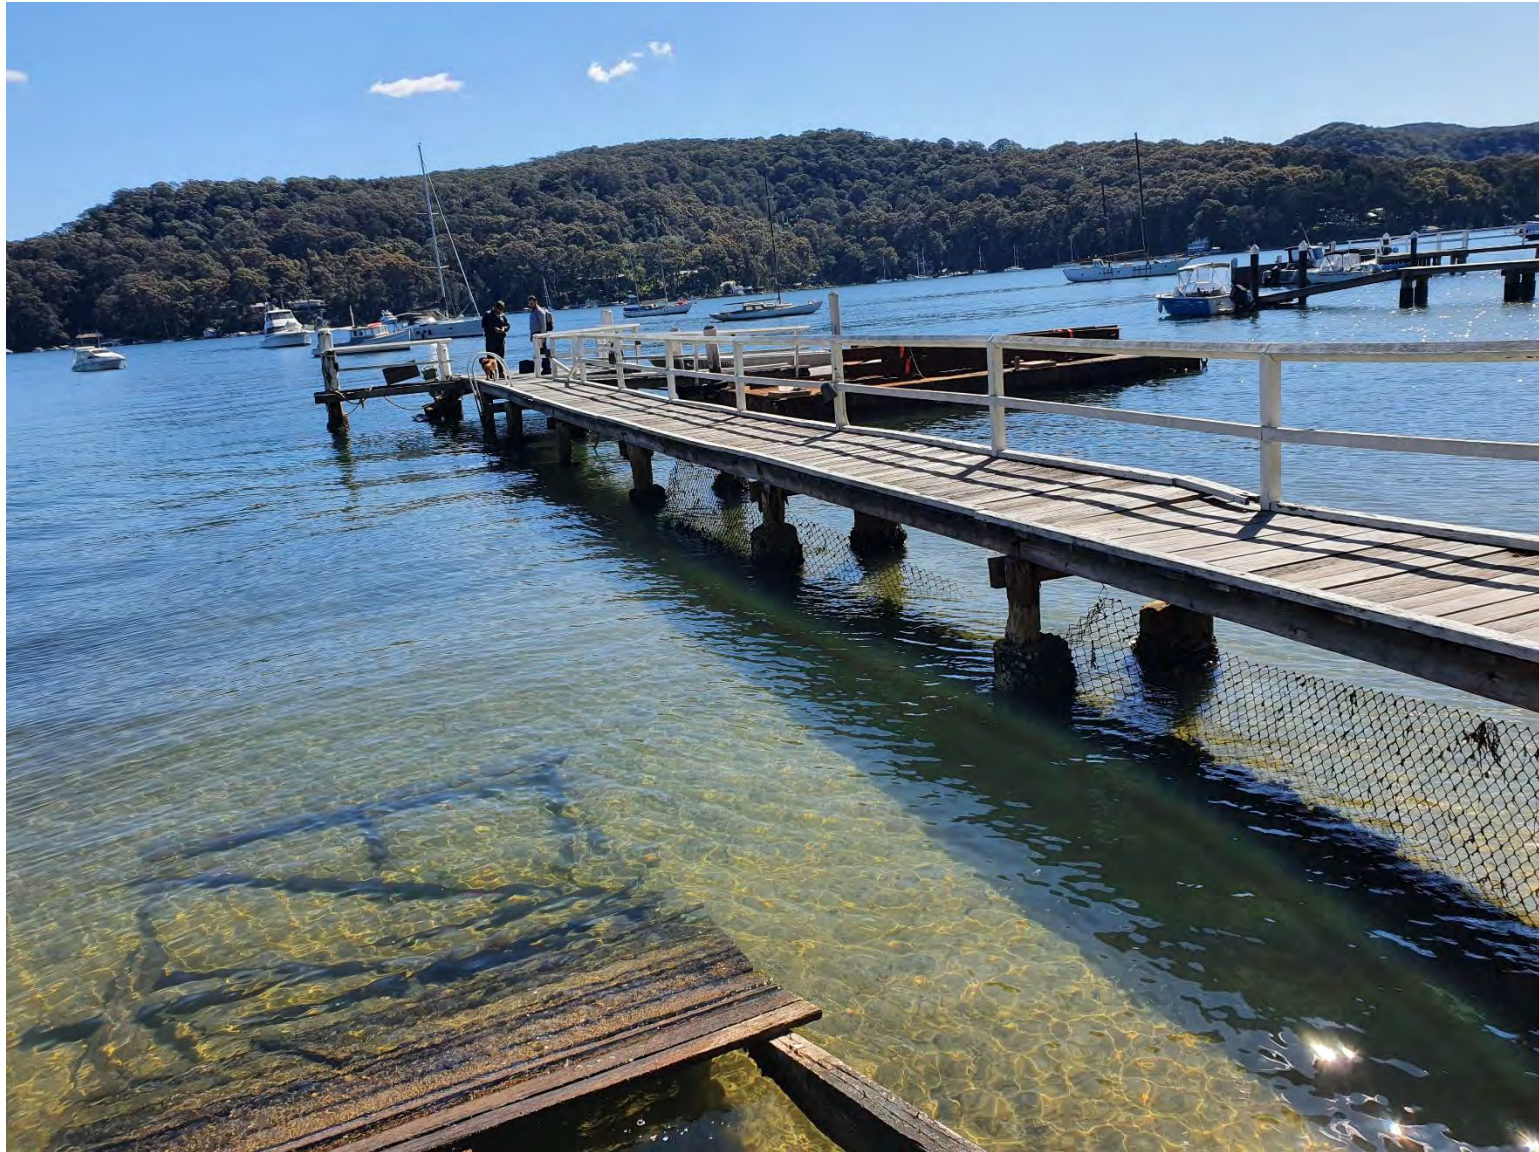
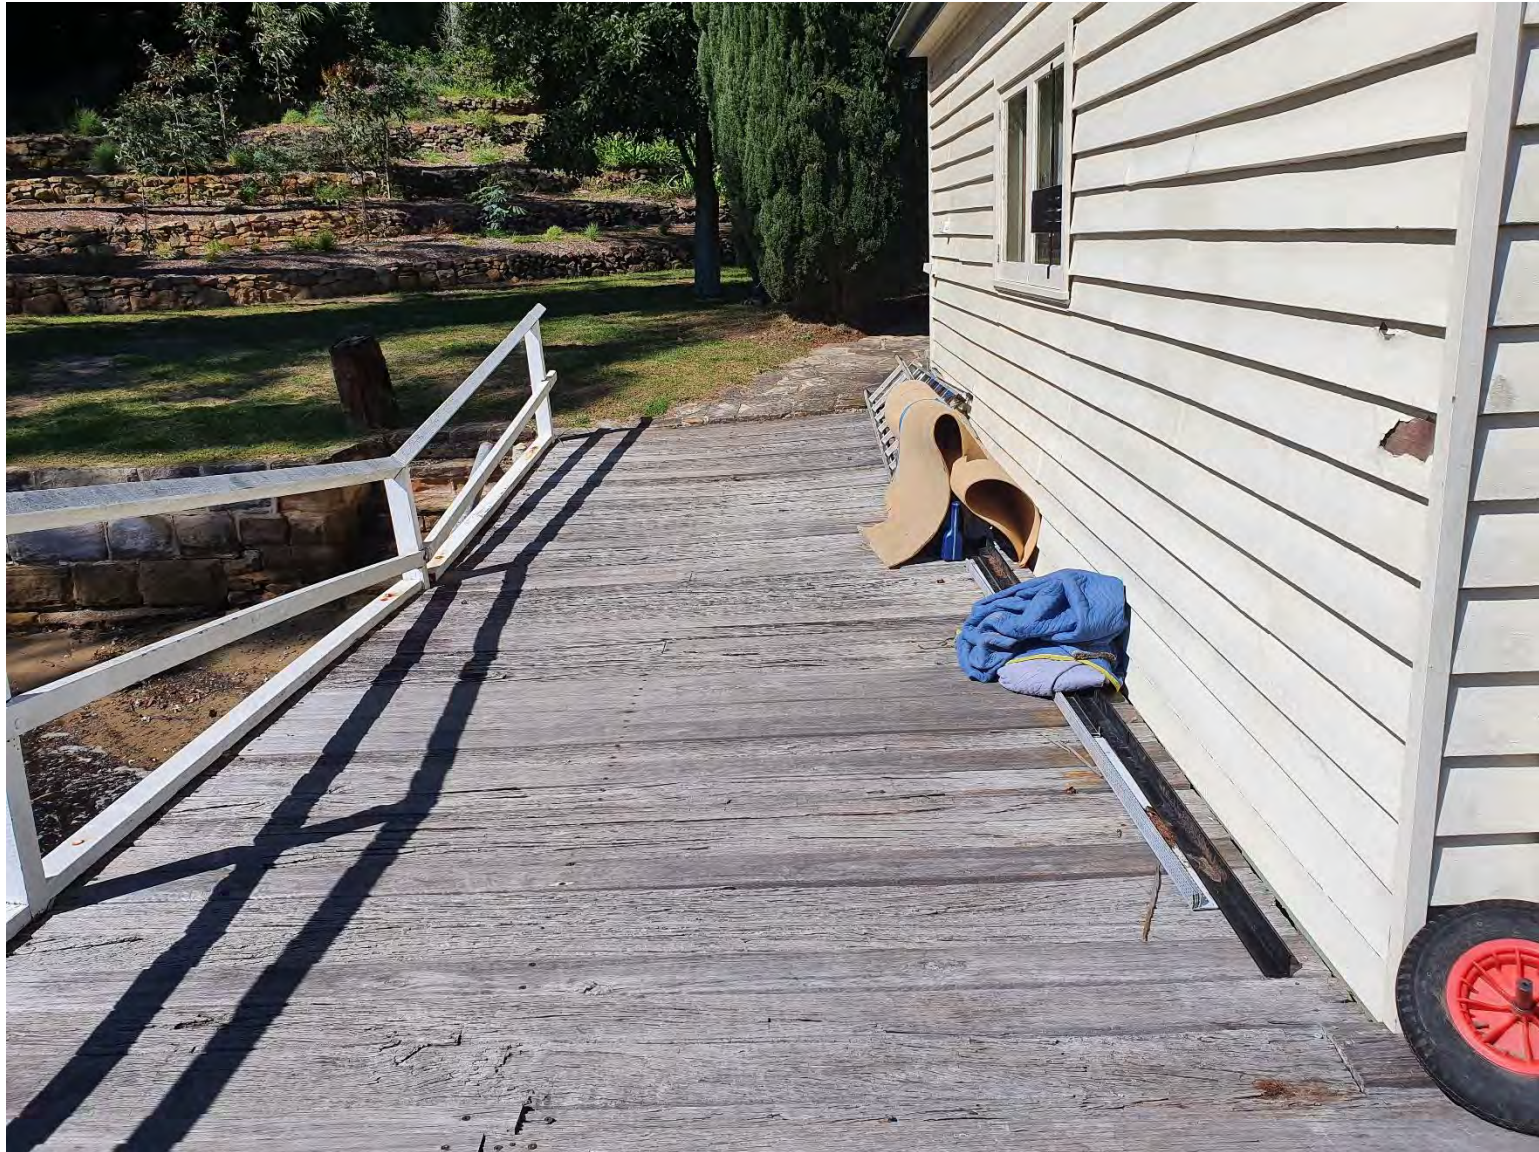
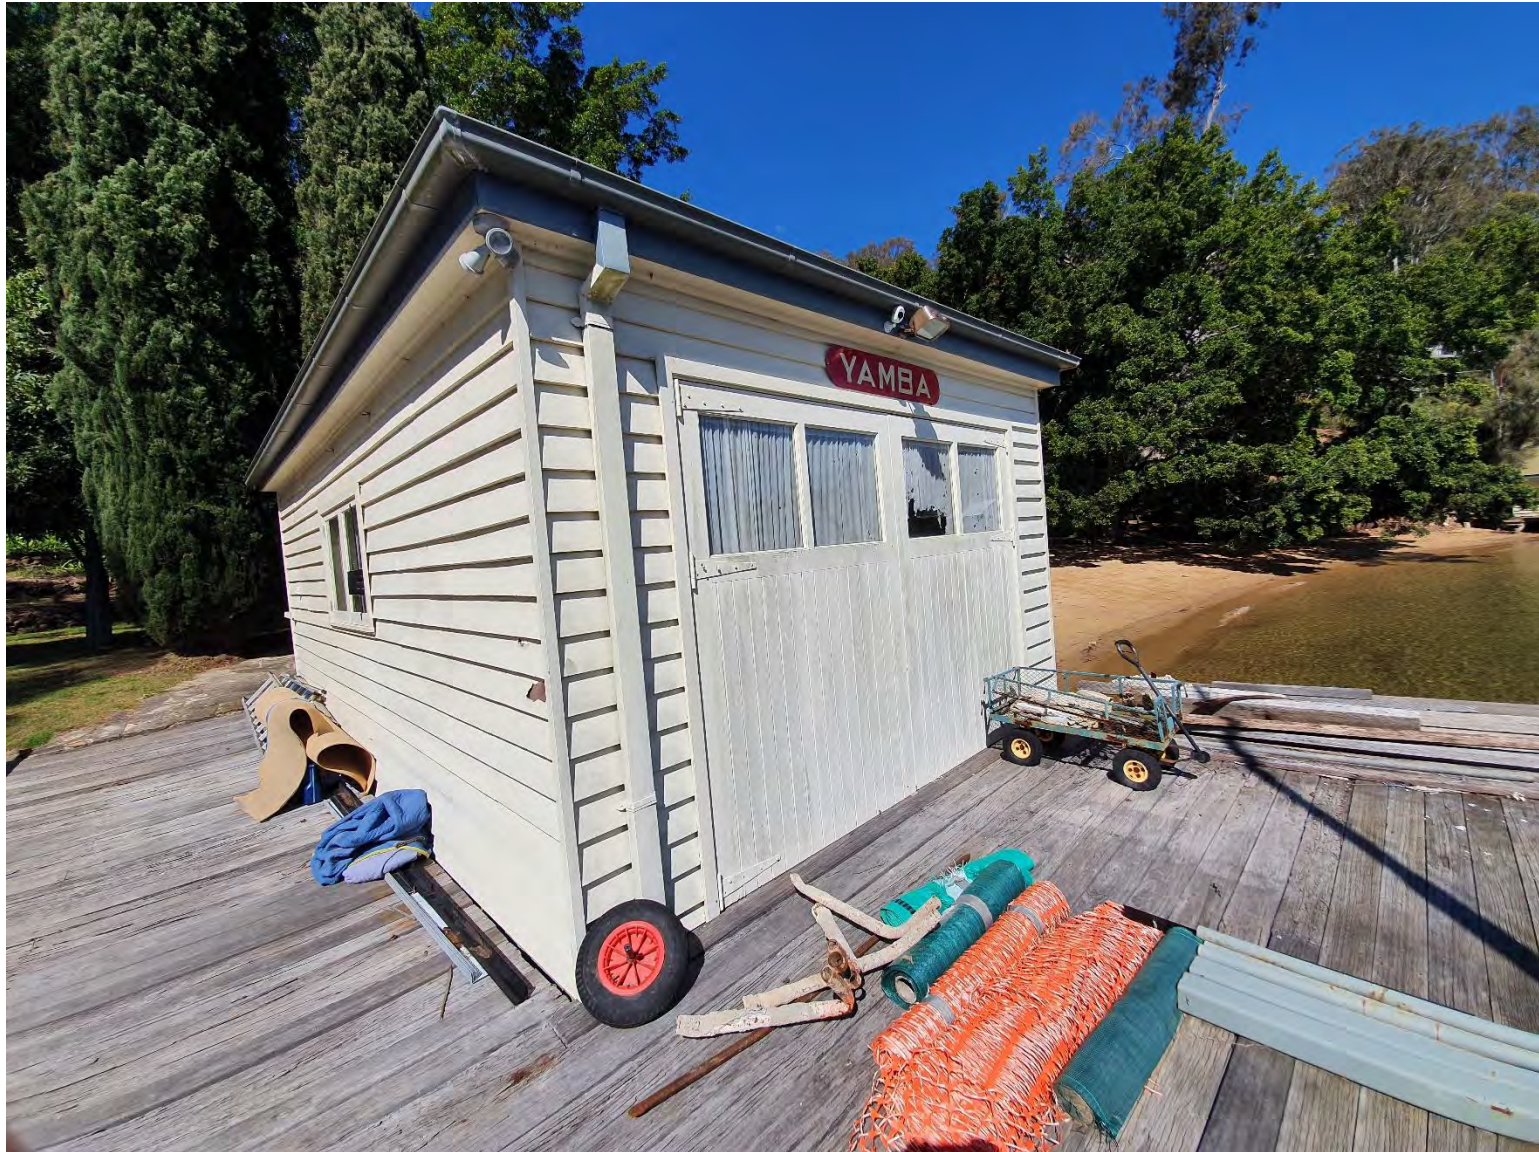
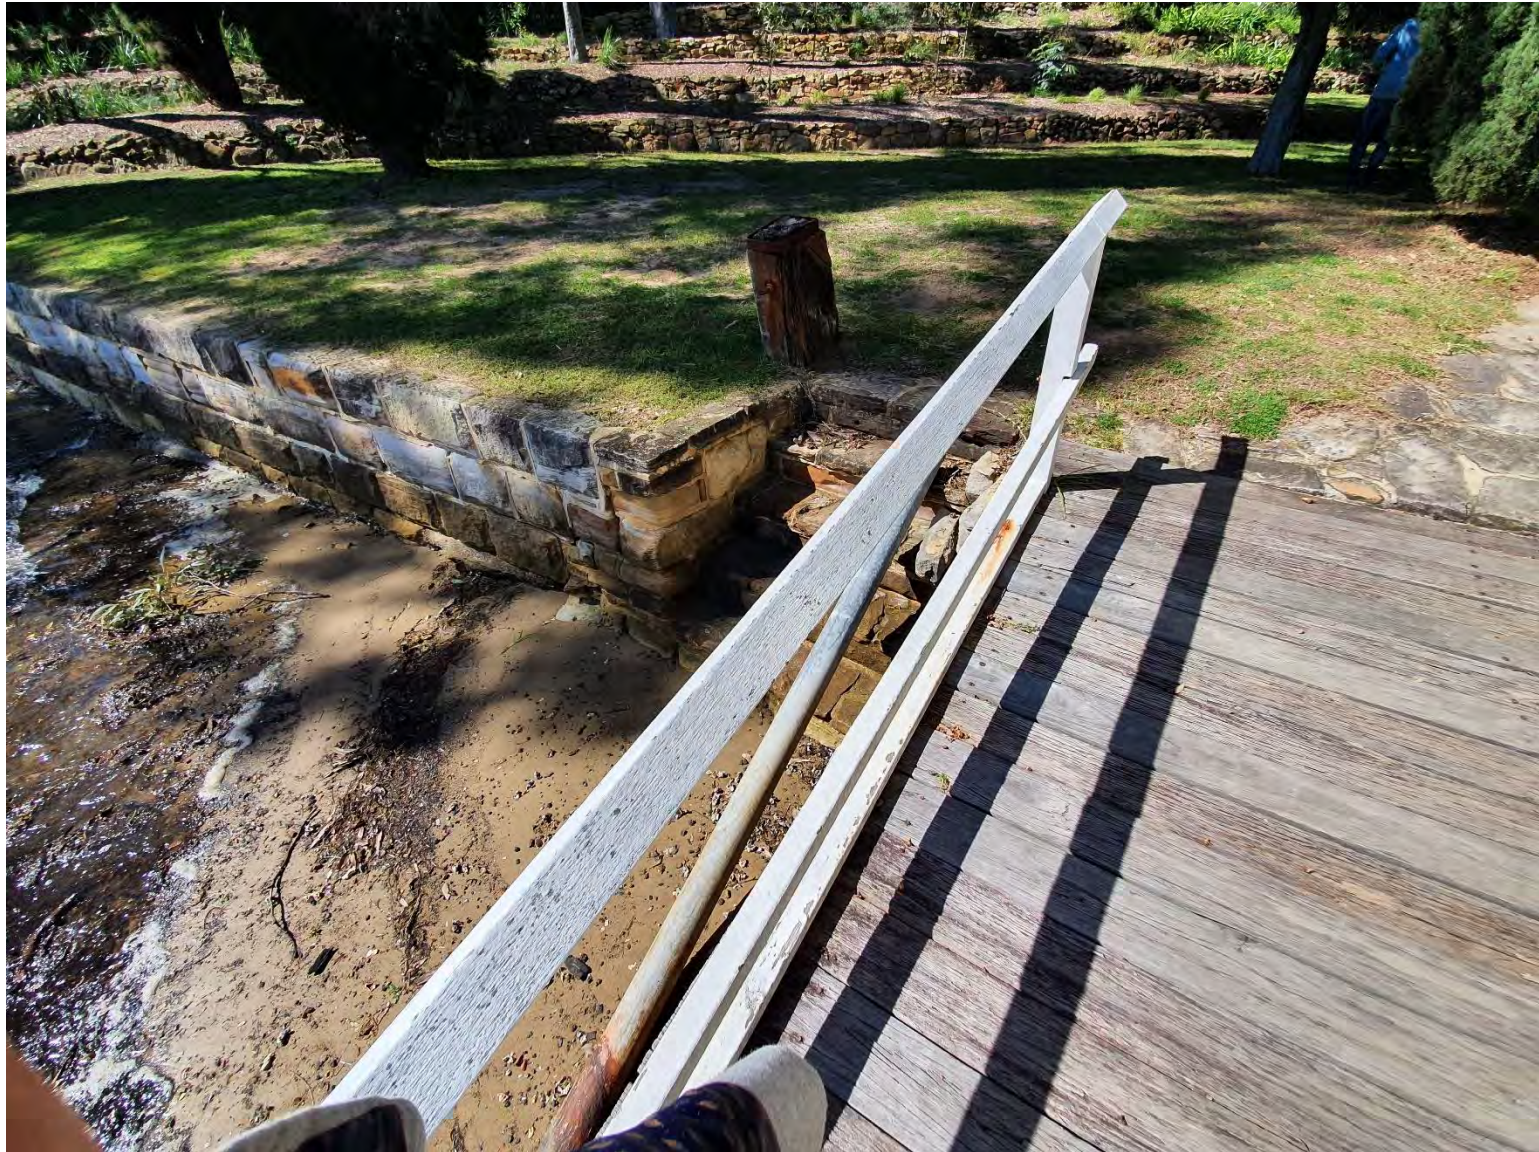
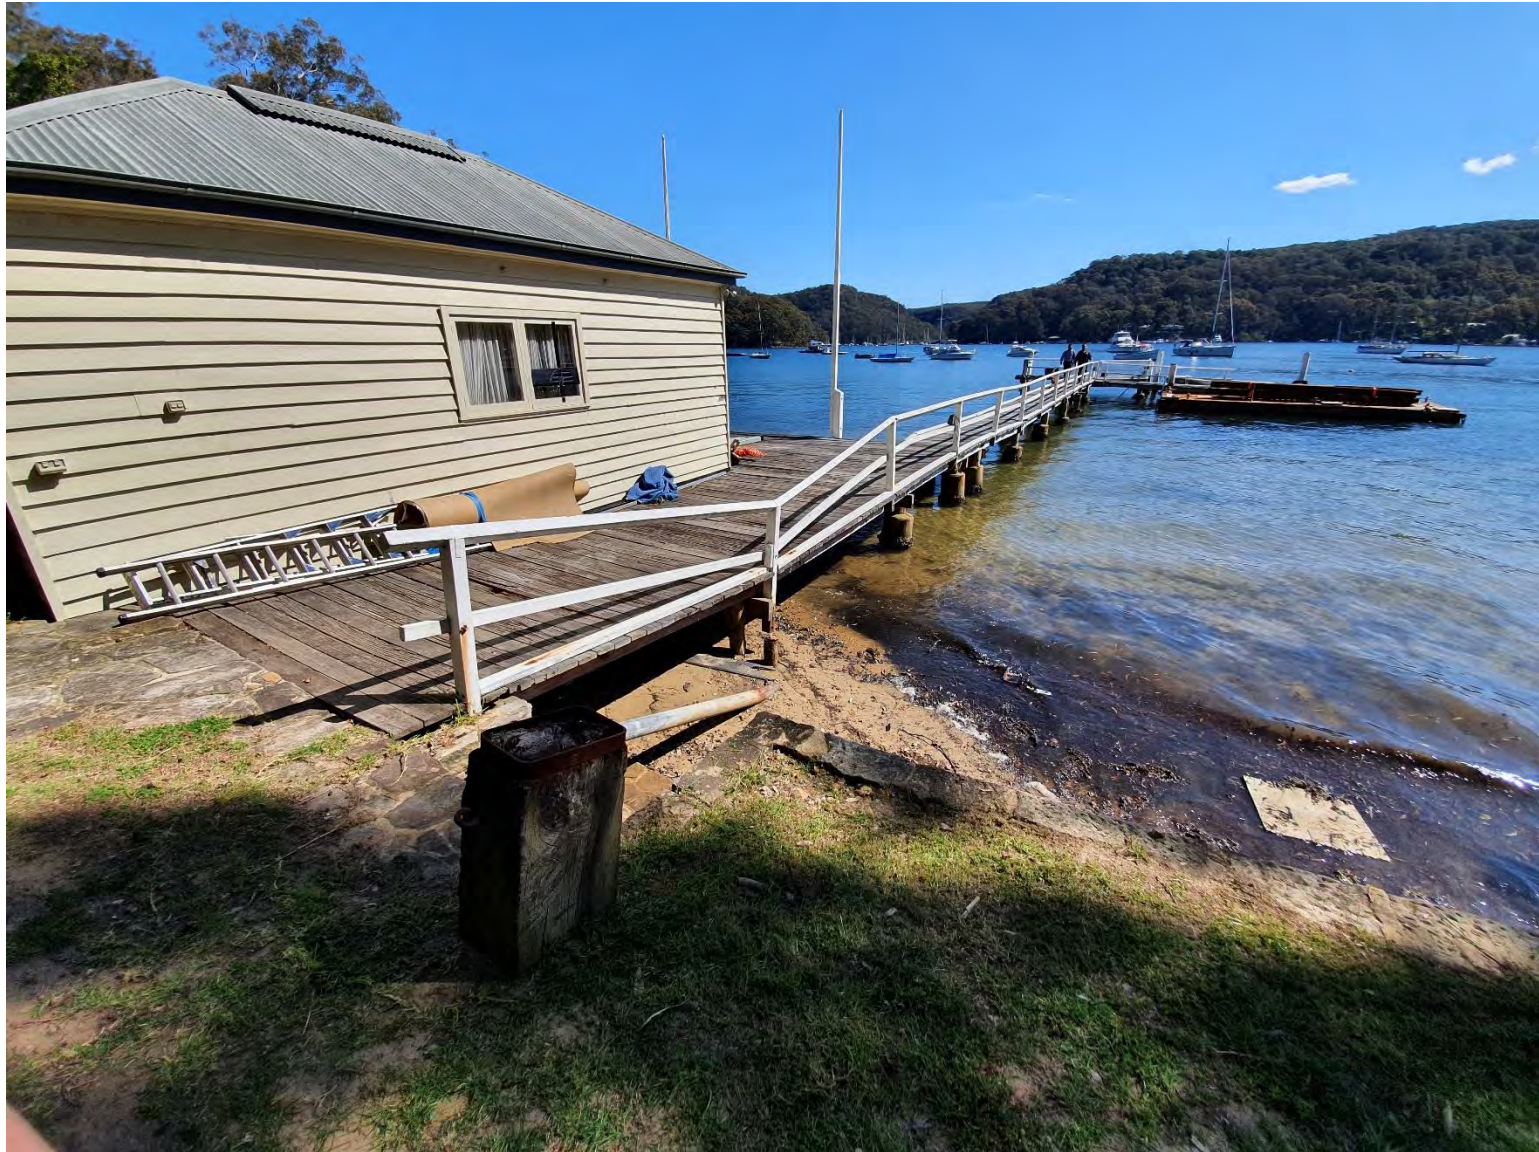
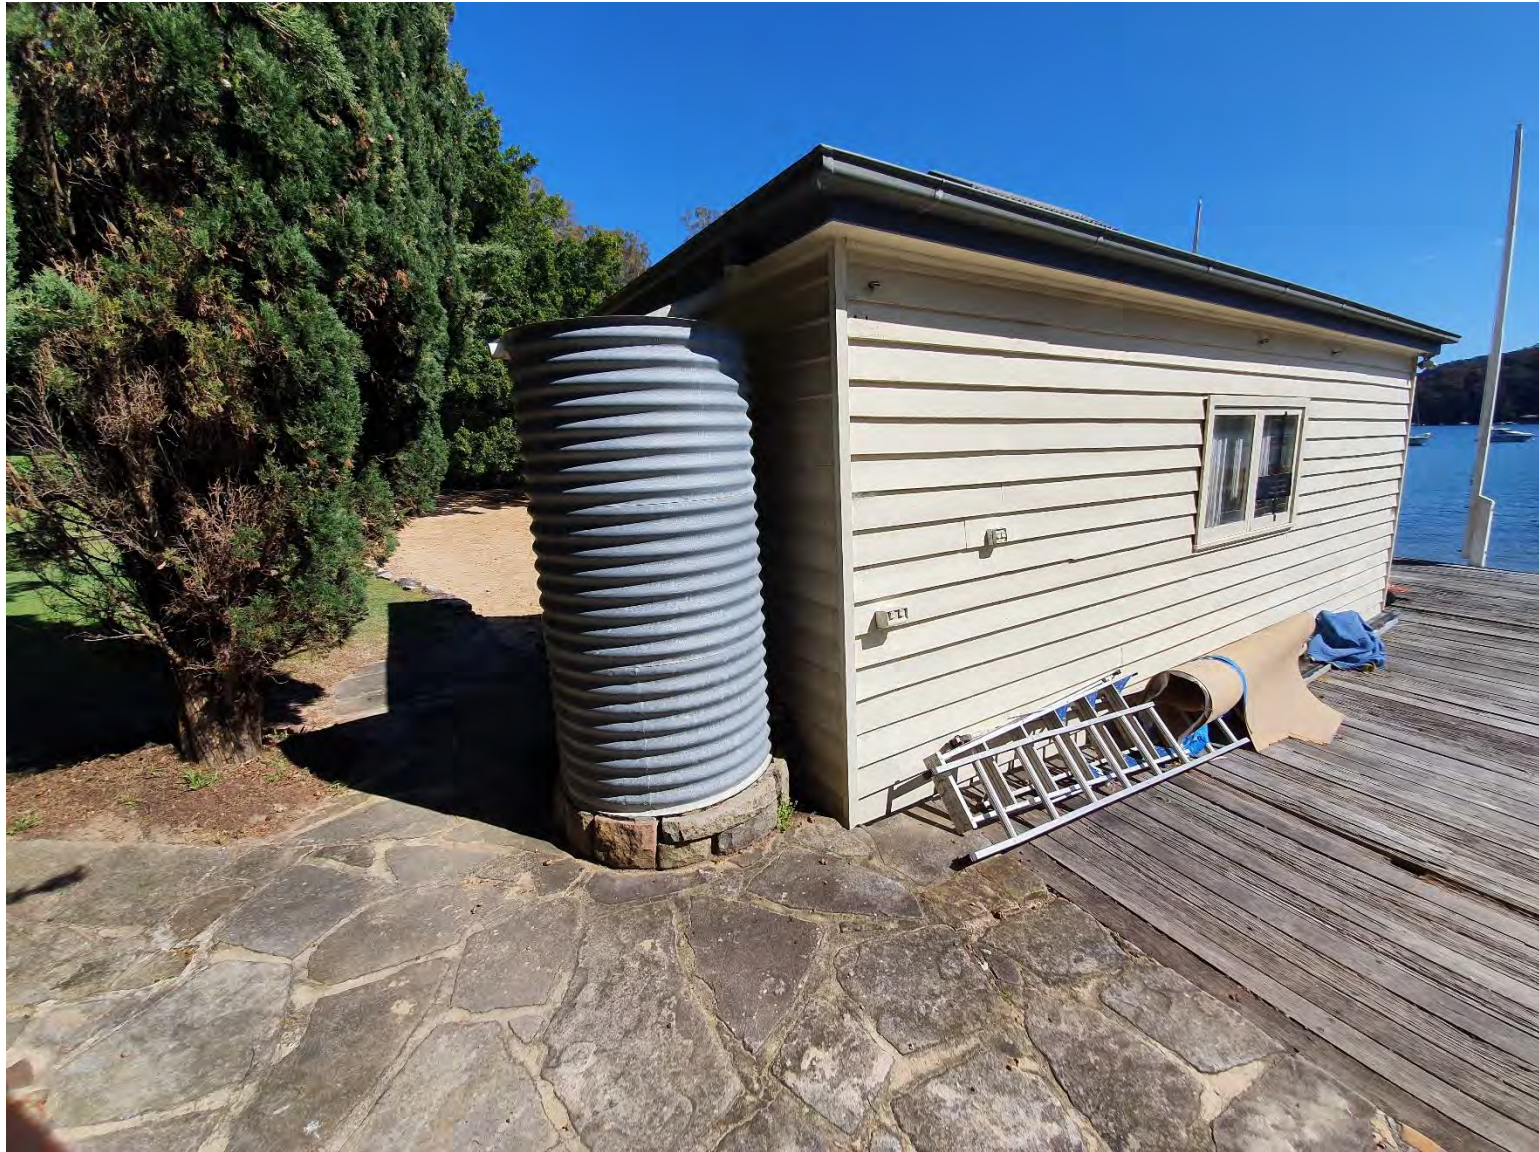
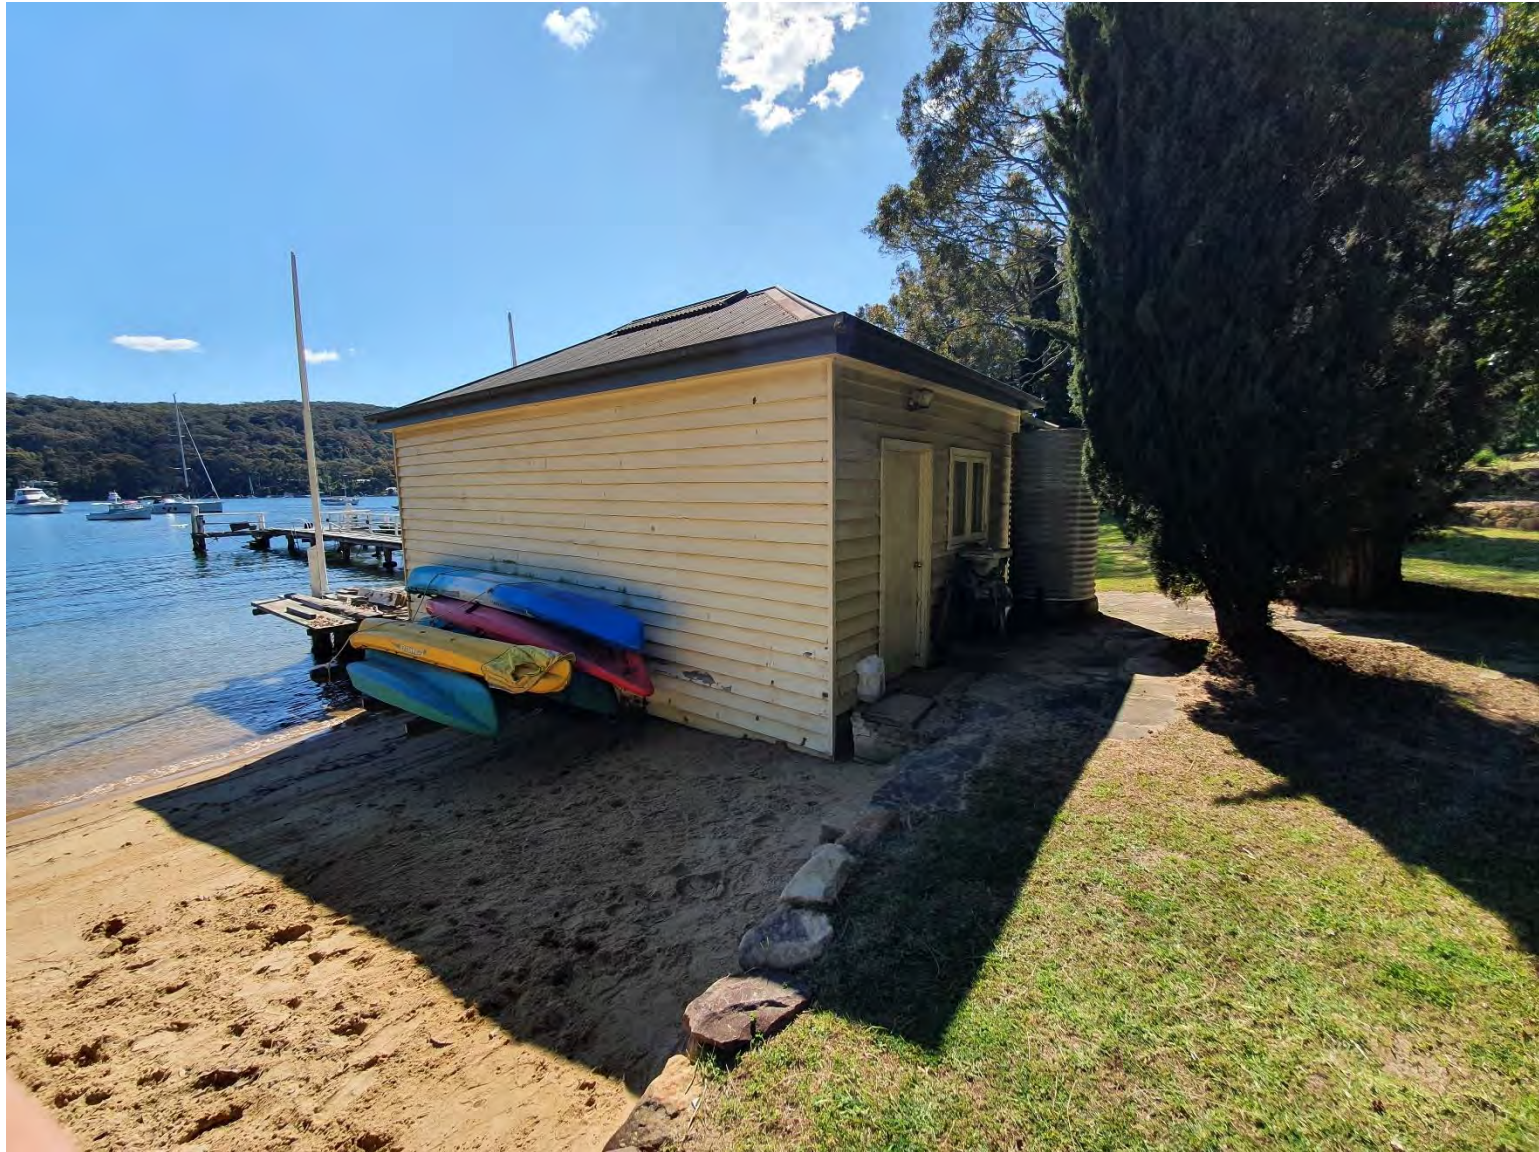
| Location | Photo Description | Photo Ref |
|---|---|---|
| | Photo Displaying the general condition of the existing shed on the Yamba wharf. Also includes some supplementary photos showing the general condition of the jetty. | 29-53 |
