**Proposed Residence
16 Ruskin Rowe, Avalon Beach NSW**

Geotechnical Investigation

Our ref: 6406-G1
15 March 2021

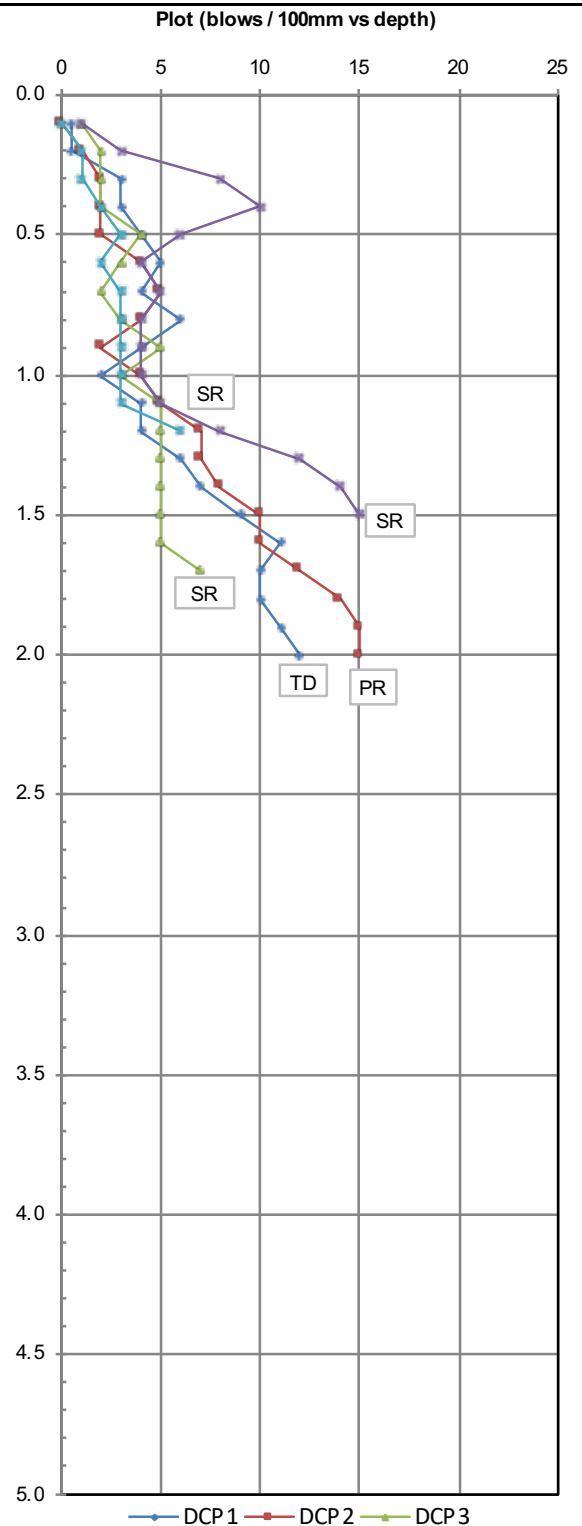
Notes:

RL = ground surface level (m) AHD
TD = target depth, PR = practical refusal (15+ blows per 100mm), SR = "solid" refusal (no further penetration and "solid" ringing sound from slide hammer)

equipment:	9kg hammer, 510mm drop, cone tip
standard:	AS1289.6.3.2-1997

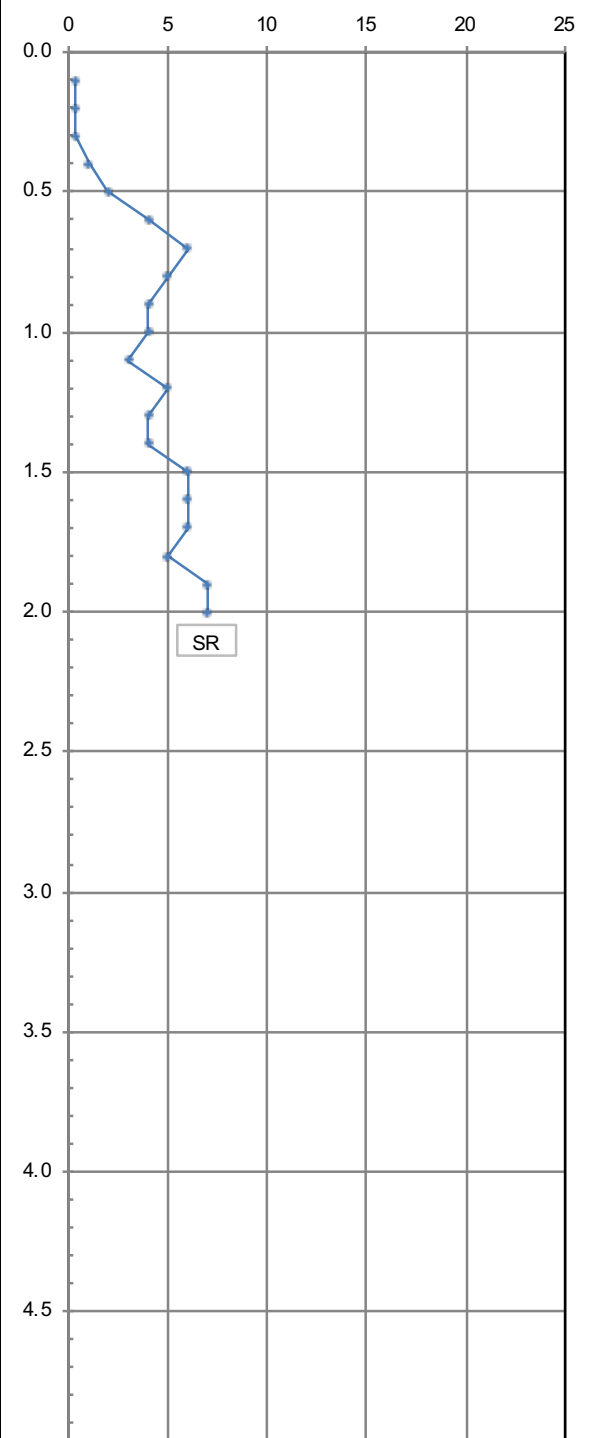
Depth (m)	Test Results (blows / 100mm)					Plot (blows / 100mm vs depth)
	DCP6					
0.00 – 0.10	0.33

0.10 – 0.20	0.33					
0.20 – 0.30	0.33					
0.30 – 0.40	1

0.40 – 0.50	2					
0.50 – 0.60	4					
0.60 – 0.70	6					
0.70 – 0.80	5					
0.80 – 0.90	4					
0.90 – 1.00	4					
1.00 – 1.10	3					
1.10 – 1.20	5					
1.20 – 1.30	4

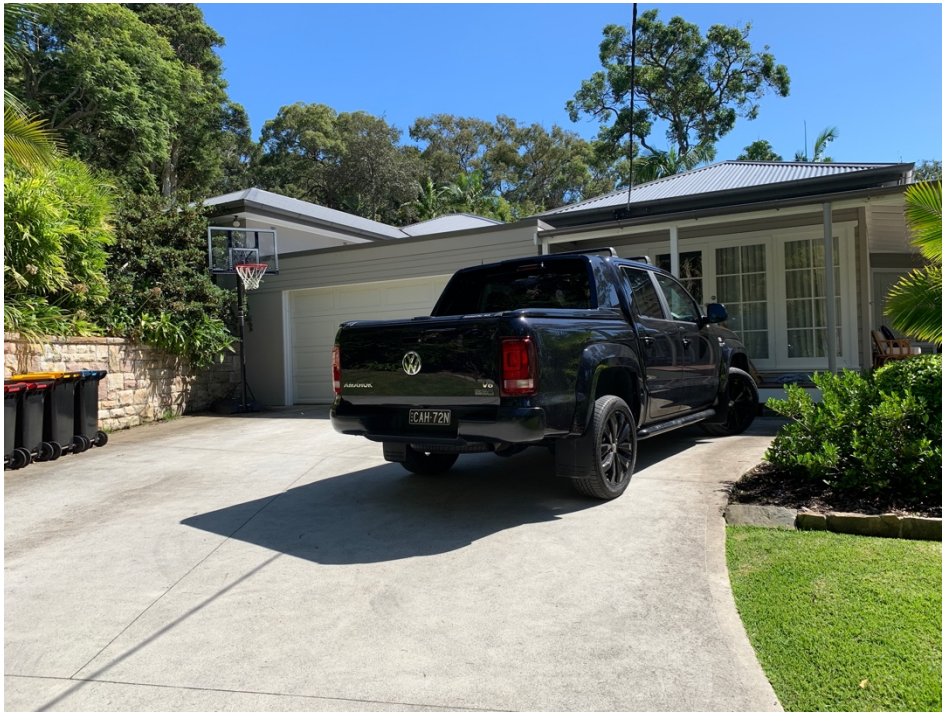
Photo 1
Overview of the
existing residence.

At the time of the investigation, the site was occupied by a single-storey, clad-built, metal-roofed residence (see Photo 1). It is in good visual condition. There were no obvious signs of instability such as cracking or ground settlement observed on the paving and stone retaining walls within the surrounding area of the house. The majority of the area is covered with short grass and scattered mature trees and an existing swimming pool located at the north-western corner at the rear (see Photo 2).

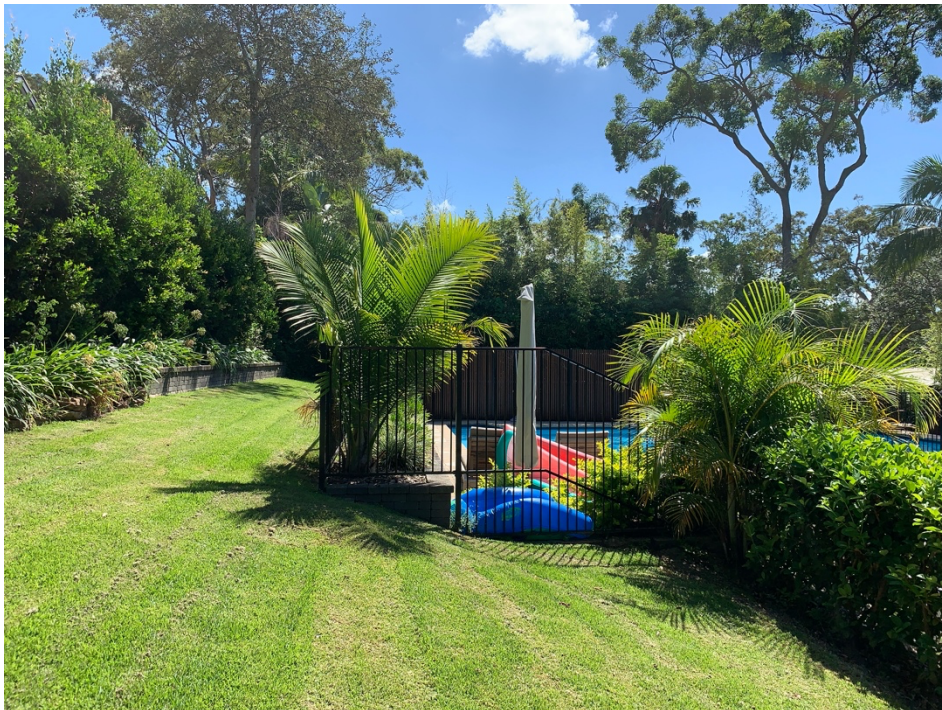
Photo 2
Overview of the
existing pool at the
rear
