Preliminary Geotechnical Assessment

For New Pool & Landscaping at
12 Blighs Road, Cromer NSW

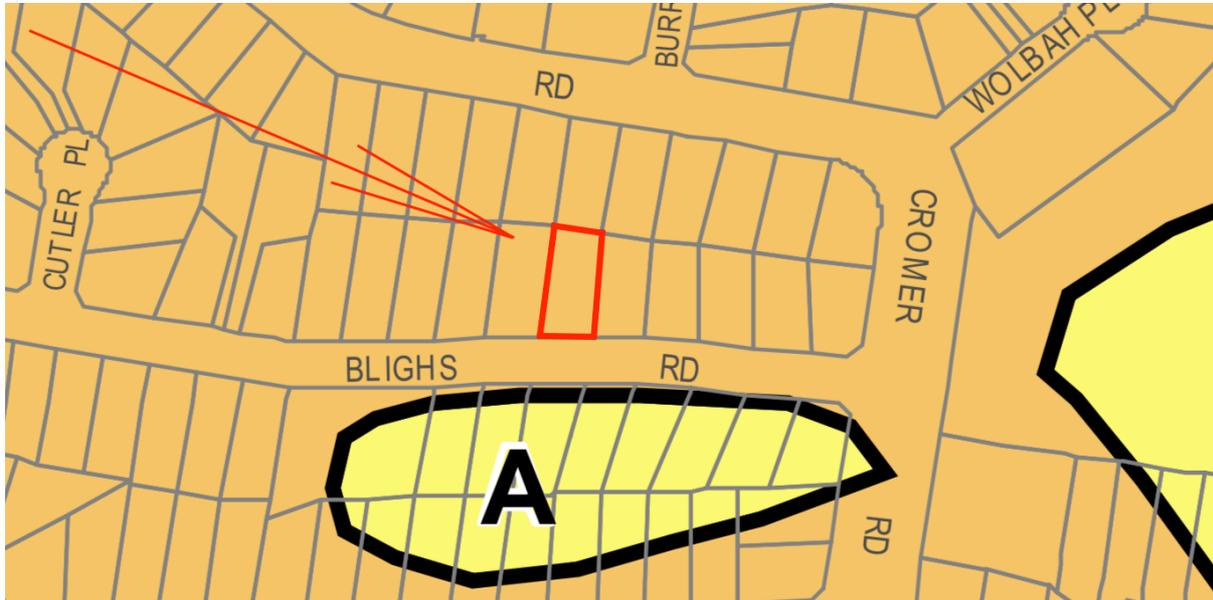
WARRINGAH LANDSLIP RISK MAP

The site is mapped as **Area B** on the Landslip Risk Map LSR_007 (**Image 1**, below).

- Area A - Slope less than 5 degrees
- Area B - Flanking Slopes from 5 to 25 degrees
- Area C - Slopes more than 25 degrees
- Area D - Collaroy Plateau Area Flanking Slopes 5 to 15 degrees
- Area E - Collaroy Plateau Area Slopes more than 15 degrees

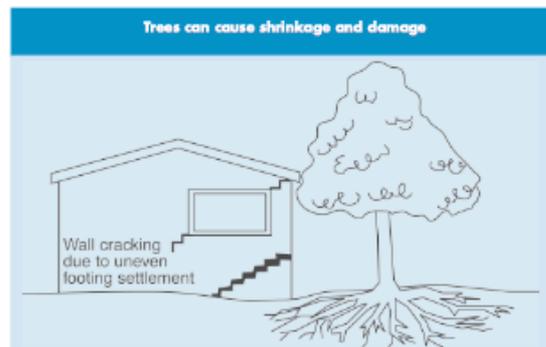
The first noticeable symptom may be that the floor appears slightly dished. This is often accompanied by some doors binding on the floor or the door head, together with some cracking of cornice mitres. In buildings with timber flooring supported by bearers and joists, the floor can be bouncy. Externally there may be visible dishing of the hip or ridge lines.

As the moisture absorption process completes its journey to the innermost areas of the building, the internal footings will rise. If the spread of moisture is roughly even, it may be that the symptoms will temporarily disappear, but it is more likely that swelling will be uneven, creating a difference rather than a disappearance in symptoms. In buildings with timber flooring supported by bearers and joists, the isolated piers will rise more easily than the strip footings or piers under walls, creating noticeable doming of flooring.

As the weather pattern changes and the soil begins to dry out, the external footings will be first affected, beginning with the locations where the sun's effect is strongest. This has the effect of lowering the external footings. The doming is accentuated and cracking reduces or disappears where it occurred because of dishing, but other cracks open up. The roof lines may become convex.
