PRELIMINARY GEOTECHNICAL ASSESSMENT:

75 Parkes Road, Collaroy Plateau

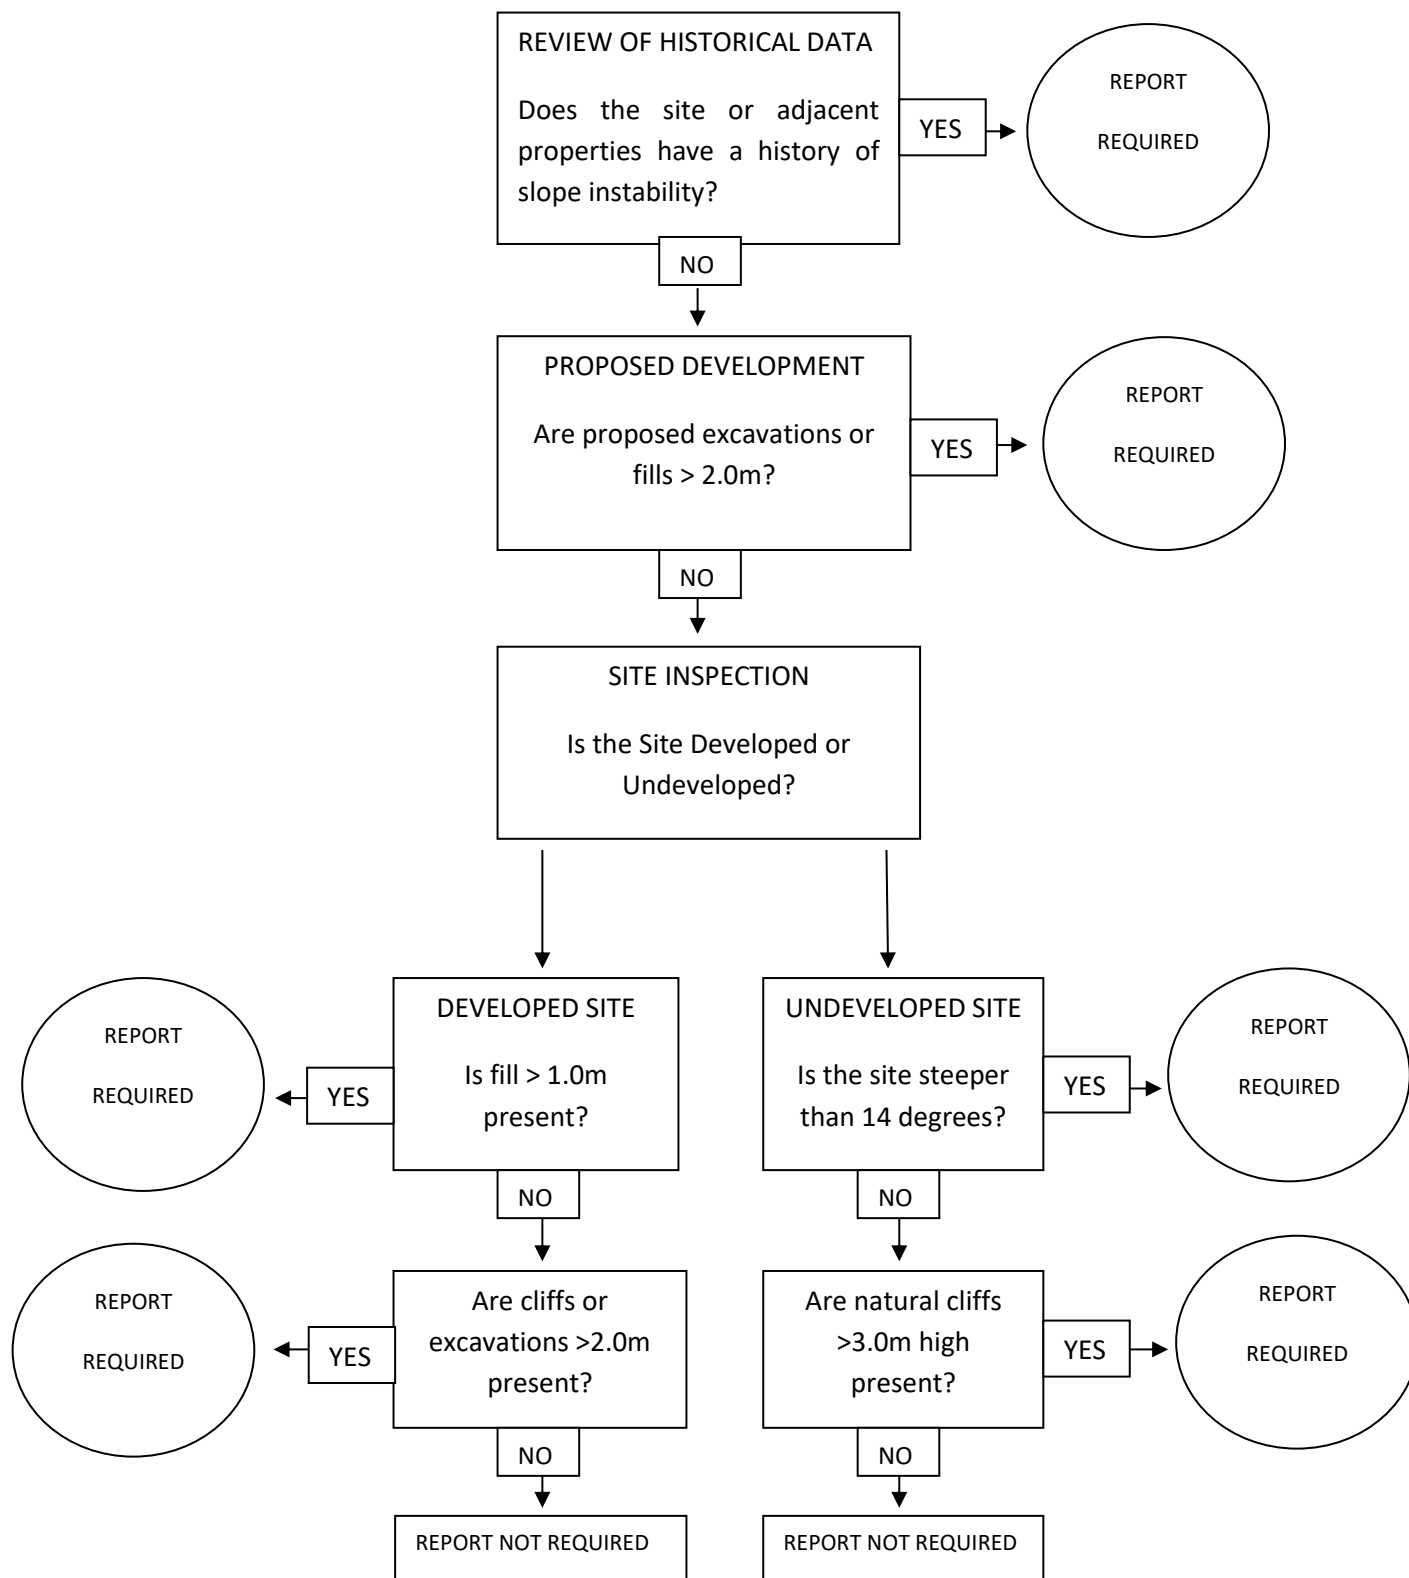
Preliminary Assessment Flow Chart – Norther Beaches Council (Warringah)

The proposed development and site conditions were considered and applied to the Council Flow Chart.
