Preliminary Geotechnical Assessment

Project: Alterations & Additions
7 Truman Avenue, Cromer NSW

Ref: AG 24477
7 November 2024

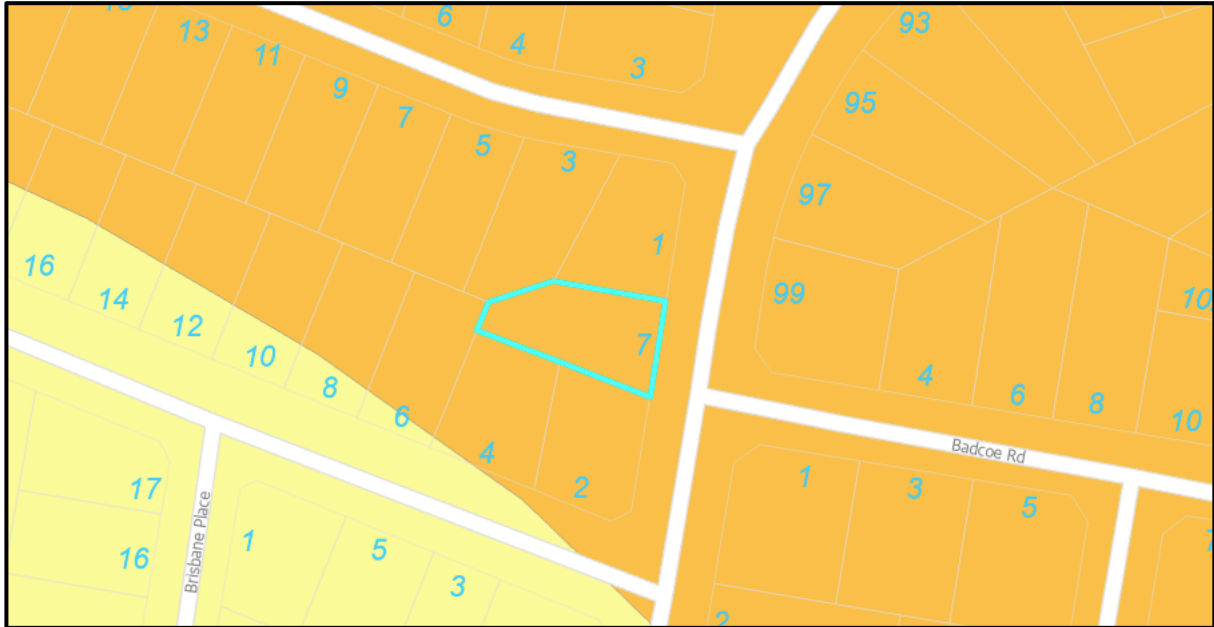
Figure 1. Warringah Landslip Risk Map:
7 Truman Avenue, Cromer NSW (© NBC Maps)

LEGEND
Warringah Landslip Risk Map
 ■ Area A - Slope less than 5 degrees
 ■ Area B - Flanking Slopes from 5 to 25 degrees
 ■ Area C - Slopes more than 25 degrees
 ■ Area D - Collaroy Plateau Area Flanking Slopes 5 to 15 degrees
 ■ Area E - Collaroy Plateau Area Slopes more than 15 degrees

The site is mapped as **Area B** subject to specific landslip risk/geotechnical hazard mapping with reference to the Warringah (WLEP) Landslip Risk Map, Northern Beaches Council (**Image 1**).
