Preliminary Geotechnical Assessment

For Alterations and Additions at
959 Pittwater Road, Collaroy, NSW

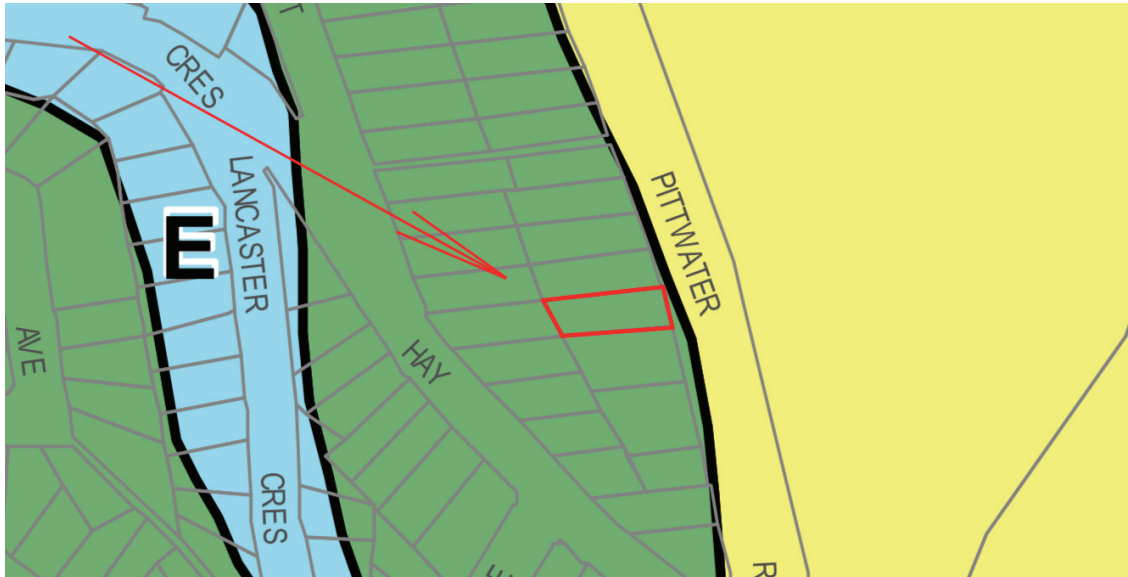
WARRINGAH LANDSLIP RISK MAP

The site is mapped as **Area D** on the Landslip Risk Map LSR_009 (**Image 1**, below).

- Area A - Slope less than 5 degrees
- Area B - Flanking Slopes from 5 to 25 degrees
- Area C - Slopes more than 25 degrees
- Area D - Collaroy Plateau Area Flanking Slopes 5 to 15 degrees
- Area E - Collaroy Plateau Area Slopes more than 15 degrees
