PRELIMINARY GEOTECHNICAL ASSESSMENT:

24 Karina Crescent, Belrose

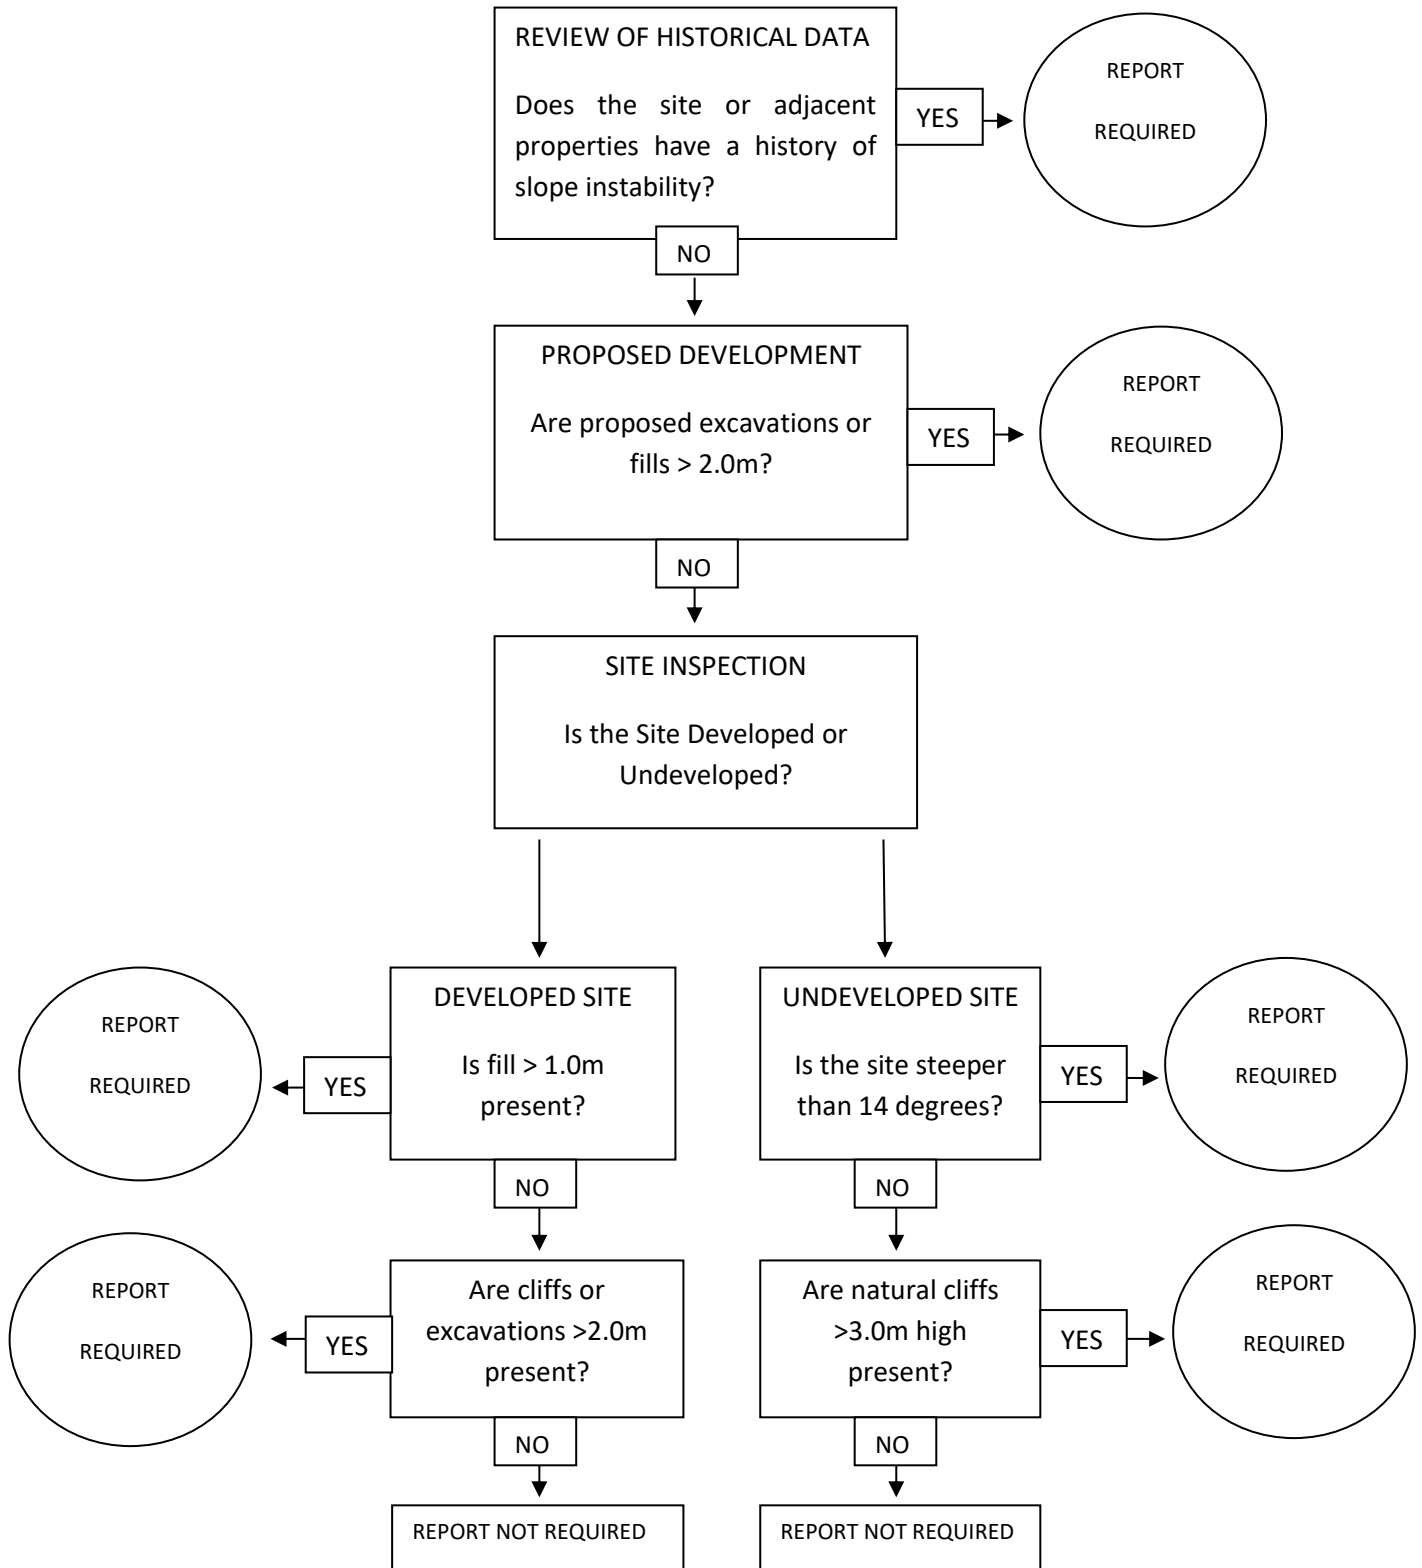
Preliminary Assessment Flow Chart – Northern Beaches Council (Warringah)

The proposed development and site conditions were considered and applied to the Council Flow Chart.
