# **Balcony Modification - 48 Beacon Ave, Beacon Hill**

## **Development Application**

Document No. 1

November 2019

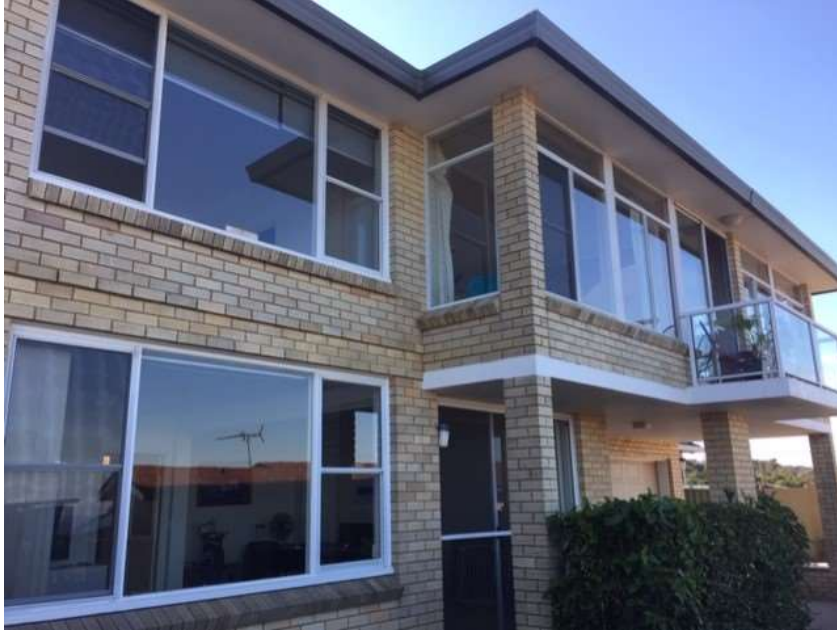
Photo above: 1<sup>st</sup> floor balcony proposed runs along the back wall of the house as per the photo above.

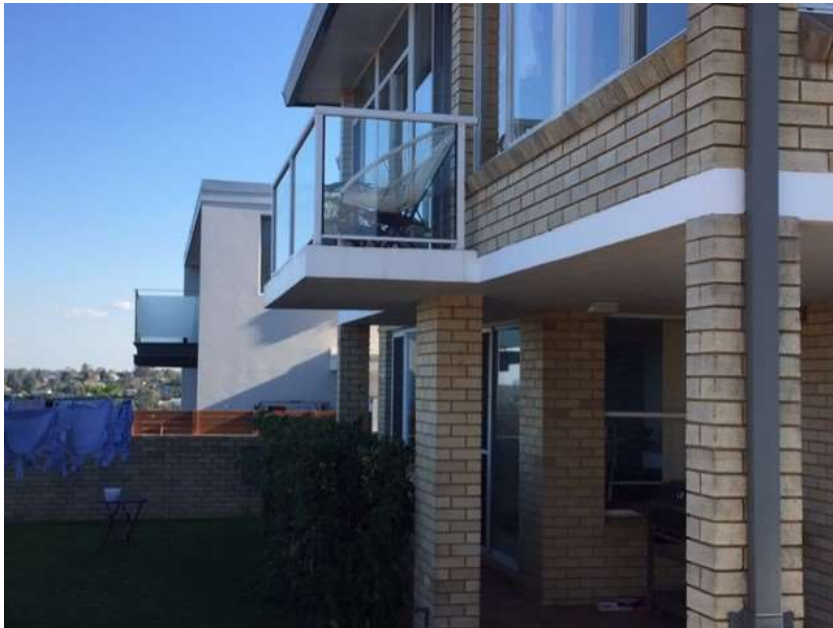
Photo above: 1<sup>st</sup> floor balcony proposed runs along the back wall of the house as per the photo above.

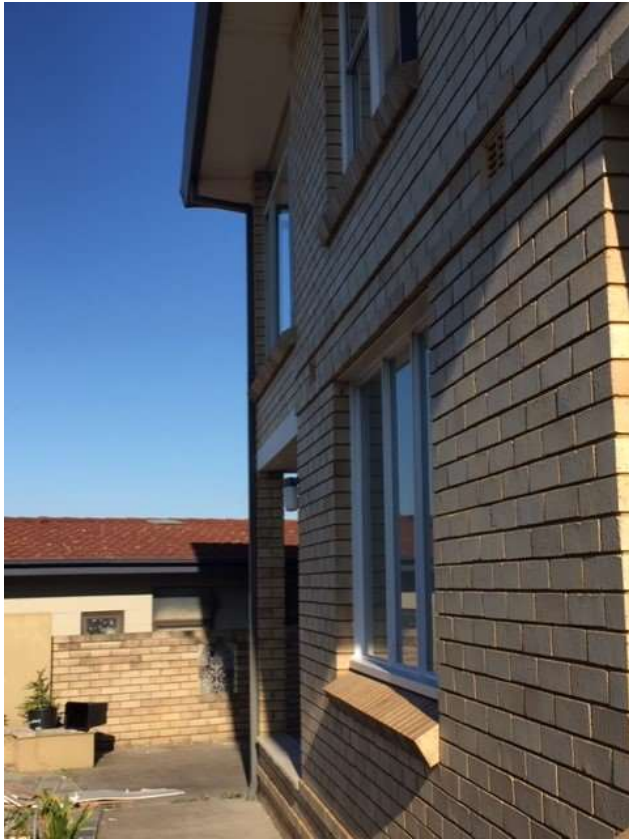
Photo above: North Eastern Side. New stairs are proposed from the new balcony, from back to front.

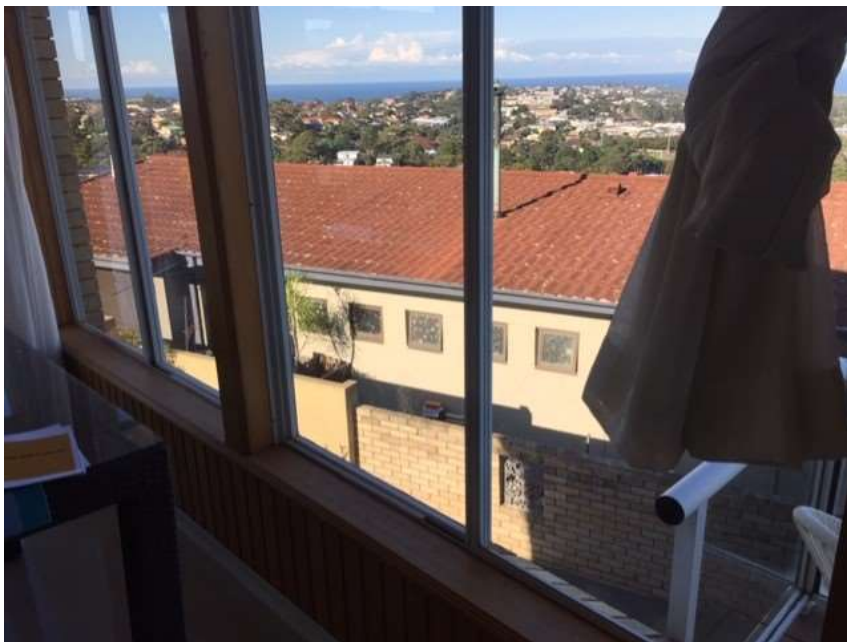
Photo above: The existing view from inside looking East into the back yard of 59 Beacon Hill Rd. This view will be blocked by the proposed balcony.

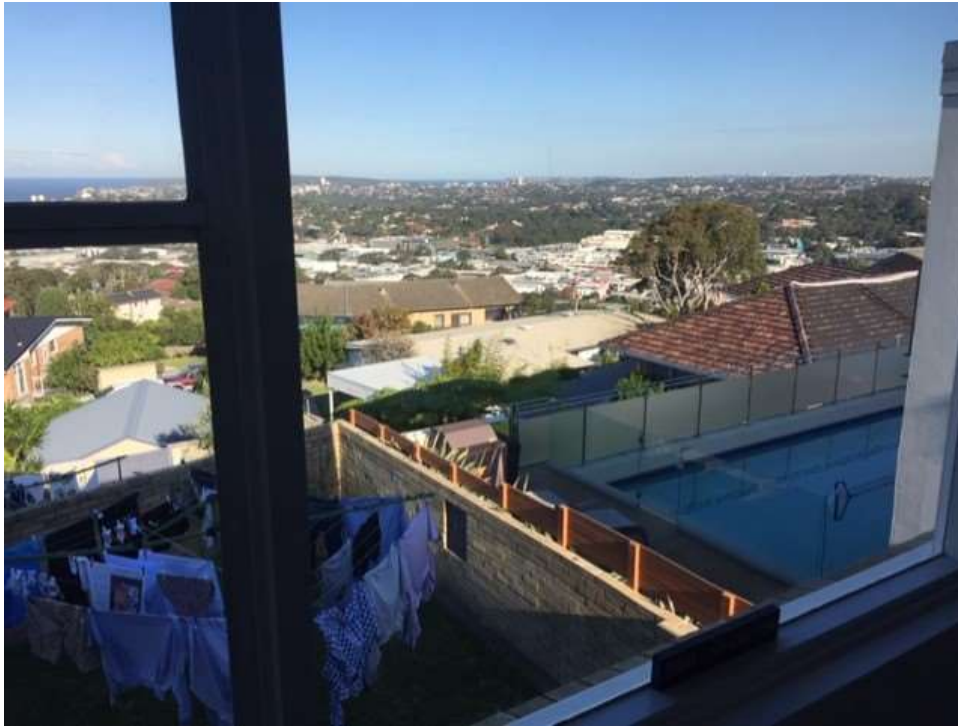
Photo above: The existing view to the South from the master bedroom into the back yard/pool area of 46 Beacon Ave, Beacon Hill. This view will be blocked by the proposed balcony.

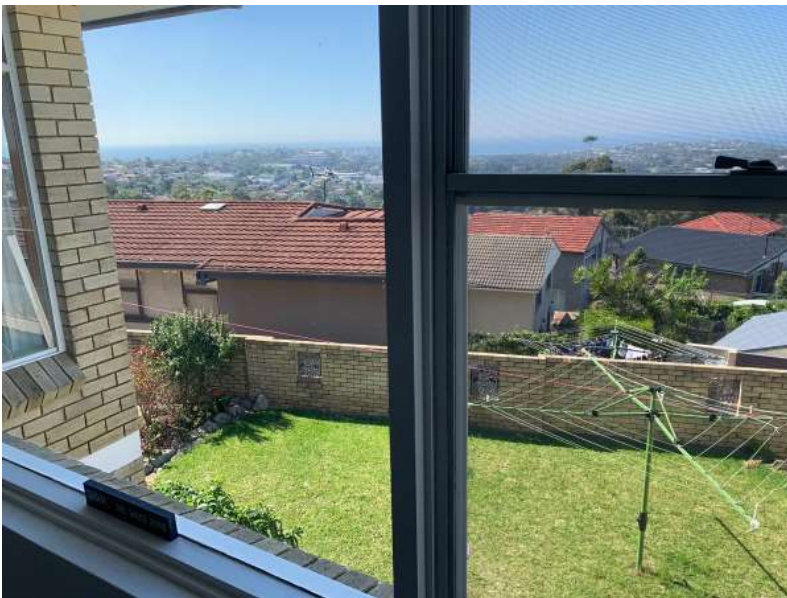
Before Development: View from Master bedroom

The photos above show the view from the master bedroom window looking east towards 59 Beacon Hill Road. The existing view is of the back of the neighbour's house and rear courtyard. This view is completely obscured by the proposed balcony and as a result, increases privacy between both properties.

The 3 main living areas of 48 Beacon Hill Rd (dining room, living room and master bedroom) currently overlook the rear court yard of 59 Beacon Hill Rd and rear windows (wet areas and a second bedroom). The proposed balcony will eliminate this view from these 3 main living areas.

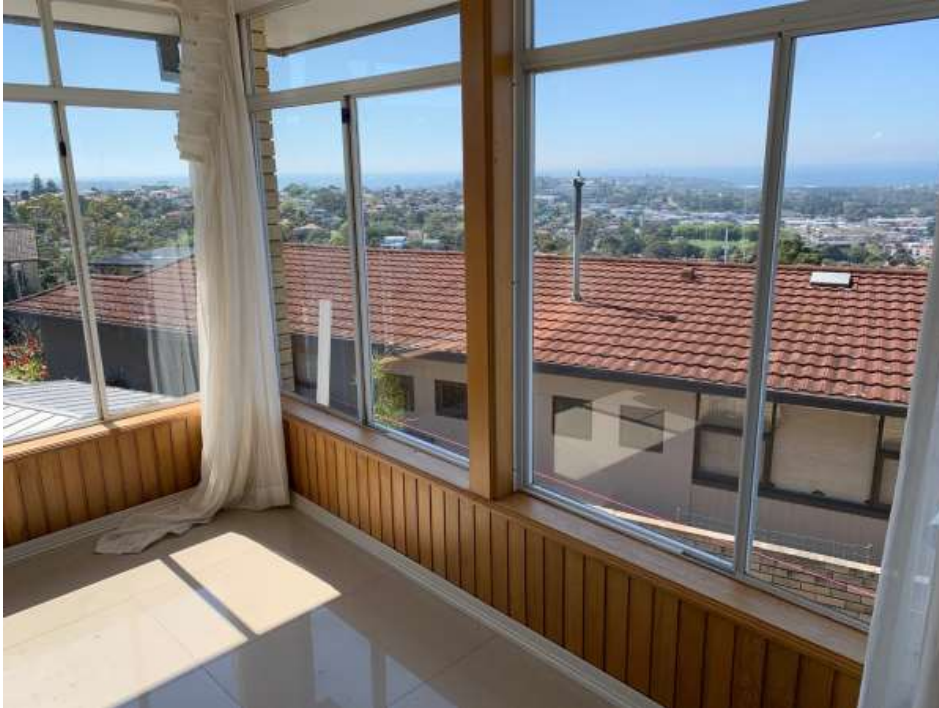
Before Development: view from Dining Room

The photos above show the view from the dining room looking east towards 59 Beacon Hill Rd. This perspective clearly shows the existing dining windows looking over the rear of 59 Beacon Hill Rd. The rear windows of the neighbours are bathrooms and a bedroom. With the inclusion of the proposed balcony the view into neighbour's property is completely obscured and as a result, increases privacy between both properties.

The walkway off the living room past the dining room will only be 1 meter wide and will therefore be utilised as circulation space only to the external staircase. The primary purpose of this walkway is rectifying the safety concern with the existing windows. As the photos show the existing windows are only 500mm off the ground and cause a significant safety concern for the residence of 48 Beacon Ave.

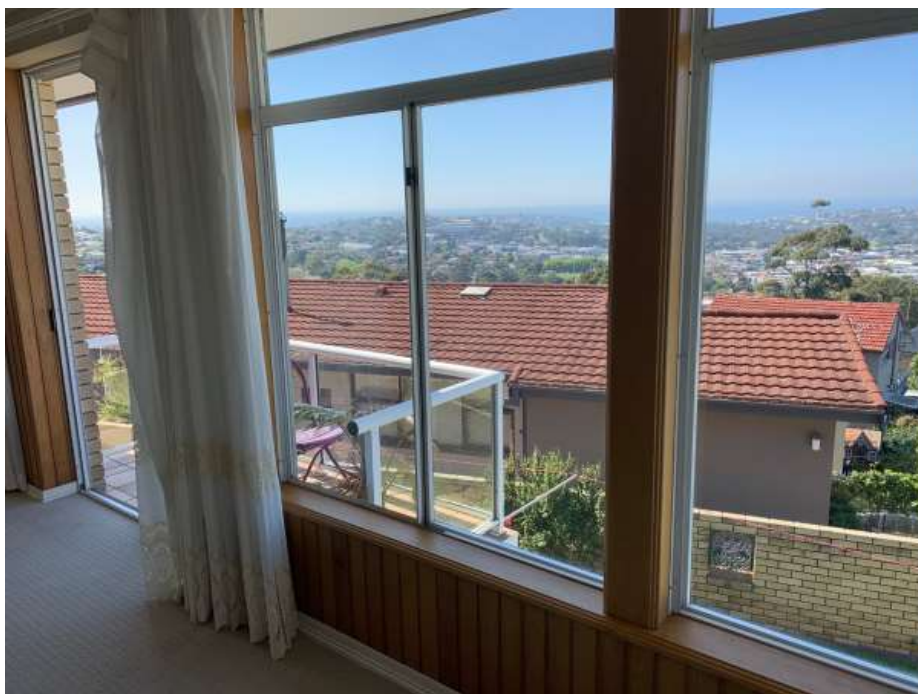
Before Development: view from the Living Room

The photos above show the view from the living room, looking east towards 59 Beacon Hill rd. This perspective clearly shows the existing living room windows looking over the rear of 59 Beacon Hill Rd. The rear window of the neighbouring property is a secondary bedroom. The inclusion of the proposed balcony results in the view into neighbour's property being completely obscured and as a result increases privacy between the properties. The before shot above shows the size of the existing balcony. The proposed design ensures that the usable balcony to the south-west is no closer to the rear boundary than the existing balcony.

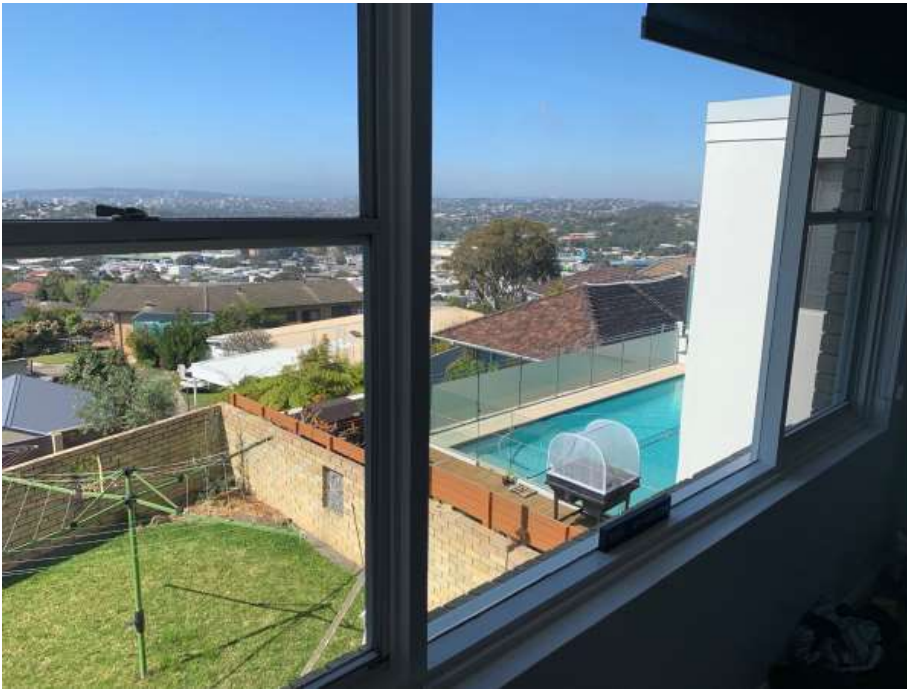
Before Development: view from master bedroom

View from master bedroom room, looking south-west towards 46 Beacon Ave. This perspective shows the existing master bedroom windows looking over the rear of 46 Beacon Ave, which includes a view into the neighbour's pool area. With the inclusion of the proposed balcony, the use of frosted glass balustrade and 1.8 meter privacy screen, the view into neighbour's property is completely obscured and as a result, increases privacy between properties.

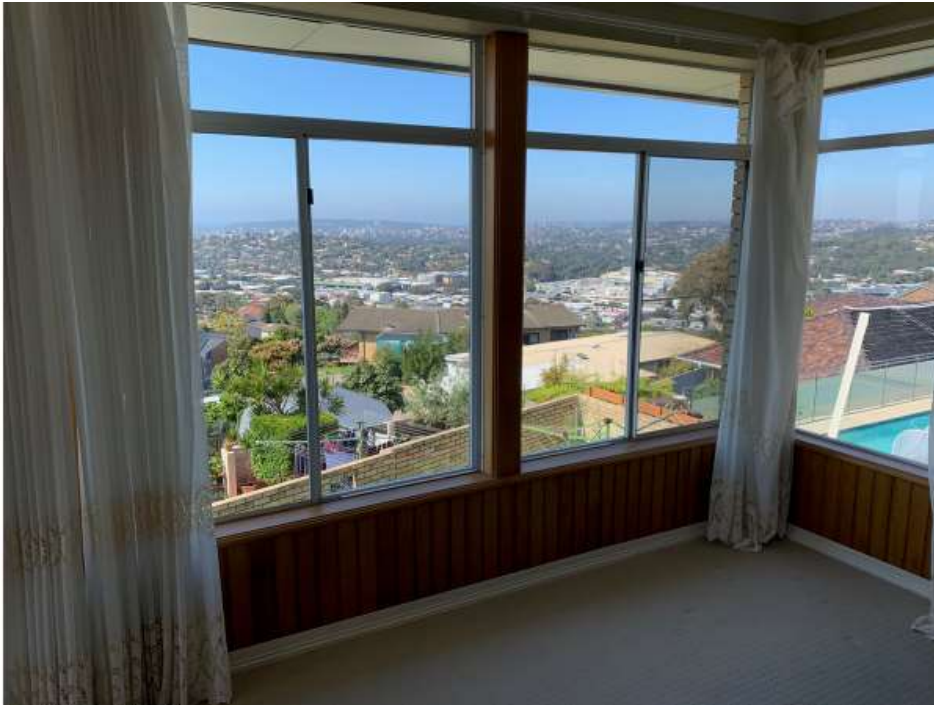
Before Development: view from living room

View from living and dining room, looking south-west towards 46 Beacon Ave. This perspective clearly shows the existing living/dining room windows looking over the rear of 46 Beacon Ave, which includes a clear view into the neighbour's pool area. With the inclusion of the proposed balcony, the use of frosted glass balustrade and 1.8 meter privacy screen, the view into neighbour's property is completely obscured and as a result, increases privacy between properties.

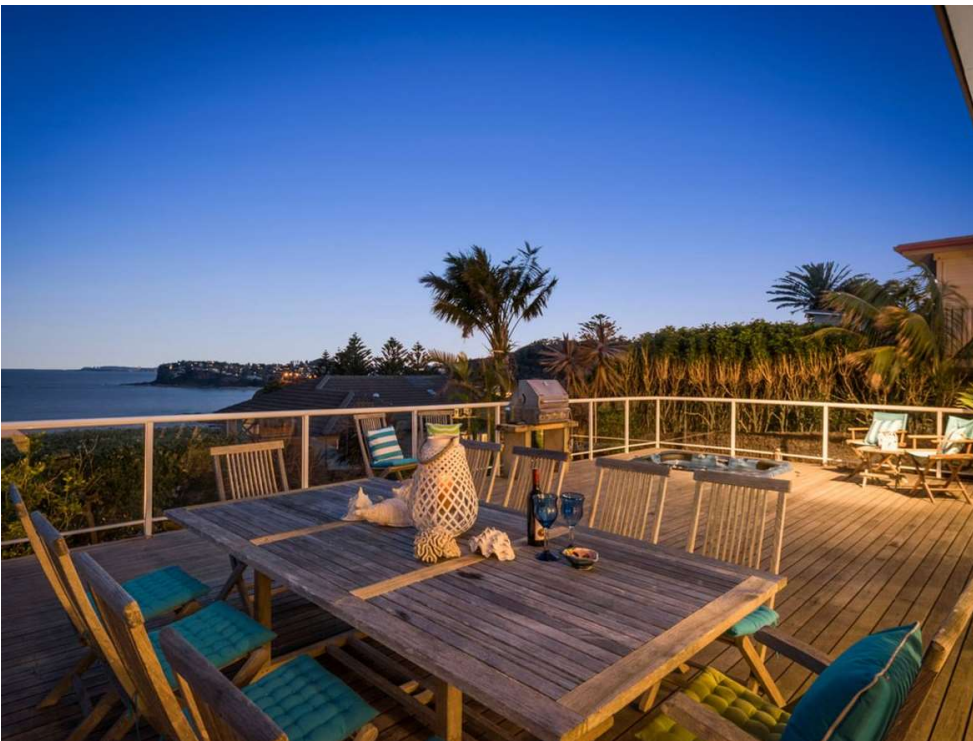
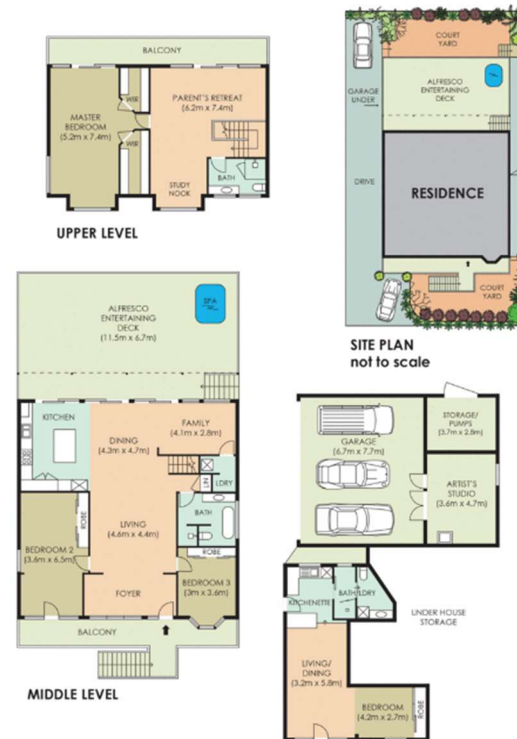
First floor rear balcony is 5 metres from the rear boundary and is overlooking neighbouring property. The balcony size is 11.5m x 6.7m = 77.05 sqm

480 Barrenjoey Road, Avalon Beach is a 4 bedroom property. The property has a rear balcony on the first floor to take in views to the south-east over the ocean. The rear balcony is within 5 metres of the rear boundary, overlooks lower lying neighbouring properties and is 77m<sup>2</sup> in size.

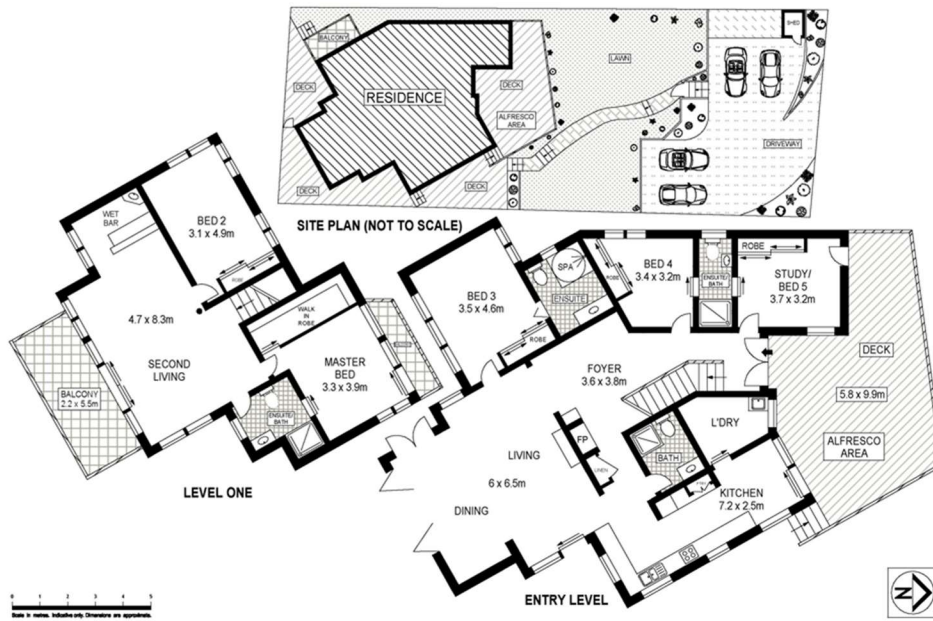
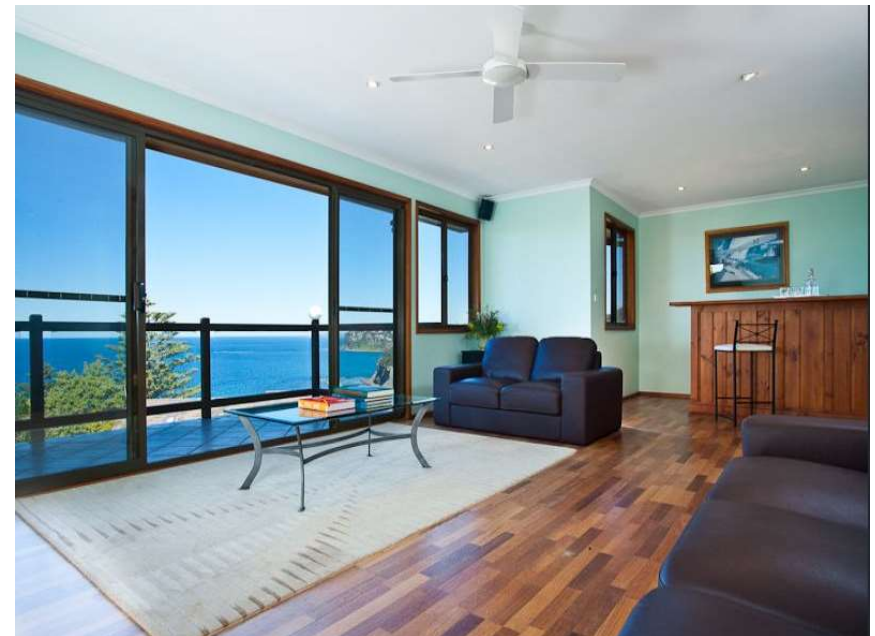
### 10.1.5 470 Barrenjoey Road Avalon Beach

First floor rear balcony is 1 metre from the rear boundary and is overlooking neighbouring property. The balcony size is approx. 12 m<sup>2</sup>.

470 Barrenjoey Road, Avalon Beach is a 5 bedroom property set towards the back of the block. The property has a rear balcony on the first floor. The rear balcony is within 1 metre of the rear boundary, overlooks lower lying neighbouring properties and is 12m<sup>2</sup> in size.
