Preliminary Acid Sulfate Soils Assessment

Project: New Swimming Pool
6 Lido Avenue, North Narrabeen NSW.

REF: AG 21321
29 September 2021

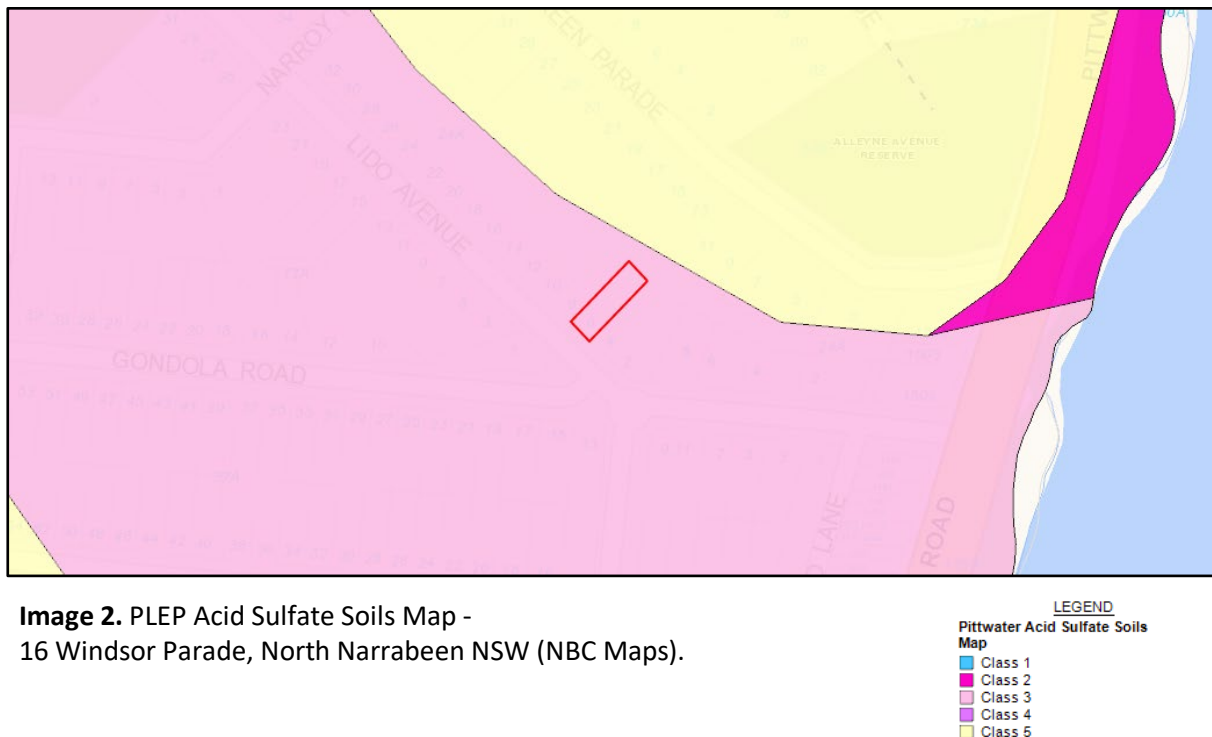
The property is mapped as '**Class 3**' in Northern Beaches Council's Pittwater Acid Sulfate Soils Map (PLEP Acid Sulfate Soils Map '025' **Image 2**).

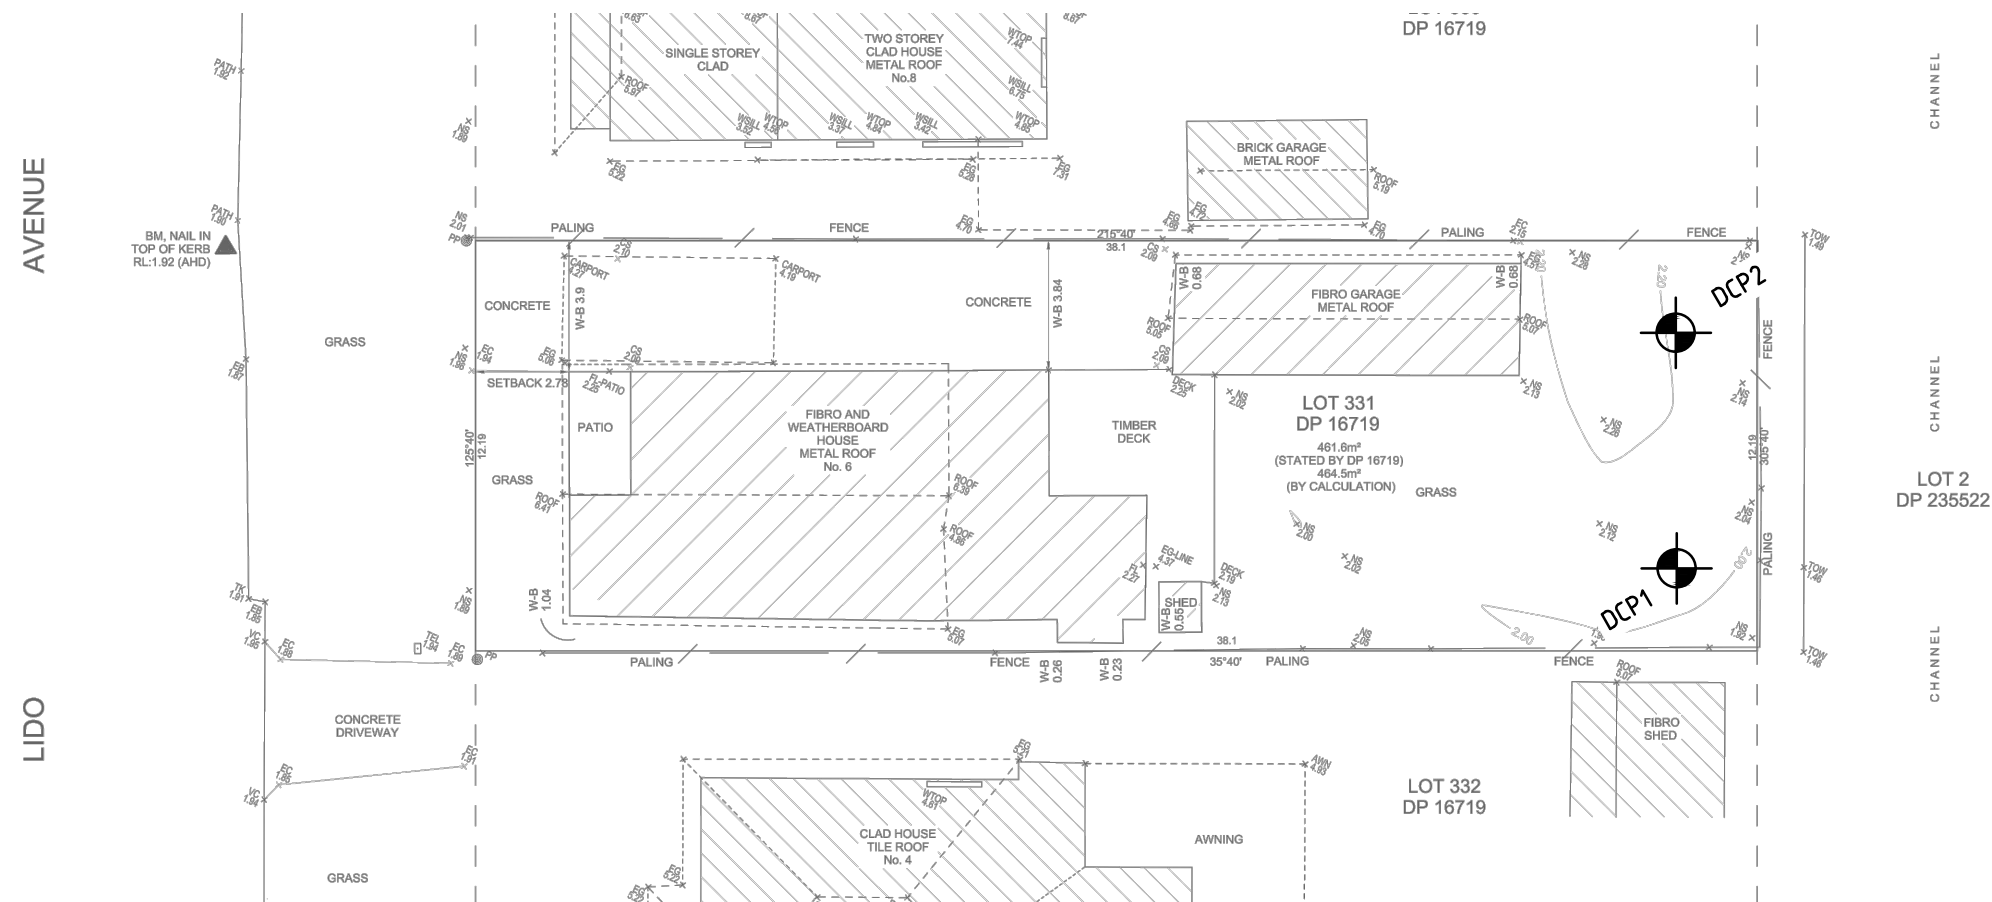
SITE PLAN/GROUND TEST LOCATIONS

DCP LOCATIONS
