DA 2021/1909 — AUAN & WARGARET

Errors in the provided design documentation

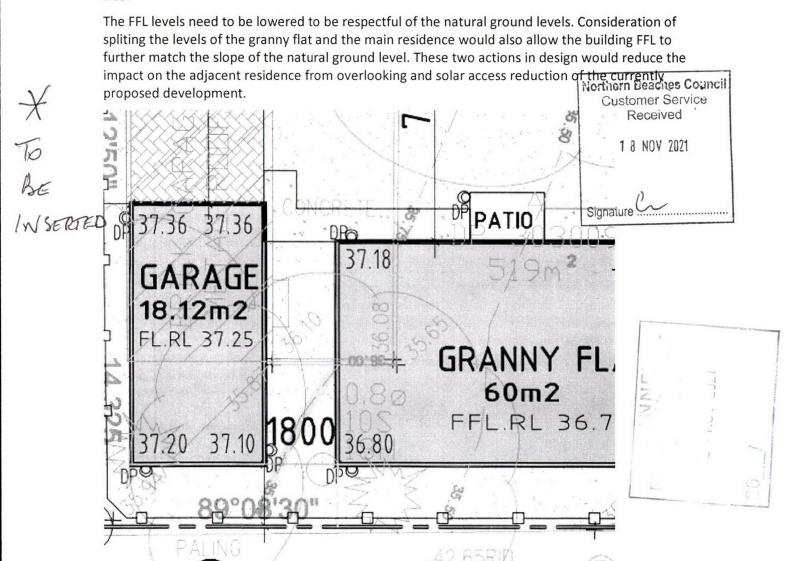
The proposed finished floor levels are significantly higher than the surveyed existing surface levels. As an example, the existing surveyed level at the western mid-section of the granny flat is 35.75 (highlighted in the figure below). The FFL proposed is 36.70, is 950 mm higher than the existing surface at the western end of the granny flat, the location the proposed FFL is closest to the existing surface level.

At the eastern end of the building the FFL is 2040 mm above the existing surface level (spot level in South East corner of 34.71 and FFL of 36.75) This is higher than the maximum allowable fence height increasing overlooking and shadow (reducing solar access) on the adjacent property.

The natural ground levels shown on all the elevations provided do not match the surveyed levels in the survey plan. This means that the roof of the two storey section is above the 8.5 m height limit also.
