Geotechnical Assessment

Project: New Dwelling
37 Heath Street, Mona Vale NSW

Prepared for:
David Hellmich
37 Heath Street
Mona Vale, NSW 2103

REF: AG 20011
1 December, 2020

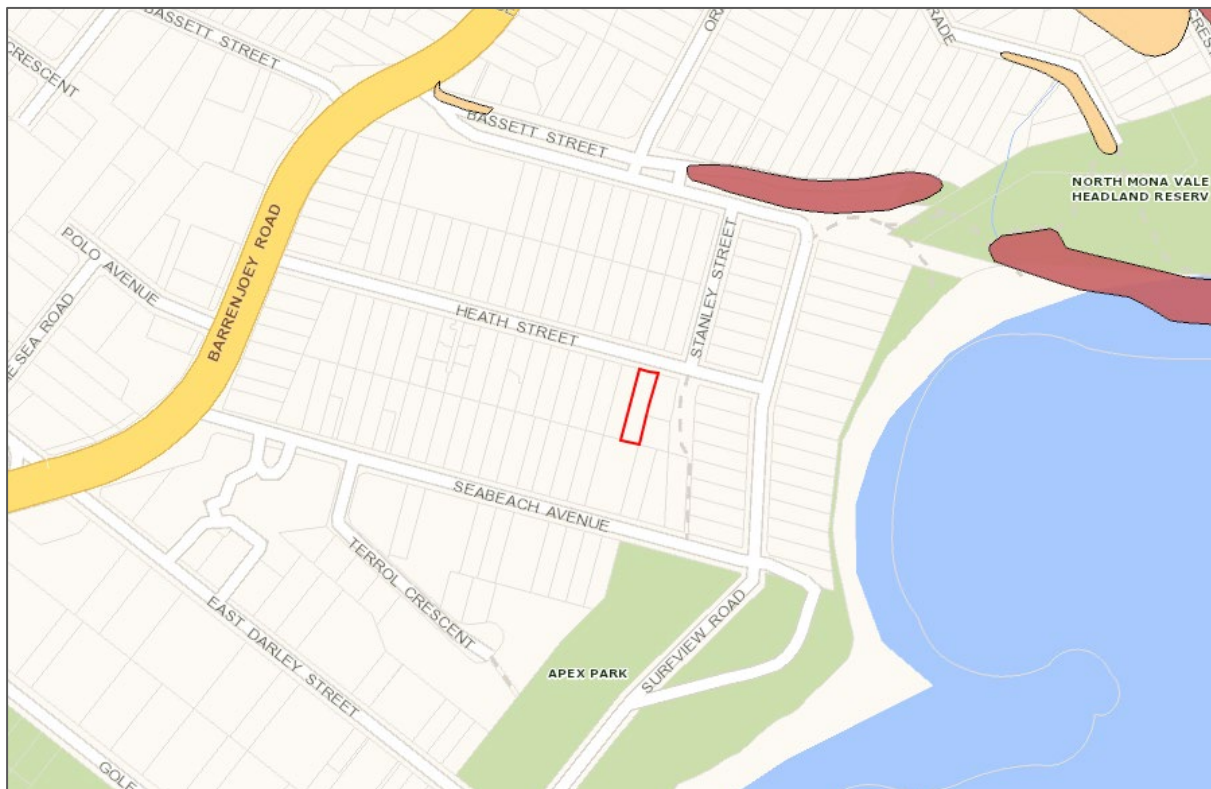
Image 2. Geotechnical Hazard Map - 37 Heath Road, Mona Vale NSW — red polygon (PLEP 2014)

Geotechnical Hazard	
 W	Geotechnical Hazard H1
 AE	Geotechnical Hazard H2

- The existing structure displayed no evidence of significant cracking or settlement that could be attributed to slope instability.
- The property is not located within a '**Geotechnical Hazard Area**' in Northern Beaches Council PLEP Geotechnical Hazard Map (**Image 2** below).

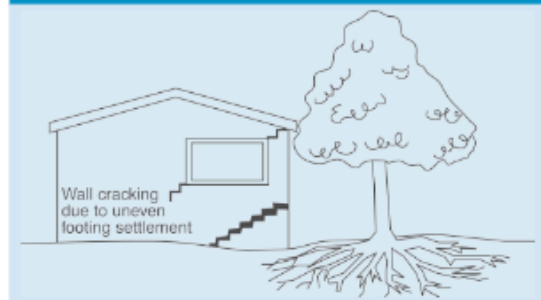
Trees can cause shrinkage and damage

As the weather pattern changes and the soil begins to dry out, the external footings will be first affected, beginning with the locations where the sun's effect is strongest. This has the effect of lowering the external footings. The doming is accentuated and cracking reduces or disappears where it occurred because of dishing, but other cracks open up. The roof lines may become convex.
