## **Geotechnical Assessment**

**Project:** Alterations & Additions  
8 Bungan Head Road, Newport NSW.

**REF: AG 21277**  
10 January 2022

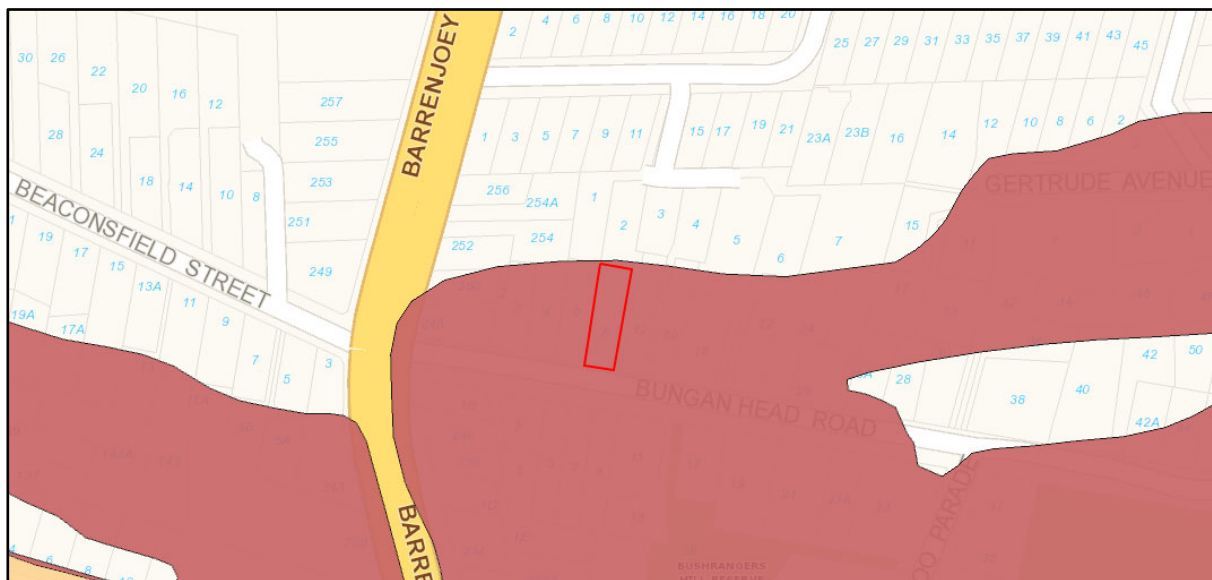
**Image 2.** PLEP Geotechnical Hazard Map  
– 8 Bungan Head Road, Newport NSW

- No evidence of significant soil creep, tension cracks or landslip instability were identified across the site or on adjacent properties as viewed from the subject site at the time of our inspection.
- Based on reference to the plan entitled "Geotechnical Hazard Mapping" (Ref. P21DCP-BC-MDCP2002, dated 2007) prepared by GHD LONGMAC on behalf of Pittwater Council, the site is mapped as **Geotechnical Hazard H1** (see Image 2).

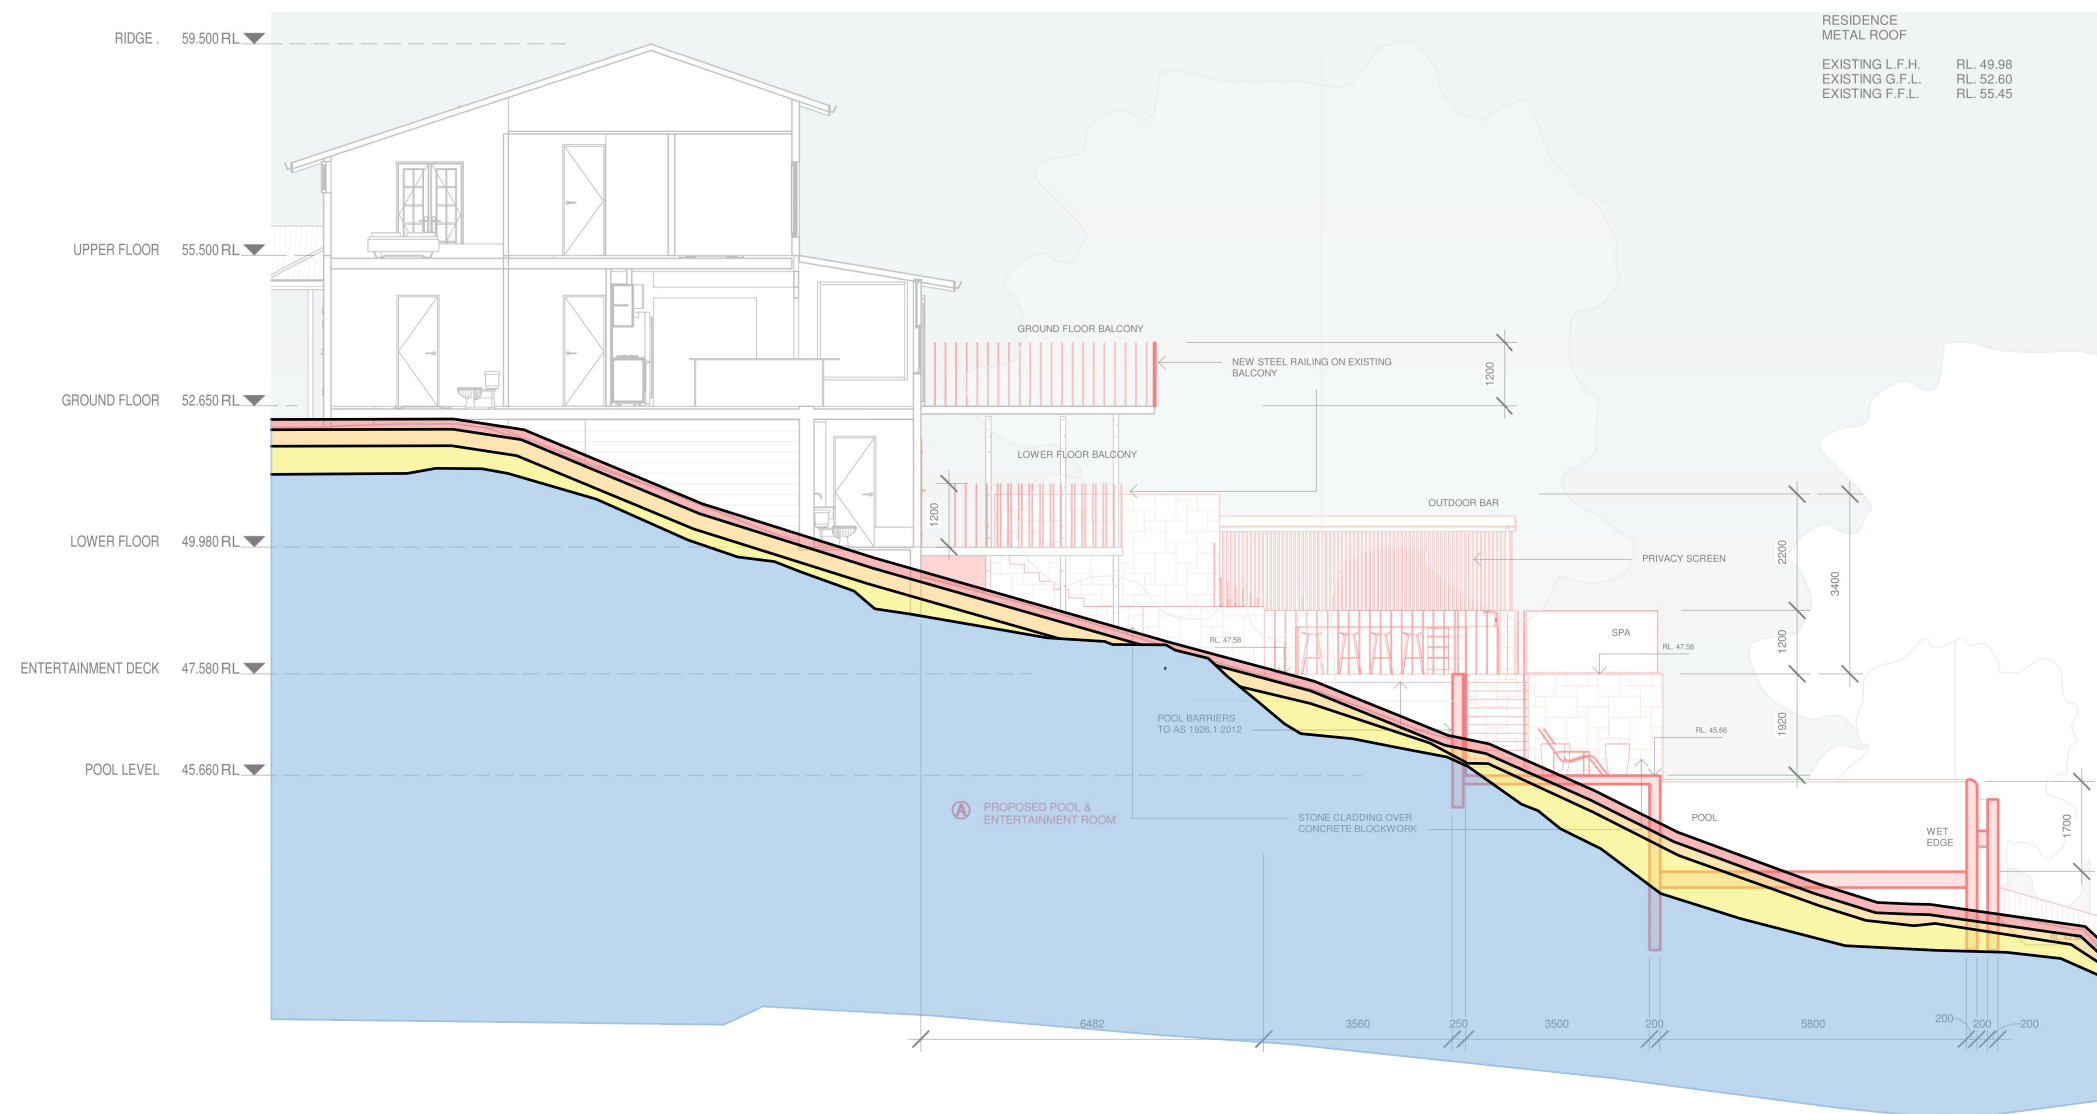
**INFERRED GEOLOGICAL SECTIONS**  
SCALE NTS

INTERPRETED SUBSURFACE SECTION ONLY.  
ACTUAL GROUND CONDITIONS MAY VARY.
