**Re: DA2022/0469 – AMENDED PLANS (“the Amended DA”);
Construction of shop top housing (“the proposal”);
1102 Barrenjoey Road, Palm Beach (“the development site”).**

We write in relation to the above Amended DA on behalf of Ms. Prue Rydstrand (“our client”) who is the owner and occupier of 1100 Barrenjoey Road, Palm Beach (“our client’s home”) which is located to the south of and which adjoins the development site.

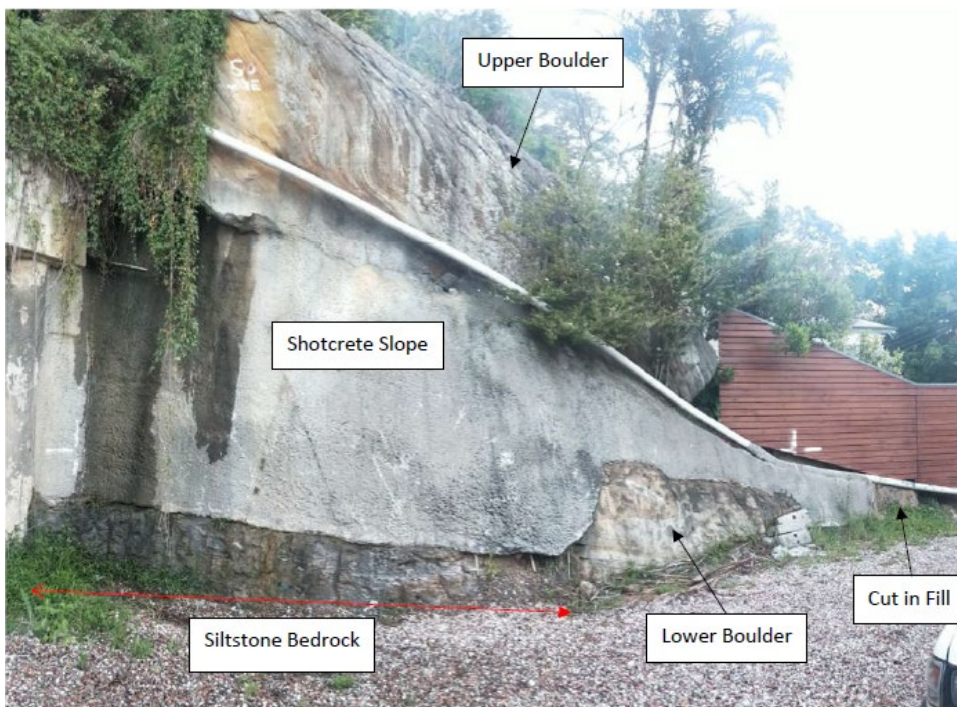
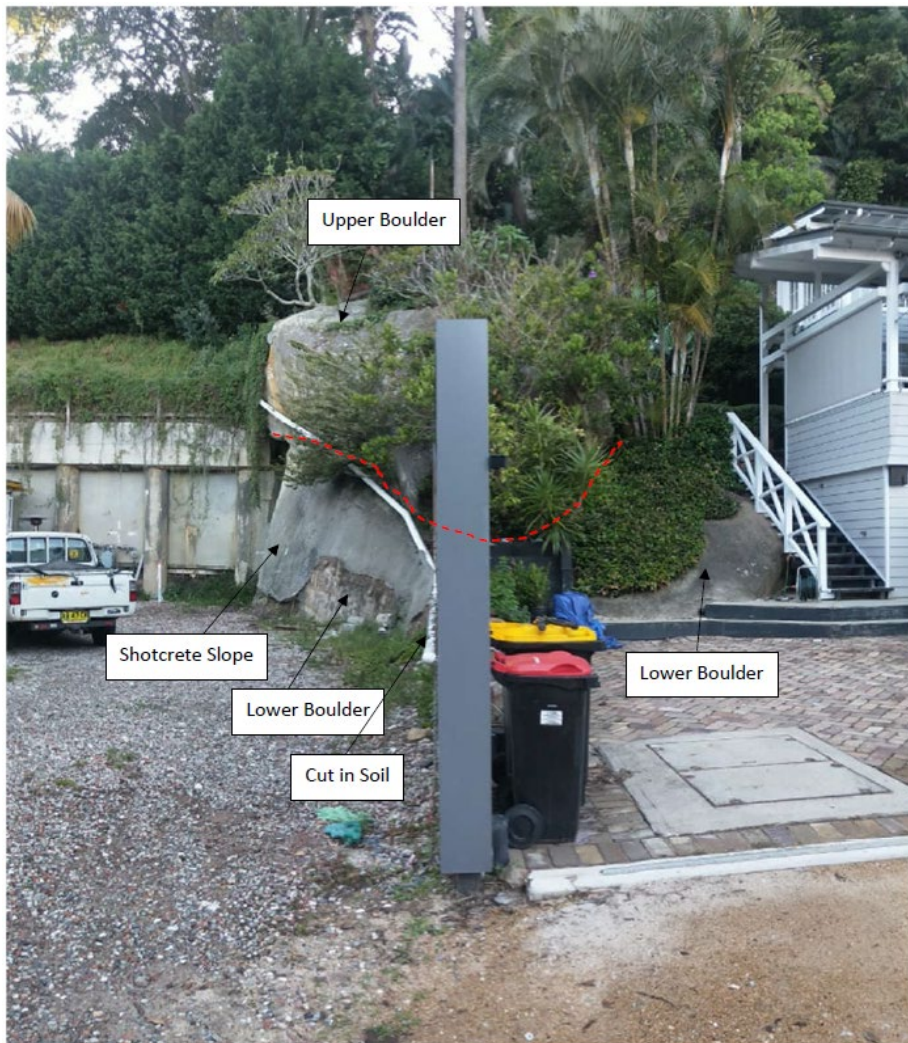
The common boundary condition between the development site and our client's home is shown on the photographs in the geotechnical report submitted with the DA: see below: -

Photos extracted from report prepared by JK Geotechnics

The JK Geotechnics report from November 2020 refers to upper and lower boulders on the southern boundary. Both of these boulders extend onto our client's property.

The geotechnical report says that “portions of the existing boulders and shotcrete (and possibly mesh and bolts) at the southern end of the site will be removed during excavation of the proposed excavation footprint) (Section 7.1.3, page 19, JK Geotechnics report).

We understand this to mean that the part of the boulder above the excavation will be removed/ cut. Our understanding is reinforced by reference to Section 7.3.3 on page 26 of the JK Geotechnics report which states:

“Following removal of the required section of the sandstone boulder along the southern boundary, excavation and support of the underlying siltstone bedrock must be completed with care.”

We do not understand these statements to suggest or imply that the large boulder is somehow to be retained in situ as both the DA and landscape plans suggest. Please
