Preliminary Geotechnical Assessment

Project: Alterations & Additions
13 Alleyne Avenue, North Narrabeen NSW

13 Alleyne Avenue, North Narrabeen NSW

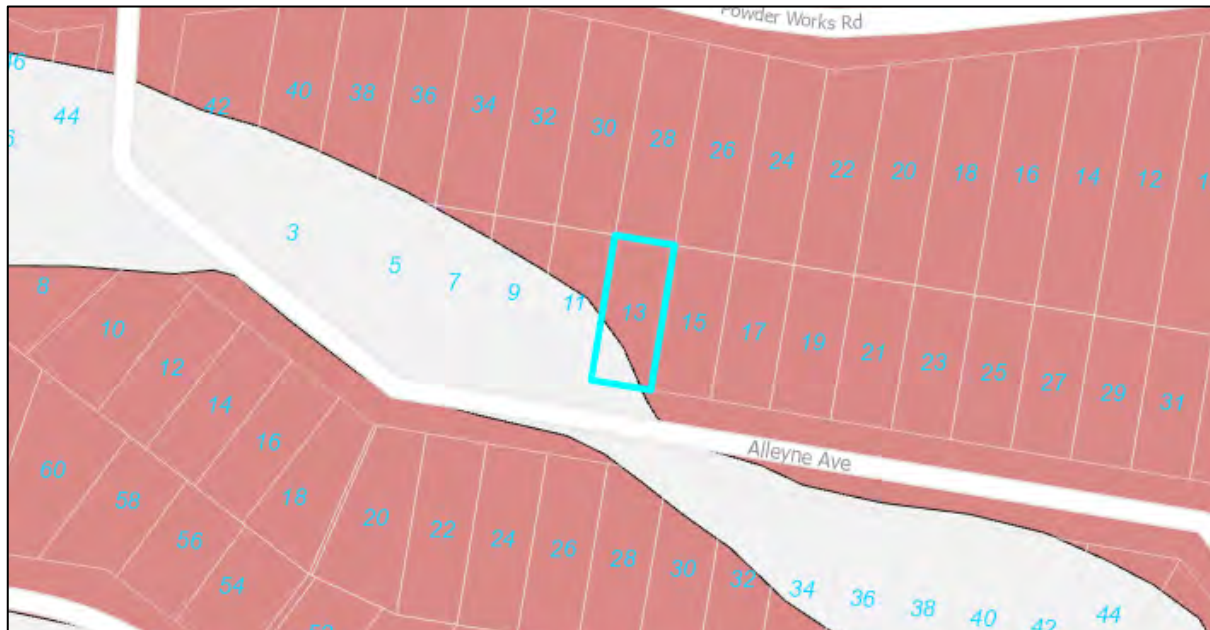
Image 1. Pittwater Geotechnical Hazard Risk Map:
13 Alleyne Avenue, North Narrabeen NSW (© NBC Maps)

LEGEND
Pittwater Geotechnical Hazard Map
■ Geotechnical Hazard H1
■ Geotechnical Hazard H2

Based on reference to the plan entitled 'Geotechnical Hazard Mapping' (Ref. P21DCP-BC-MDCP2002, dated 2007) prepared by GHD LONGMAC on behalf of Pittwater Council, the site is located within **Geotechnical Hazard Zone H1**.

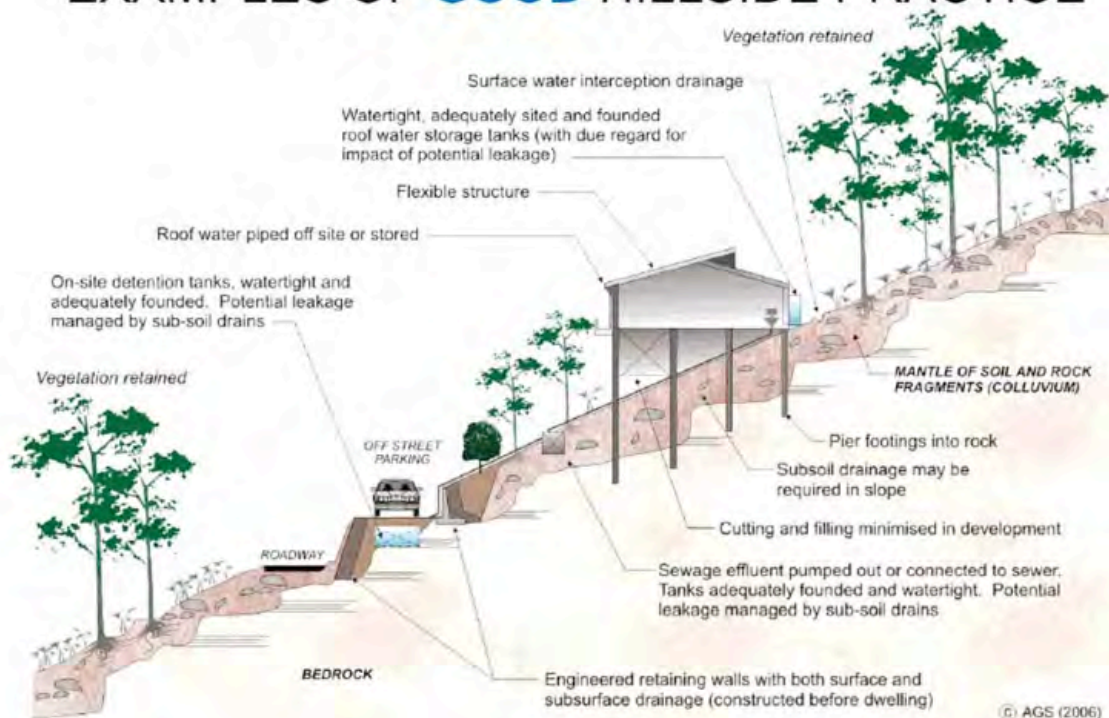
EXAMPLES OF **GOOD** HILLSIDE PRACTICE

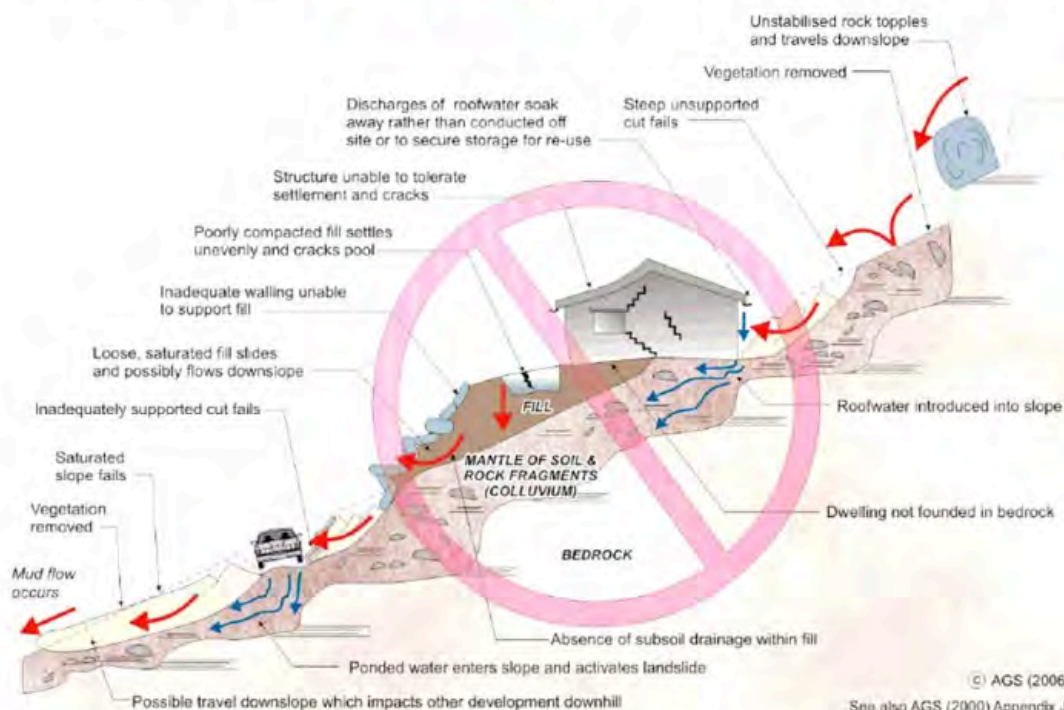
EXAMPLES OF **POOR** HILLSIDE PRACTICE
