Geotechnical Assessment

Proposed Light Industries, and/or Warehouse and Distribution

323-327 Warringah Road, Frenchs Forest NSW

Ref: CG22-0774-A Rev 0

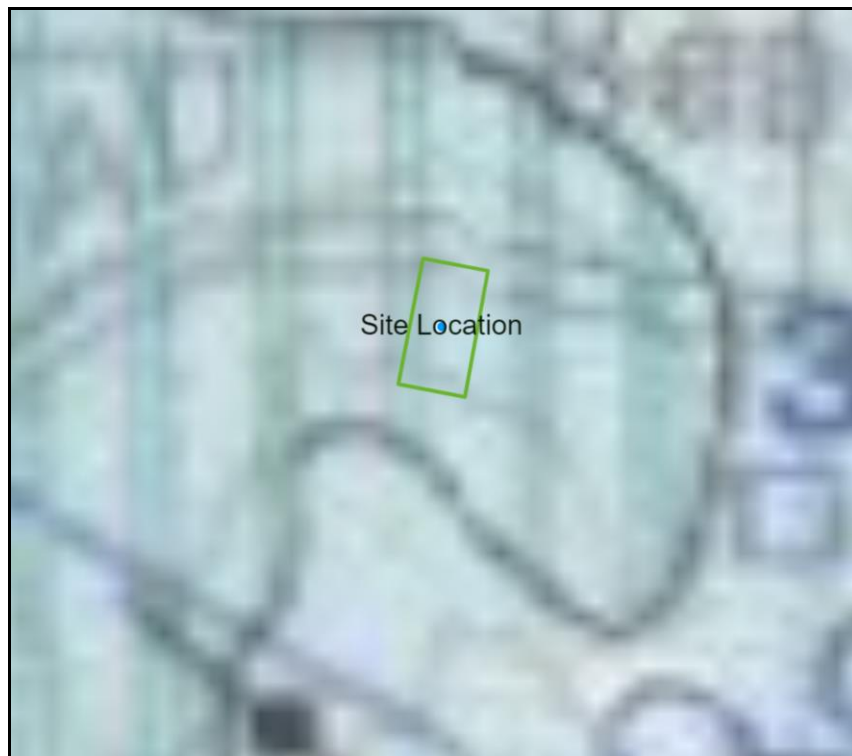
Based on review of Sydney 1:100,000 Geological map Geological Series Sheet 9130 (Edition 1) 1983 indicates that site is underlain by Middle Triassic Aged Geology Wianamatta Group (Rhs) which generally comprises shale, laminate black to dark grey shale and laminite.

Figure 2: Geology of the site (Sydney 1:100,000 Geology Map)

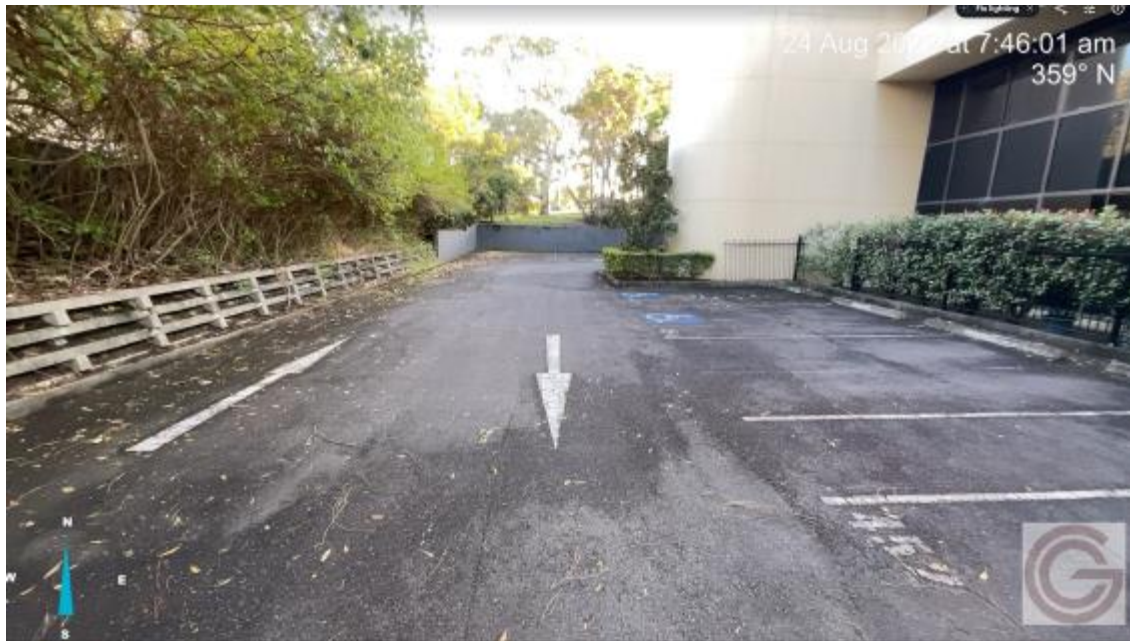
Photo 3: Site view showing retainign walls on the north and west boundary

The site is occupied by a commercial three storey building, an open carpark and landscaping area. A block retaining wall and crib walls were observed along the northern and western boundary respectively. By visual observations, the existing structures appears to be in a reasonably good condition.

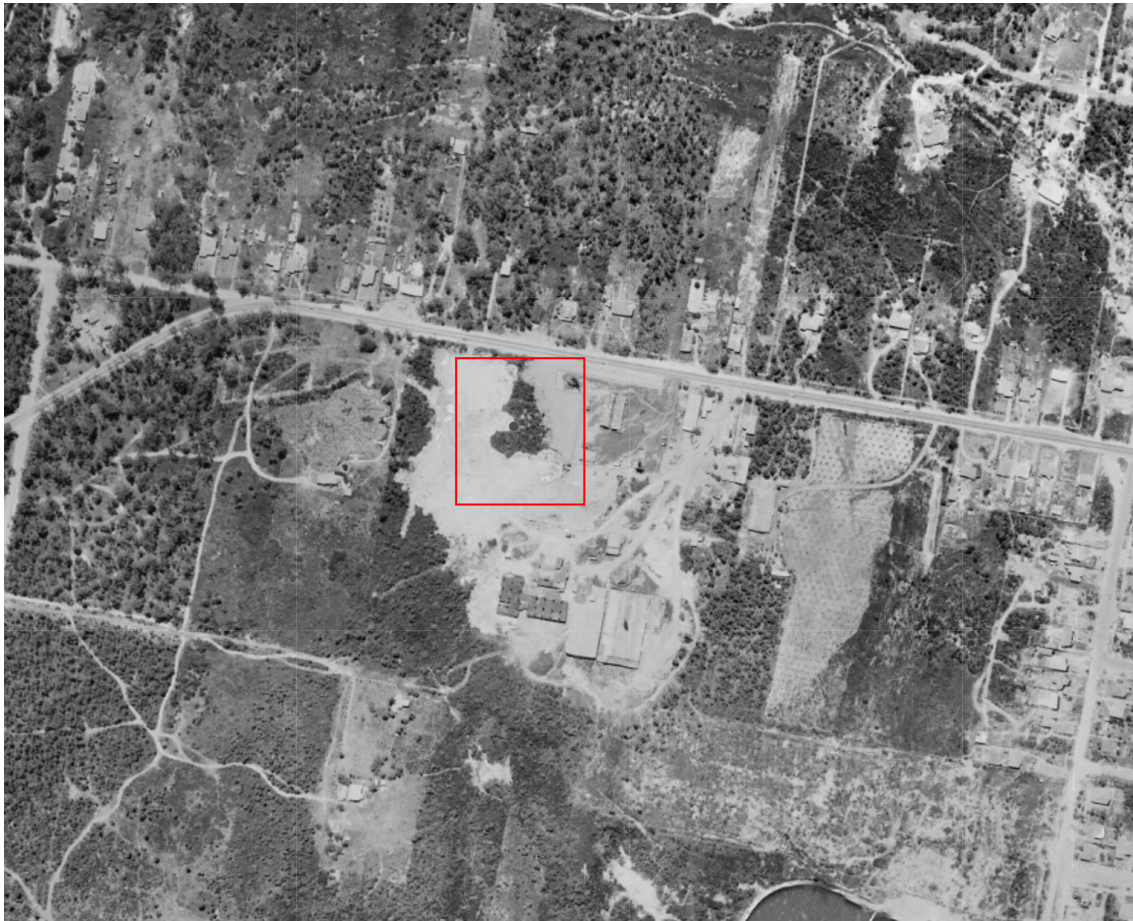
Photo 5: Historical Aerial Image of Year 1955

- In 1955 the site is observed to be cleared of vegetation and the topsoil appear to have been disturbed;
- In 1965 and 1970, it appears that significant earthworks was carried out on site in the south west side;
- In 1971 and 1975, the area on the south of the site appeared to be filled;

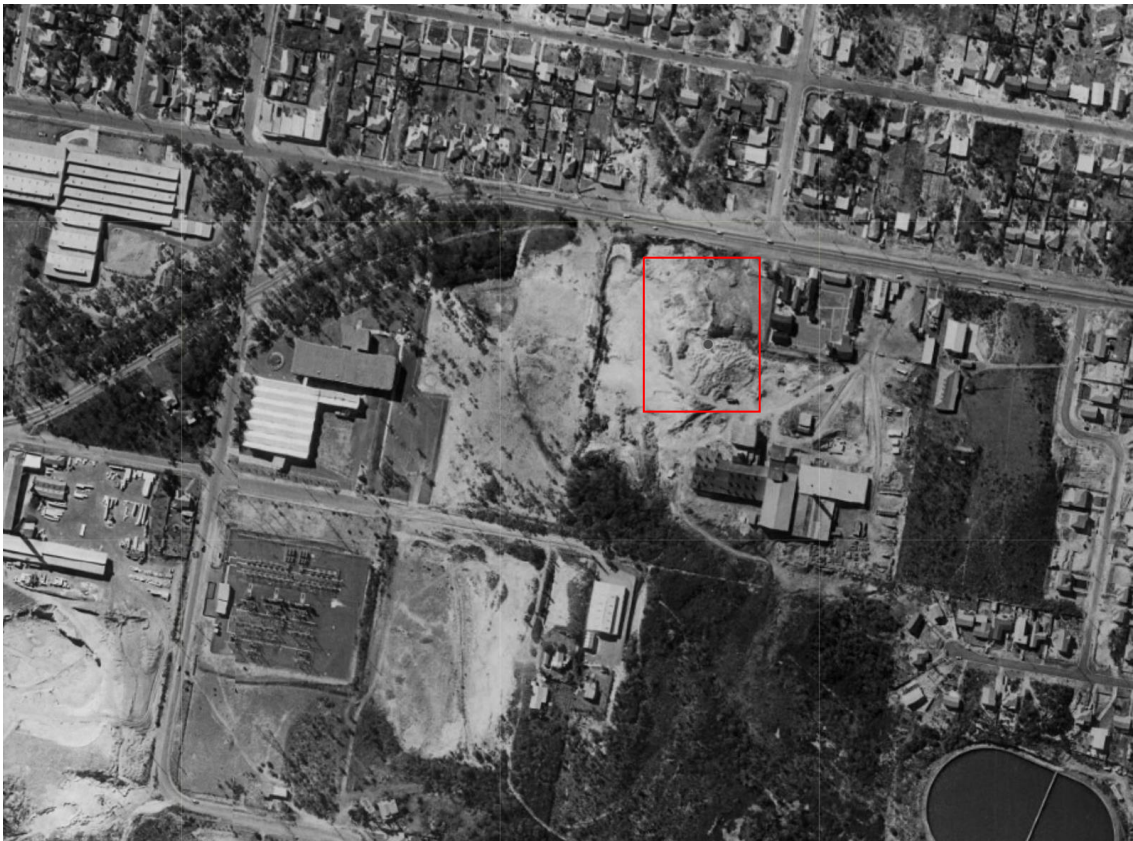
Photo 6: Historical Aerial Image of Year 1965

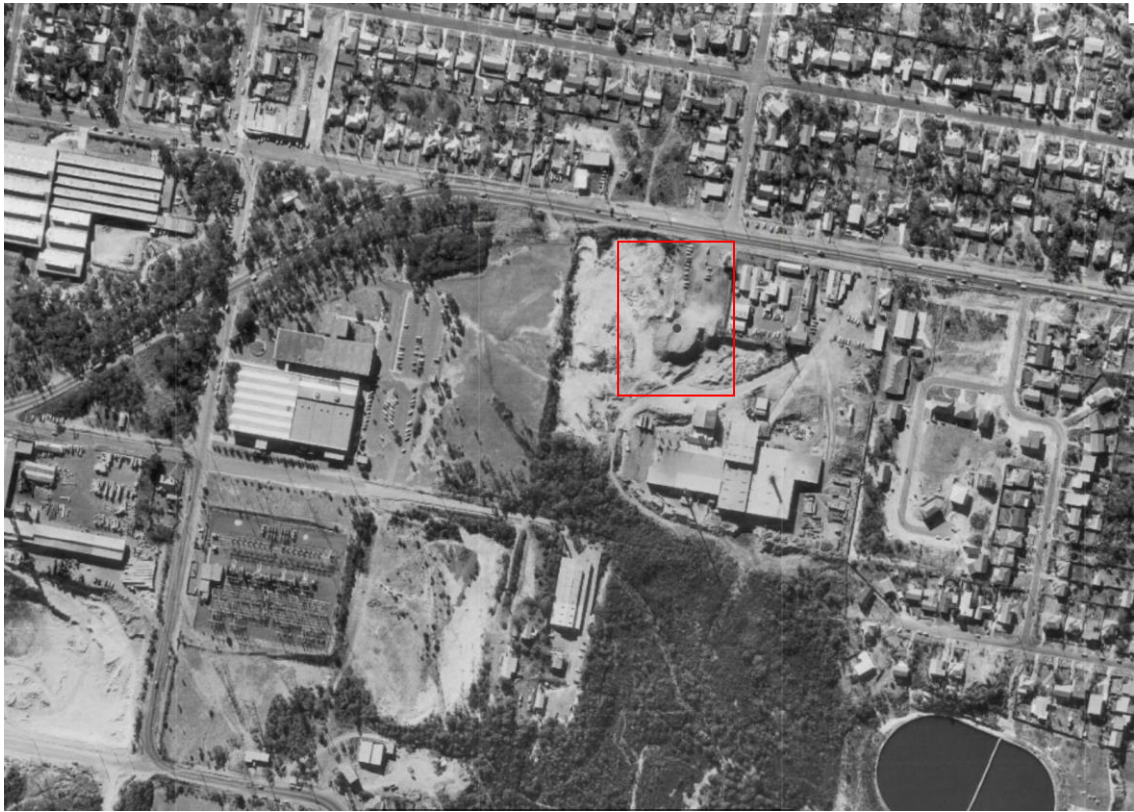
Photo 7: Historical Aerial Image of Year 1970

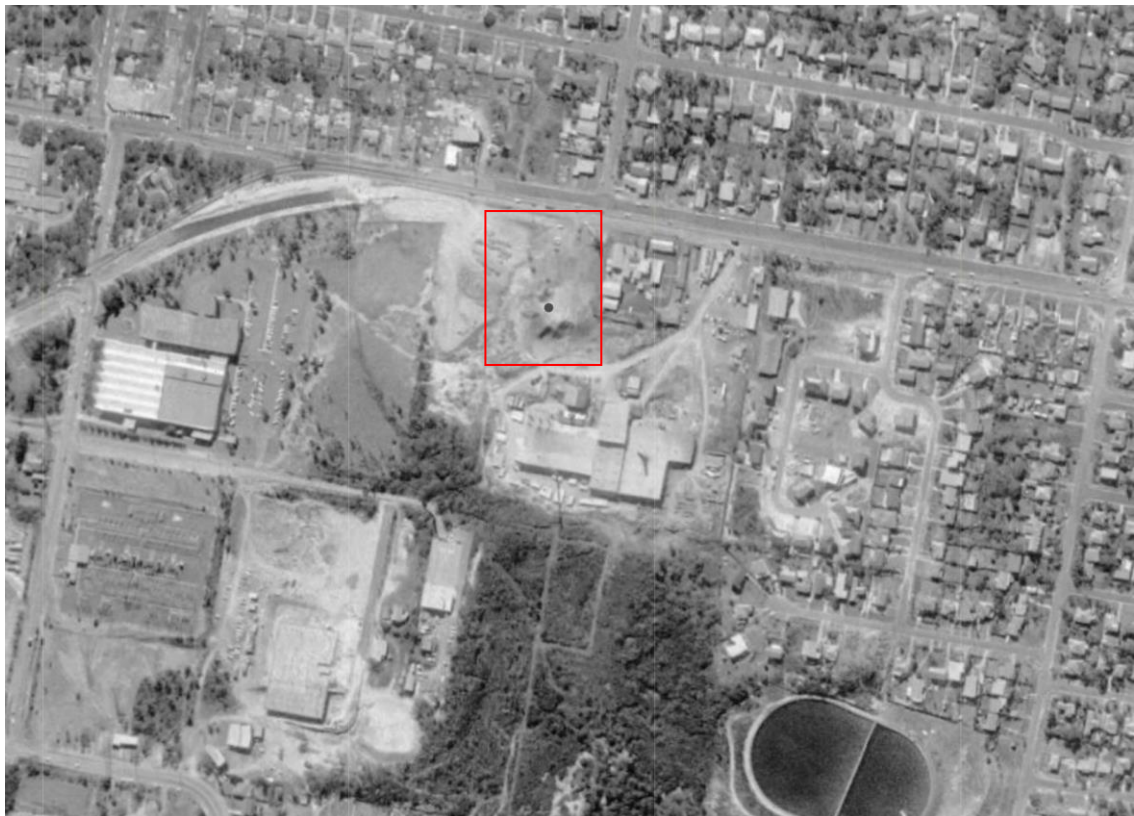
Photo 8: Historical Aerial Image of Year 1971

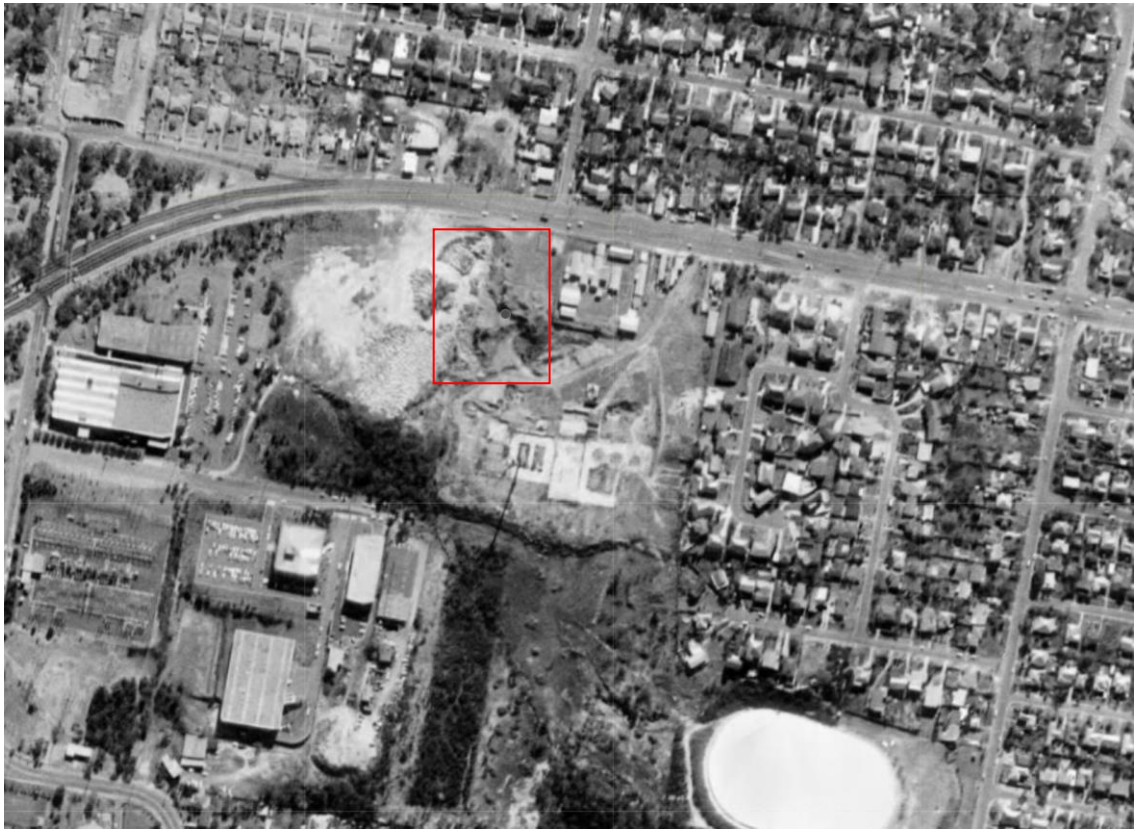
Photo 9: Historical Aerial Image of Year 1975
