## **Preliminary Geotechnical Assessment**

**Project:** Swimming Pool & Associated Landscaping  
116 Elimatta Road, Mona Vale NSW

**Ref:** AG 22119  
4 April 2022

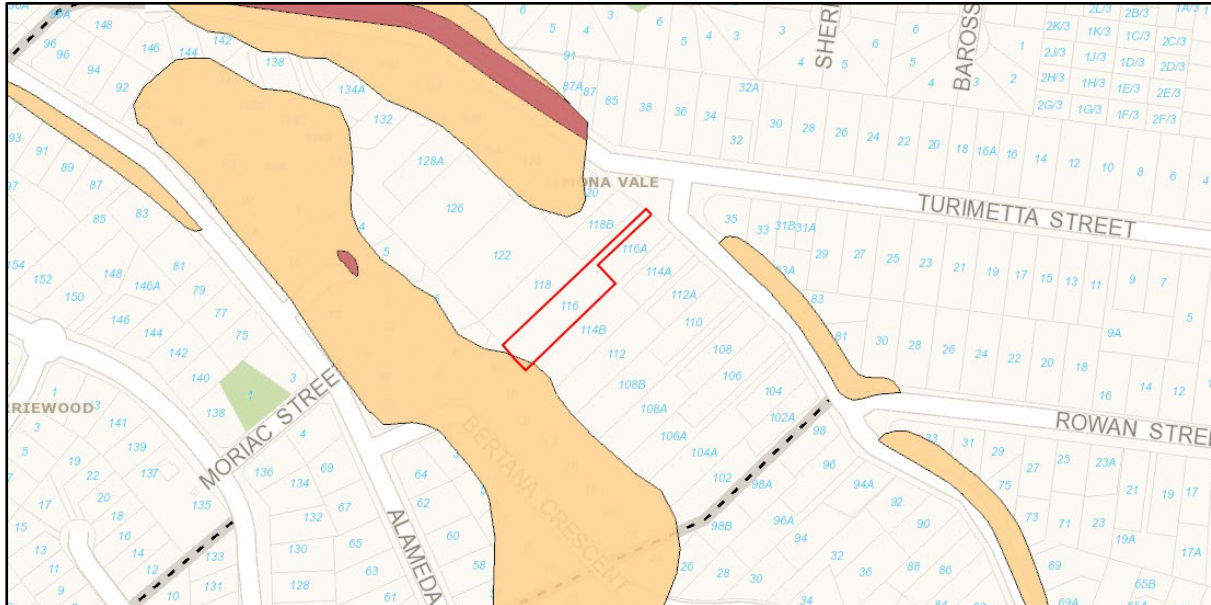
**Image 1.** Pittwater Geotechnical Hazard Risk Map: 116 Elimatta Road, Mona Vale NSW (© NBC Maps)

Based on reference to the plan entitled 'Geotechnical Hazard Mapping' (Ref. P21DCP-BC-MDCP2002, dated 2007) prepared by GHD LONGMAC on behalf of Pittwater Council, the site is located within **Geotechnical Hazard Zone H2**.
