## AS2870-2011 SITE CLASSIFICATION

Lot 30 No 37 Wareham Crescent, Frenchs Forest  
New South Wales

AS2870 Site Classification

**Class P**

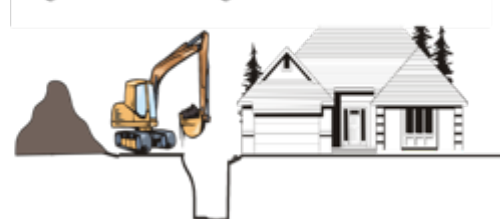
Fig. 11 De-stabilizing house foundations

- Ensuring that excavations are well supported or are dug to avoid collapses. (Fig. 11)
- Constructing well-compacted and retained 'soil aprons' around the building to stop erosion.

- Special considerations if any excavations are to be dug near adjoining structures. (Fig. 11)
- Sloping the soil and paths away from the building by the minimum amount required by the building regulations to prevent water flowing towards the building foundations. (Fig. 10 & 18)

- Running machinery over shallow drain pipes may break them causing leaks and subsequent foundation movements.
- Any excavations close to building footings can cause them to sink by disturbing the foundation material or by drying the foundation clay. (Fig 11)
