Report on  
Desktop Groundwater Assessment

Proposed Industrial Development  
100 South Creek Road, Cromer

Prepared for  
EG Funds Management Pty Ltd

Project 86951.00  
November 2020

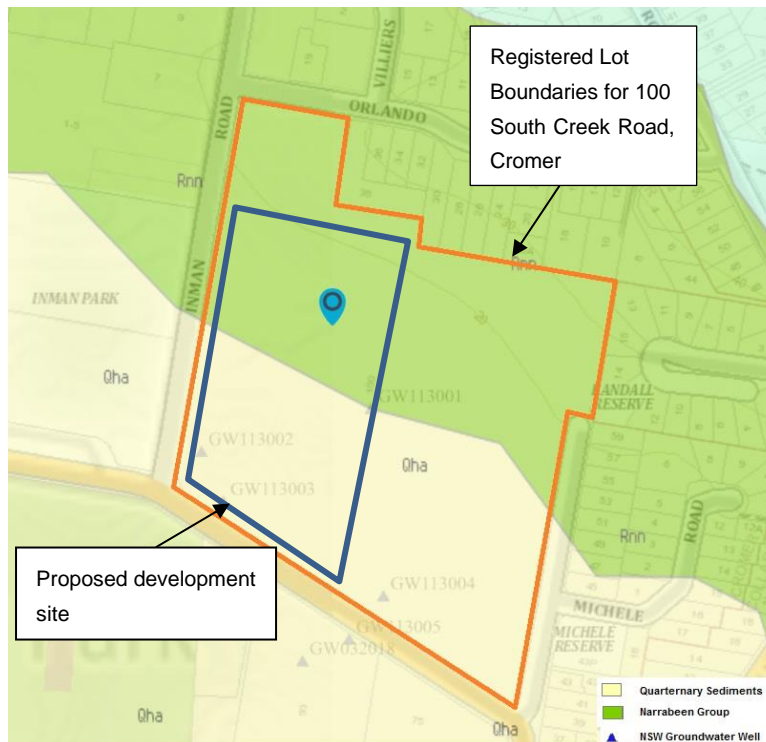
**Figure 1.** Excerpt from geological map sheet 9130 for Sydney.

Reference to the Sydney 1:100 000 Series Geological Map Sheet (9130) indicates that the site is on or near a geological boundary. The upper portion of the site, over the northern half of the broader site, is shown to be underlain by Narrabeen Group rocks of Triassic age (comprising interbedded laminite, shale, quartz and sandstone) and the southern portion is underlain by alluvial stream deposits of Quaternary age (comprising silty to peaty quartz sand, silt and clay). An excerpt from the geological map is given in Figure 1.

The location of Water NSW-registered groundwater wells is also shown in Figure 1. For the four registered wells located on the site (drilled in 2010), no measurement of the standing water level is recorded. All boreholes (i.e. wells) were drilled to a depth of 7.5 m.

Borehole and cone penetration test (CPT) investigations carried out at the site suggest that the geological boundary between areas underlain by bedrock and alluvium is located further to the north than shown on the geological map (and Figure 1), with relatively deep soils encountered over most of the proposed development footprint.
