Ref: SRE/711/WH/20

RE: PRELIMINARY GEOTECHNICAL ASSESSMENT FOR PROPOSED ALTERATIONS & ADDITIONS AT 44 ENNERDALE CRESCENT, WHEELER HEIGHTS NSW 2097 - PRELIMINARY GEOTECHNICAL ASSESSMENT

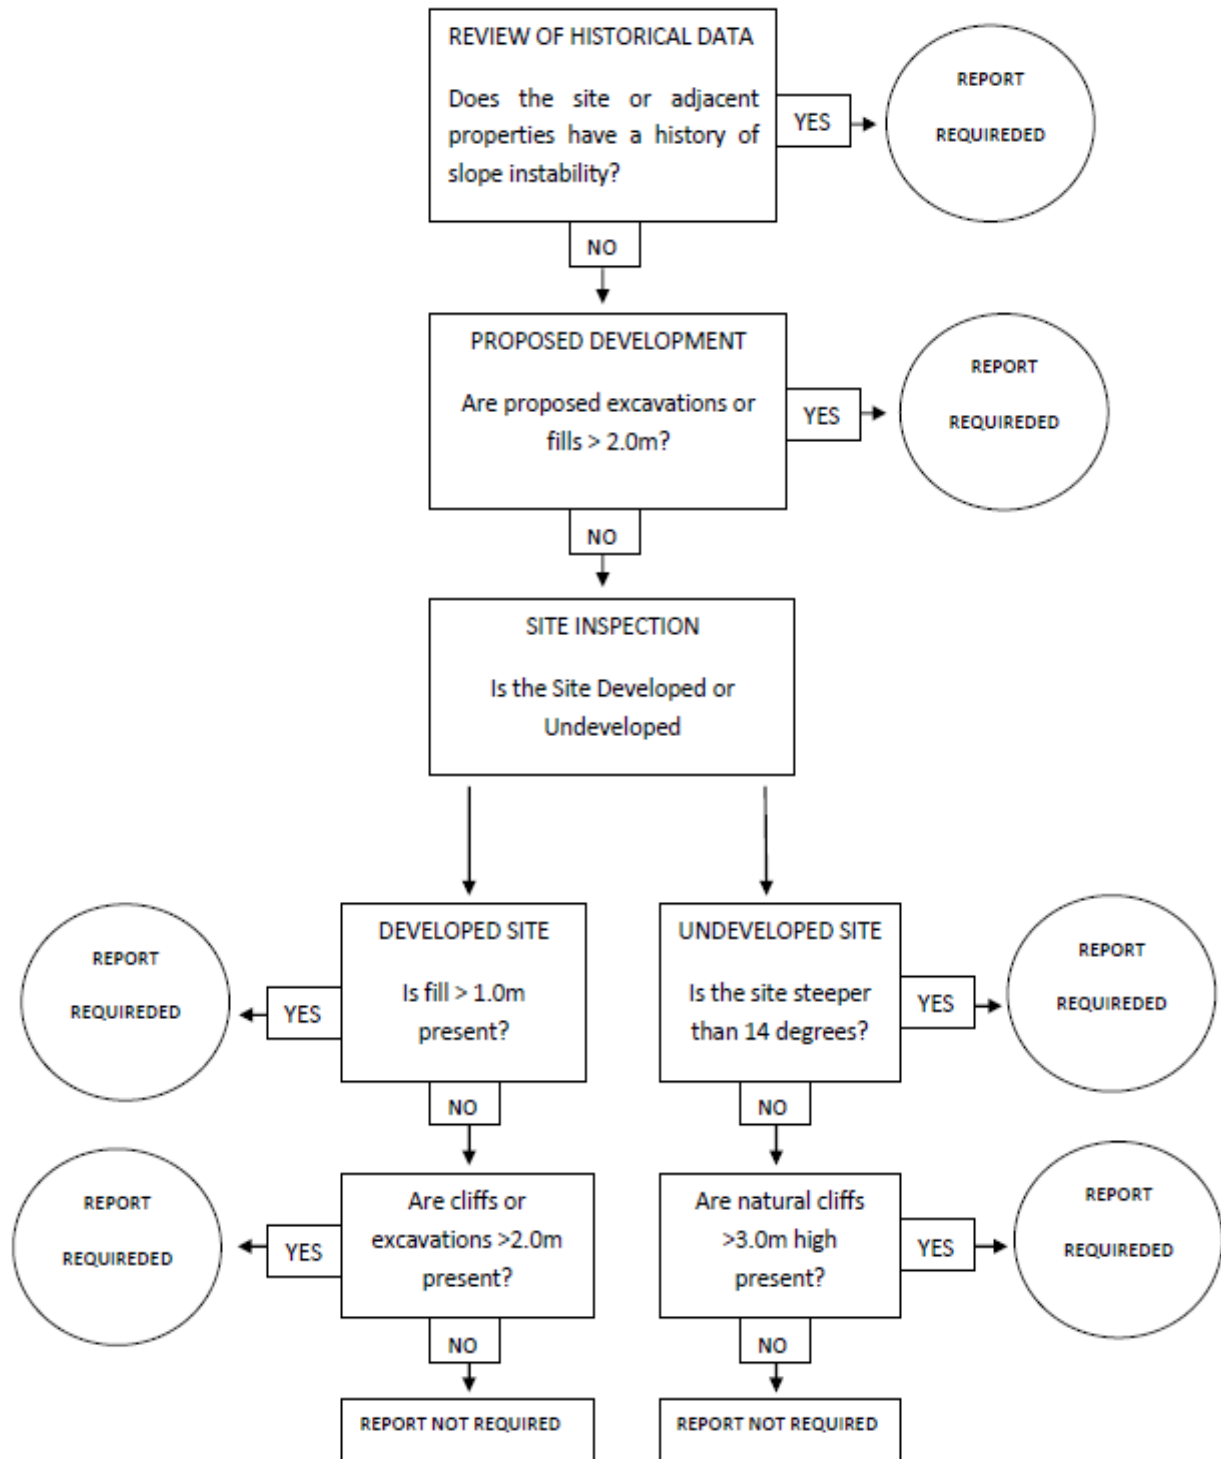
APPENDIX 1

CHECKLIST FLOW CHART FOR COUNCIL'S ASSESSMENT OF SITE CONDITIONS AND NEED FOR GEOTECHNICAL REPORT IN LANDSLIP RISK CLASSES B AND D

Appendix 1 – Checklist Flow Chart for Council's Assessment of Site Conditions and Need for Geotechnical Report in Landslip Risk Classes B and D
